## SALDANHA BAY AQUACULTURE DEVELOPMENT ZONE ENVIRONMENTAL CONTROL OFFICER SUMMARY REPORT 16

**July 2023**

Anchor Research & Monitoring Report No. 2014/16\_2c

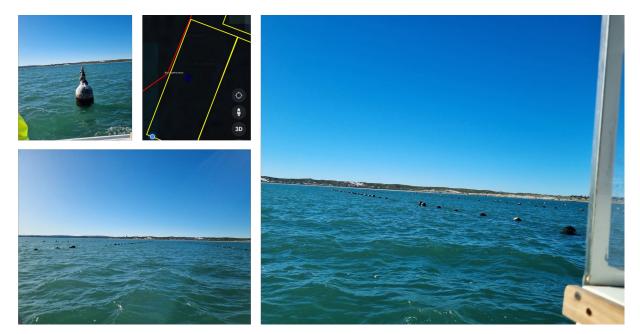
## 3.6.1 BLUE SAPPHIRE PEARLS

Farm name	Location	Species	Compliance status	Comment
Blue Sapphire Pearls	Big Bay	Mussels	PC	4 mussel lines and 3 oyster lines, all taut, straight, suitably floated and marked with unique markers. However, some of the floats and buoys had been affected by biofouling.
K2019005713	Big Bay	Mussels	NC	I I mussel lines are authorised in this farm and only 7 installed to date. Lines I, 4 and 6 were taut and straight. These lines had very low biofouling on them. It assumed that the rest of the infrastructure is missing or sunken.
K2019005725	Big Bay	Mussels	NC	I I mussel lines are authorised in this farm and only 7 installed to date. Line I was broken and partially sunken. Lines 2, 5, 6 and 7 were missing or completely sunken. Line 4 appeared to be under water.
Madima General Agriculture Trading	Big Bay	Mussels	NC	I I lines are authorised, 6 lines active and 2 dormant in this farm. A few lines were taut and straight but very low and ready for harvesting. These lines were not biofouled. Lines with a cluster of buoys were evident. Lines 3, 4 and 6 have sunken. Parts of line 3 and 4 were tangled together. There were also ropes floating under water.

Figure 3.2. BSP longlines observed to be straight, taut, suitably floated, and marked with unique identifiers (top and bottom left and right). Live Google Earth pin of location of compliance photograph in relation to the BSP Big Bay licence area (yellow boundaries) (top middle).

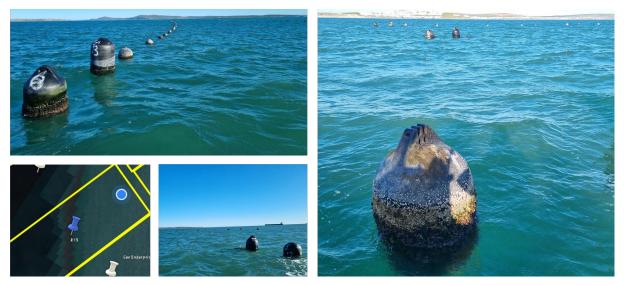
## 3.6.2 K2019005713 (K13)

The K2019005713 (K13) farm is authorized for a total of 11 mussel lines. Currently, only 7 lines are present on the farm, and the 4 additional lines are yet to be installed. Among them, lines 1, 4, and 6 were found to be taut and straight and they were not affected intensively by biofouling (Figure 3.3). As for the remaining lines, it is assumed that the infrastructure is either missing or sunken, hence the Non-Compliant rating (Table 3.2).

Figure 3.3. K13 line 6 observed to be taut, straight, suitably floated and marked with unique identifiers (top left). Live Google Earth pin of location of compliance photograph in relation to the K13 Big Bay licence area (yellow boundaries) (bottom left). Sunken line (bottom middle) and a float with some biofouling (right).

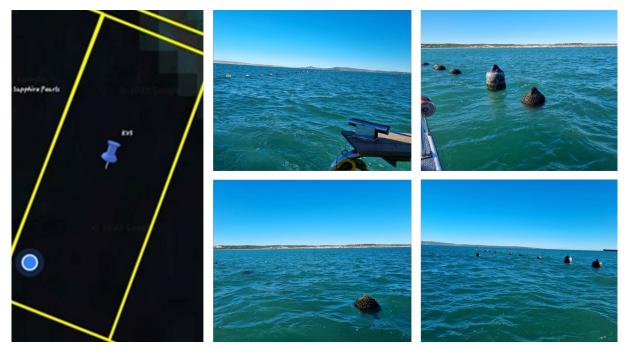
## 3.6.3 K2019005725 (K25)

K2019005725 (K25) also have 11 mussel lines officially authorised and also have 7 lines present on the farm. The 4 additional lines have not been installed yet. Upon inspection, it was noticed that line 1 had suffered damage and was broken, leaving it partially submerged. Lines 2, 5, 6, and 7 were not found in their expected positions and were likely missing or entirely submerged. Line 4 was observed to be under the water's surface. Some biofouling on buoys was observed (Figure 3.4). As such, the farm was rated as Non-Compliant with Operational Guidelines (Table 3.2).

Figure 3.4. Live Google Earth pin of location of compliance photograph in relation to the K25 Big Bay licence area (yellow boundaries). K25 lines observed to be taut, straight, suitably floated and marked with unique identifiers with some biofouling (top left). Sunken line (bottom middle) and faded identifying marker (top right) line 4 appeared to be under water (bottom right).

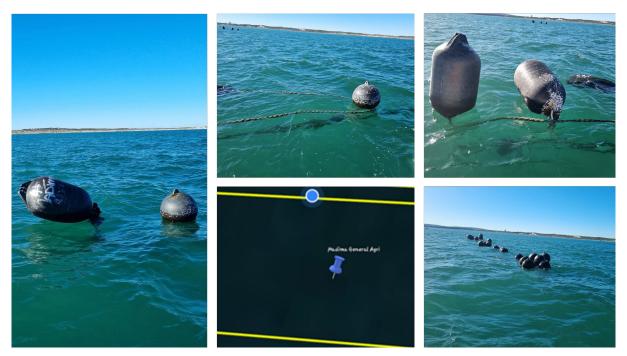
## 3.6.4 MADIMA GENERAL AGRICULTURE TRADING (MAD)

Madima General Agriculture Trading (MAD) have a total of 11 authorised mussel lines. Presently, only 6 of these lines are in existence on the farm, and the 5 additional lines are yet to be installed. Some of these lines were observed to be taut and straight, but they were positioned very low in the water indicating they were ready for harvesting. The majority of these lines were not affected by biofouling. Additionally, there were lines with clusters of buoys grouped together (Figure 3.5). Lines 3, 4, and 6 were found to be completely sunken. The entanglement of parts of lines 3 and 4 poses a risk to whale entanglement, creating further complications in the mussel farm operation. This situation requires immediate attention and action to prevent any harm to marine wildlife and to ensure the safe and sustainable functioning of the farm. Furthermore, during the inspection, floating ropes were spotted beneath the water's surface, adding to the complexities of the situation. This farm is therefore rated as Non-Compliant with Operational Guidelines (Table 3.2).

Figure 3.5. MAD Broken lines which were floating above surface water (top left and right). Visible identifying marker on the float and very low biofouling (left). Live Google Earth pin of location of compliance photograph in relation to the MAD Big Bay licence area (yellow boundaries) (bottom middle). A cluster buoys grouped together (bottom right).

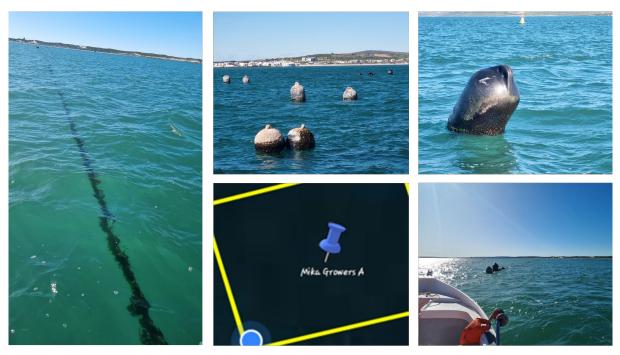
#### 3.6.5 MIKA GROWERS (MIK)

Mika Growers	Big Bay	Mussels	NC	11 mussel lines are authorised and 3 dormant in this farm. However, there were end floats with numbers 13 and 12 which were sunken with no buoys or droppers nor stock. In addition, line 1 had no stock, only lines 4, 5, 6, 9 and 11 were taught and straight. Line 10 was missing an end float. Consequently, all infrastructure was biofouled. The remaining lines were sunken or missing. A single buoy was floating about on its own with no visible line.
Mmmagri Consult	Big Bay	Mussels	NC	I I mussel lines are authorised, 10 active and 3 dormant in this farm. The visible lines on this farm were very low particularly line 7. End floats on with no visible markers. The buoys are in groups of three or more. Major gap between line I and 4. A broken line was also observed.
Pluto Mussels and Trading	Big Bay	Mussels	NC	I I mussel lines are authorised, 6 active and 5 dormant in this farm. Line 3 and 4 are close to each other. Line 3 partially sunken. A long rope on the surface with just a buoy holding it up. The remaining infrastructure is missing or sunken. A float which belongs to Pluto Mussel and Trading was floating between SASF2 and Simunye mussel boundaries.

There should be 11 authorised mussel lines located Mika Growers (MIK) farm boundary. During the inspection, it was noticed that there were sunken end floats with the numbers 13 and 12. These floats had no buoys, droppers, or product attached to them. This farm is not permitted to have lines 12 and 14. In addition to this, there was no notification to the ECO about adding the remaining 4 approved lines. Line I was found to have no product, meaning there were no mussels attached to it. Only lines 4, 5, 6, 9, and 11 were observed to be taut and straight, indicating that they were properly installed and operational. However, line 10 was missing an end float. Most of the infrastructure, including the buoys and floats, was heavily affected by biofouling (Figure 3.5). This could potentially have implications on the overall health and productivity of the mussel farm. Moreover, the remaining lines were either sunken or missing entirely. There was also a solitary buoy floating aimlessly with no visible line attached to it. Therefore, MIK is rated as Non-Compliant with Operational Guidelines (Table 3.2).

Figure 3.6. Dormant MIK line (left) and buoys with heavy excess biofouling (top middle). Faded identifying marker on end float (top right). Live Google Earth pin of location of compliance photograph in relation to the MIK Big Bay licence area (yellow boundaries) (bottom centre).

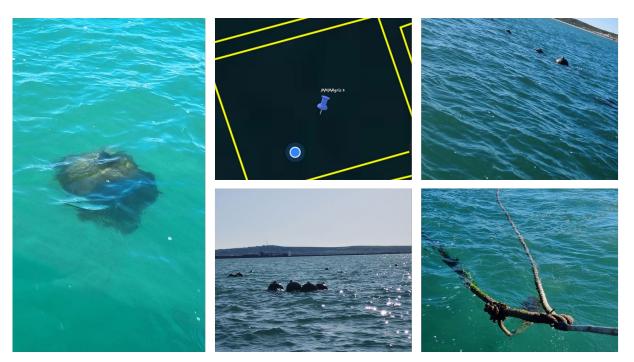
#### 3.6.6 MMMAGRI CONSULT (MMM)

Figure 3.7. A MMM buoy under water with excess algae (left). Live Google Earth pin of location of compliance photograph in relation to the MMM Big Bay licence area (yellow boundaries) (top middle). A very low line (top right), cluster of buoys (bottom middle) and broken line (bottom right).

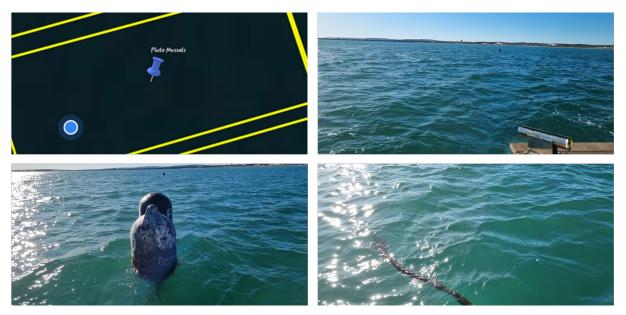
## 3.6.7 PLUTO MUSSEL & TRADING (PLU)

A total of 11 mussel lines are authorised in Pluto Mussel & Trading (PLU) farm boundary. Currently, only 6 lines are present on the farm, and the 5 additional lines are yet to be installed. Notably during site inspection, lines 3 and 4 were very close to each other. In addition to this, line 3 appeared to be partially sunken. Furthermore, there was a long rope observed on the water's surface, with only a buoy keeping it afloat. This indicates that some part of the infrastructure might be missing or submerged beneath the water (Figure 3.8). Additionally, it was noticed that most of the remaining infrastructure, presumably the other mussel lines, is either missing or sunken. Interestingly, a float that belongs to Pluto Mussel and Trading was found floating in an area between SASF2 and Simunye Mussel boundaries. PLU is therefore rated as Non-Compliant with Operational Guidelines (Table 3.2).

Figure 3.8. Live Google Earth pin of location of compliance photograph in relation to the PLU Big Bay licence area (yellow boundaries) (top left). Lines missing or sunken (top right), end floats very close to each other (bottom left) and a broken line (bottom right).

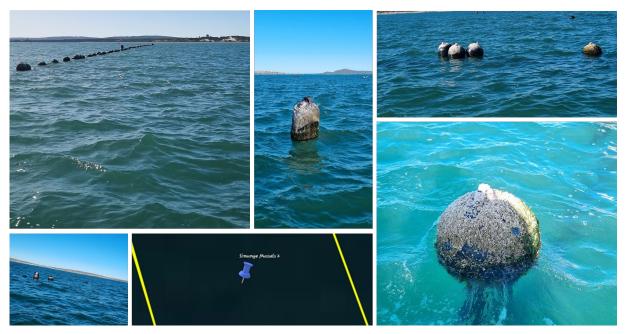
## 3.6.8 SIMUNYE MUSSELS (SIM)

Simunye Mussels	Big Bay	Mussels	NC	I I mussel lines are authorised, 6 active and I dormant in this farm. Line 2 was taut and straight but was biofouled. Line I had no stock. Lines 3, 4, 5 and 6 are either sunken or missing.
Southern Atlantic Sea Farms 2	Big Bay	Mussels	NC	I I mussel lines are authorised in this farm. No infrastructure or product was observed but unidentified end float and 3 buoys were floating about on this farm.
Ulwazi Kukutya	Big Bay	Mussels	NC	6 mussel lines are authorised and 3 dormant in this farm. Line 3 was the only line existing on this farm and was sunken. Two buoys were

Simunye Mussels (SIM) have 11 authorised mussel lines. At present, only 6 are present on the farm, and the 5 additional lines are yet to be installed. During the inspection, it was observed that line 2 were taut and straight but affected by biofouling. Line 1 had no mussel product i.e., there were no mussels present on this line. Furthermore, there were concerns about lines 3, 4, 5 and 6, as they were either sunken under the water or entirely missing (Figure 3.9). This raises questions about the integrity of the infrastructure and the need for further investigation or repairs to ensure the farm operates efficiently and effectively. SIM is therefore rated as Non-Compliant with Operational Guidelines (Table 3.2).

Figure 3.9. A SIM line observed to be taut, straight, suitably floated and marked with unique identifiers (top left). An end float with faded identifying marker (top middle), buoys in groups of 3 (top right), a sunken line (bottom left). Live Google Earth pin of location of compliance photograph in relation to the SIM Big Bay licence area (yellow boundaries) (bottom middle). A buoy with excess biofouling (bottom right).

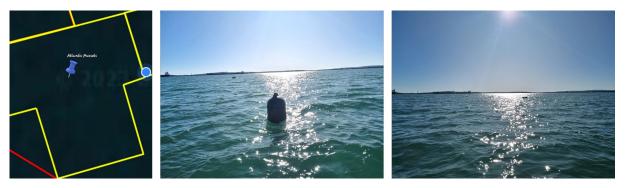
## 3.6.9 SOUTHERN ATLANTIC SEA FARMS 2 (SASF2)

The Southern Atlantic Sea Farms 2 (SASF2) is authorised for 11 mussel lines. During the inspection, no infrastructure or mussel products were observed on the site. Nonetheless, there were some floating infrastructures noted, including an unidentified end float and three buoys, which might be related to the mussel farming operation (Figure 3.10). The duty of care and remediation of environmental damage is defined in Section 28 of the Act which form part of the National Environmental Management Act (NEMA), and SASF2 was issued with a notice of suspension of right in accordance with Section 28 due to whale entanglement and compliance issues related to permit applications on 21 November 2022. SASH is again rated as Non-Compliant with Operational Guidelines (Table 3.2).

Figure 3.10. Live Google Earth pin of location of compliance photograph in relation to the SASF2 Big Bay licence area (yellow boundaries) (left). No infrastructure or product was observed but unidentified end float (middle) and 3 buoys were floating about on this farm (right).

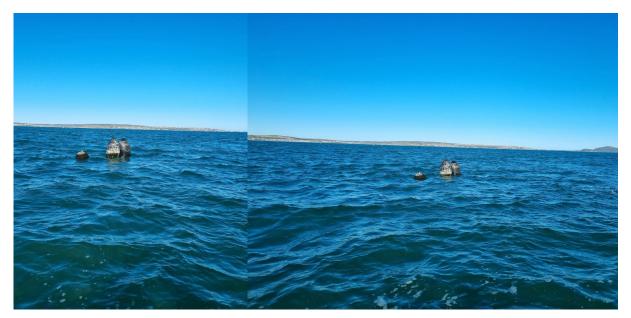
### 3.6.10 ULWAZI KUKUTYA (ULW)

There are a total of 6 authorised mussel lines and 3 dormant on Ulwazi Kukutya (ULW). However, during the inspection, it was discovered that only line 3 was present, and found to be sunken under the water (Figure 3.11). Moreover, two buoys were observed underwater, but there was no visible line attached to them, indicating that some part of the infrastructure might be missing or submerged. Additionally, there was no other infrastructure, such as the remaining mussel lines, found on this farm, which might suggest that further installation or maintenance is needed to establish the complete mussel farm as intended. ULW is therefore rated as Non-Compliant with Operational Guidelines (Table 3.2).

Figure 3.11. Line 3 was the only line existing on the ULW farm and was sunken (left and right).

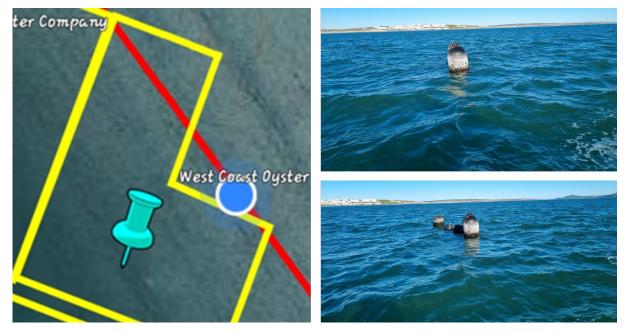
## 3.6.11 WEST COAST OYSTER GROWERS (WCOG)

Farm name	Location	<b>S</b> pecies	Compliance status	Comment
				seen underwater with no visible line. No additional infrastructure was seen on this farm.
West Coast Oyster Growers	Big Bay	Mussels/ oysters	NC	14 mussel lines are authorised, 11 active and 2 dormant in this farm. Only lines 2 and 6 were taut and straight. Lines did not have end floats. End floats with no lines and identifying markers have faded. The rest of the lines were missing sunken. Most of the infrastructure had excess biofouling.

West Coast Oyster Growers (WCOG) have a total of 14 authorised mussel lines. Currently, only 11 lines are present on the farm, and there has been no notification to the ECO about adding the remaining 3 approved lines. During the inspection, it was found that only lines 2 and 6 were taut and straight, suggesting they were properly tensioned and functioning as intended. One important issue noticed was that the lines did not have end floats, which are crucial for keeping the lines afloat and visible. Moreover, there were end floats observed, but they had no visible lines attached to them, and their identifying markers had faded over time, making it challenging to identify the lines successfully. Additionally, most of the infrastructure, such as the other mussel lines, was either missing or sunken underwater, which could have implications on the farm's productivity and stability (Figure 3.12).

Figure 3.12. Live Google Earth pin of location of compliance photograph in relation to the WCOG Big Bay licence area (yellow boundaries) (left). End floats with no lines and identifying markers have faded and the rest of the lines were missing sunken (top and bottom right).

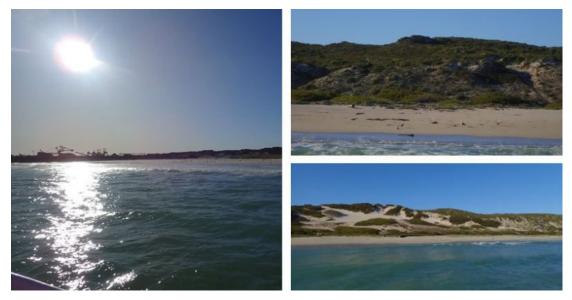
Spreeuwalle beach was inspected by the ECO during the July 2023 site inspection whilst on the boat (Figure 3.8). During the beach inspection seven black torpedo floats were observed (Figure 3.17). Moreover, several floats were floating about in the surface waters. No identifying

features were visible on any of the items. The famer owners/operators and business rescue practitioners have been notified of the existence and location of this equipment and plans have been made to remove it.

Figure 3.16. Spreeuwalle beach with black torpedo floats.

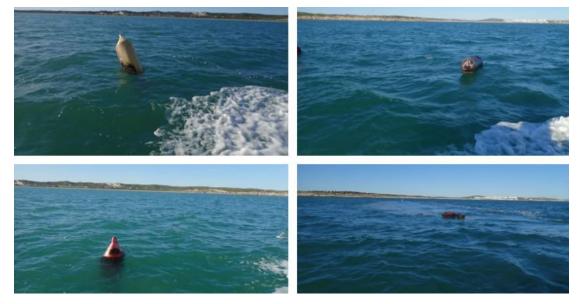
Figure 3.17. Several photographic evidence showing floats in bay with no identifying features.

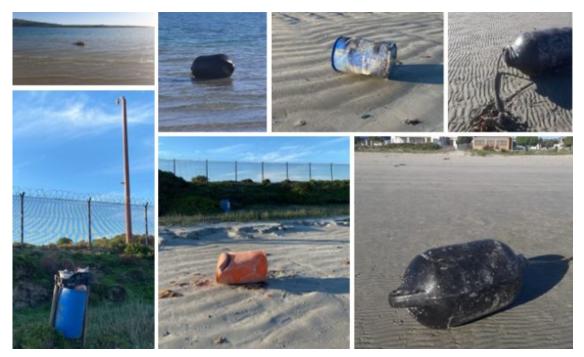
On the 11 July 2023, an incident report (IR July 23-01) was logged that a yellow float from SBOC and three floats from the SASH group were observed on Langebaan beach near Pearly's restaurant and the lagoon opening. On the 12 July 2023, another incident report (IR July 23-02) reported black, blue, and orange floats from the SASH farm, specifically WCOG, in the water and on the beach. On 20 July 2023, IR July 23-03 was logged for seven black floats seen on Spreeuwalle Beach during a site inspection. These incident reports highlight the presence of various floats from different farms in the Big Bay precinct, raising concerns about the potential impact on the environment and marine life in the affected areas (Figure 3.17). It is

Figure 3.18. Several floats found on Langebaan Beach, Saldanha.

important for farm operators or the Claritas team take appropriate actions to prevent these occurrences in the future. The farm operators were notified about these incidents.

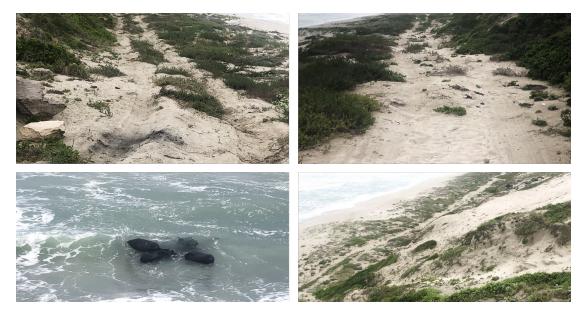
On July 29, 2023, a local resident reported vehicular damage to the vegetated supratidal beach platform in Big Bay, Saldanha (IR July 23-05). The resident reported that the tracks were left by vehicles associated with the aquaculture industry. It is worth noting that access to this area is restricted to a single point (Sunrise Energy). As a result, whomever is responsible for controlling the entrance to this area likely has records that could be relevant to the investigation. Additionally, on the same day, a longline with floats was observed in the process of washing ashore in the same area (IR July 23-05, Figure 3.19).

Figure 3.19. Vehicular damage to the vegetated supratidal beach and a line with floats washing ashore.
