SALDANHA BAY AQUACULTURE DEVELOPMENT ZONE ENVIRONMENTAL CONTROL OFFICER SUMMARY REPORT 21

December 2023

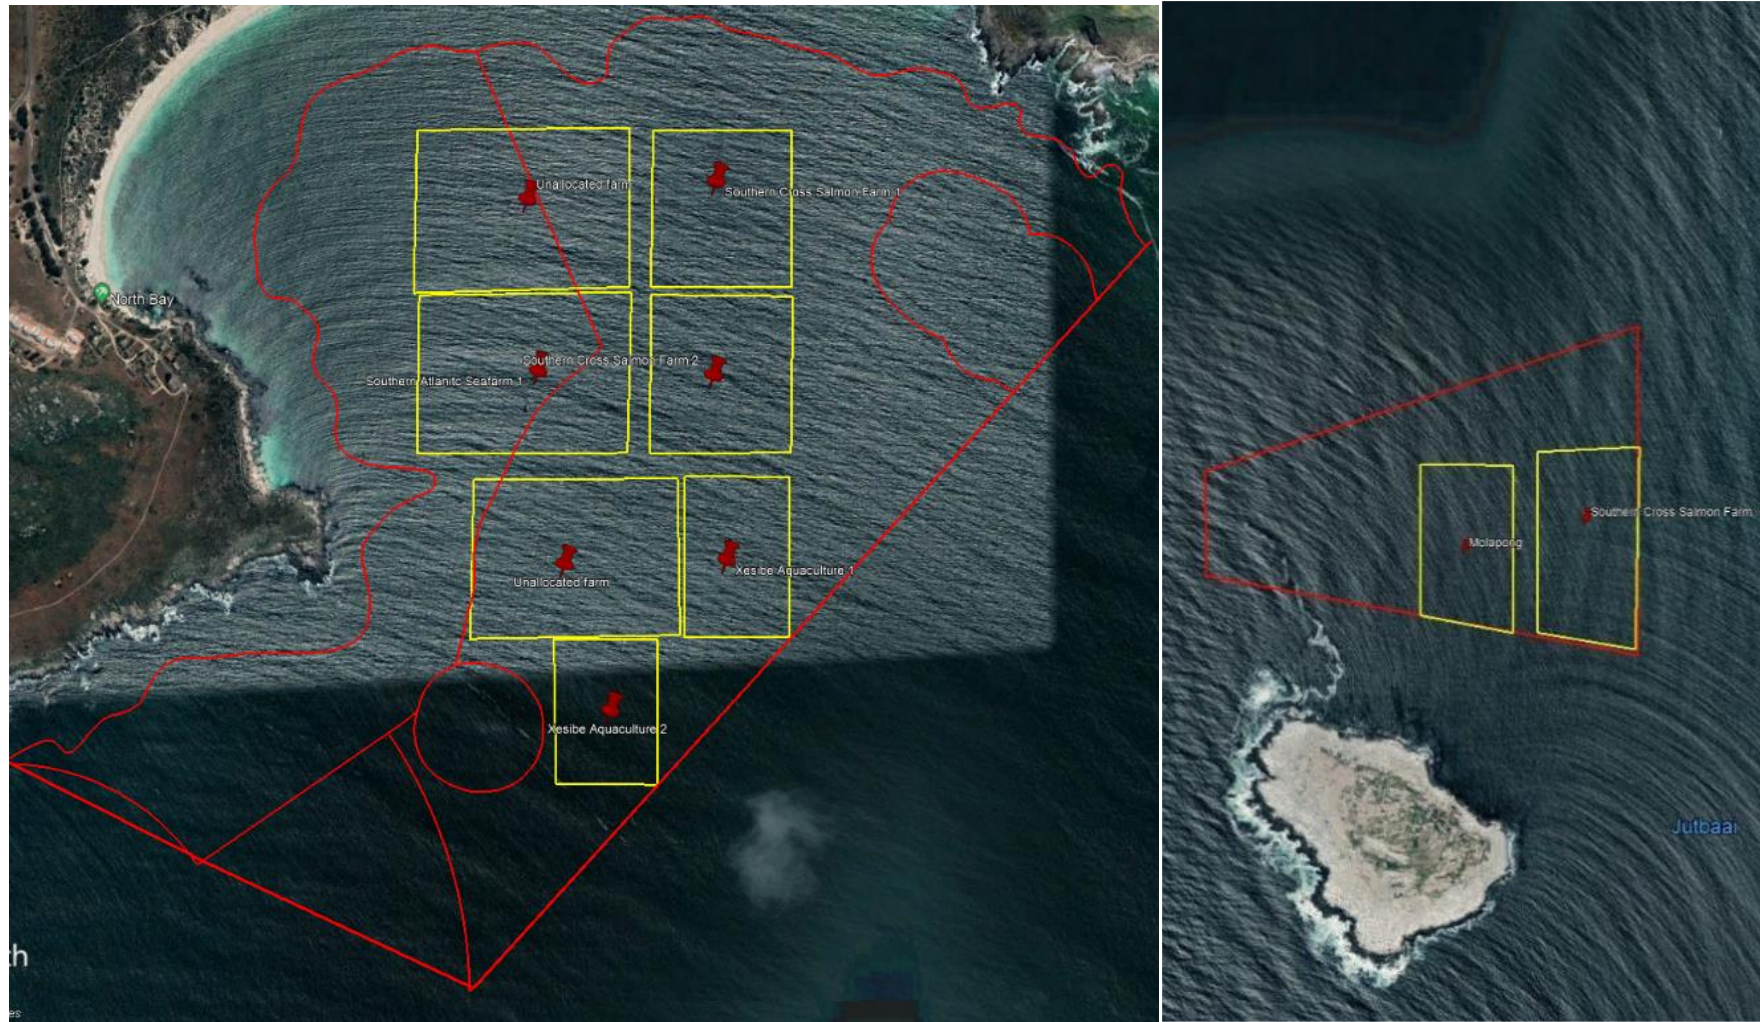
Figure 2.3. (Left) Bivalve culture in Outer Bay North (OBN) and (right) finfish culture in Outer Bay South (OBS).

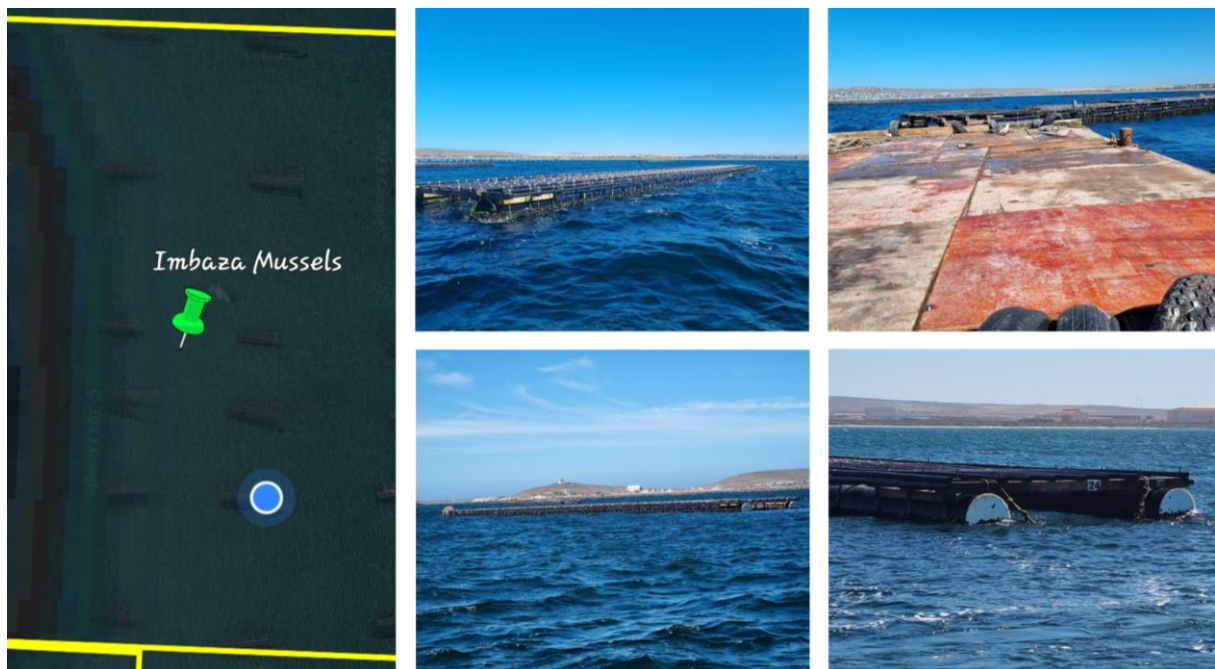
Figure 3.1. Live Google Earth pin of location of compliance photograph in relation to the IMB SB licence area (yellow boundaries) (right). Most of IMB's rafts were in good condition and no issues with litter, excess equipment, or loose items on the rafts or barges (middle top and bottom). The barge was in good condition, nicely cleaned after use (top right). A raft with IMB's unique markers and sequential number for identification (bottom right).

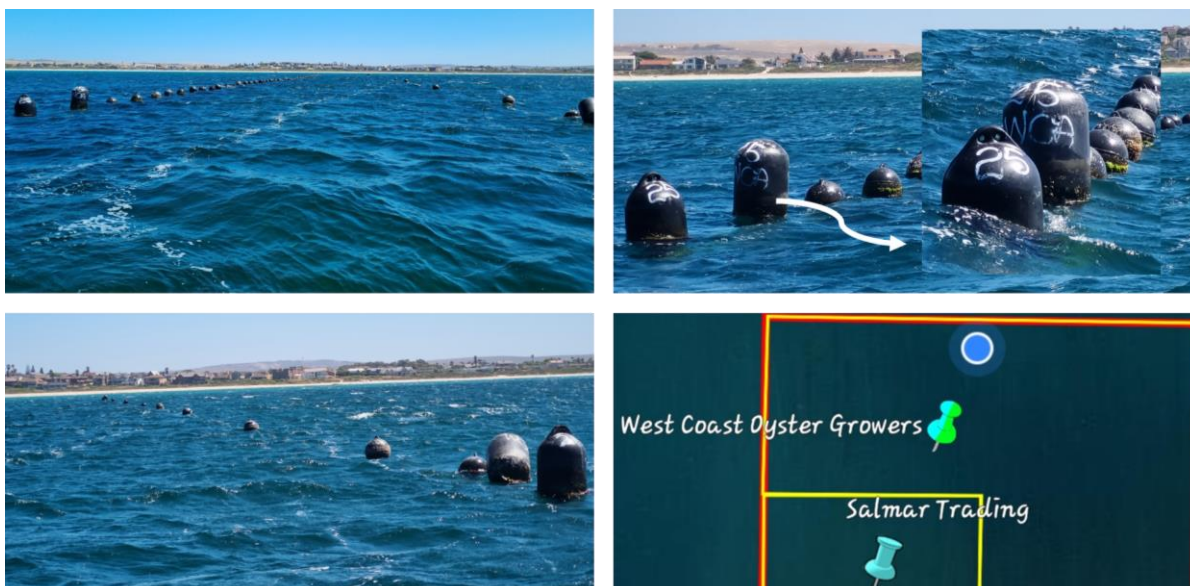
In conclusion, the condition of the farms is generally good and are compliant with most of the expected standards. Partial compliance was attributed to the incorrectly labelled and lack of unique identifiers on the end floats with corresponding numerical sequential order.

Figure 3.2. All mussel lines at WCOG were observed to be taut, straight, suitably floated (top and bottom left). However, marked with incorrect unique identifiers (top right). Live Google Earth pin of location of compliance photograph in relation to the WCOG SB licence area (yellow boundaries) (bottom right)

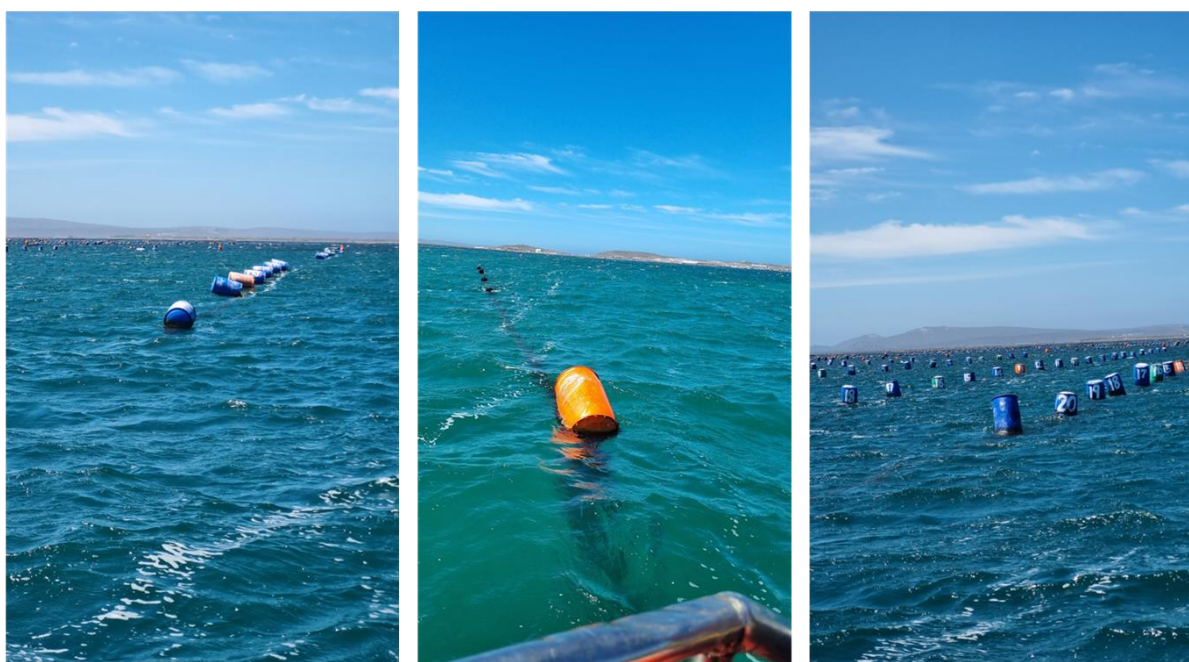
Figure 3.3. All oyster lines at WCOG were observed to be taut, straight, suitably floated (left and right). One of the dormant lines (middle).

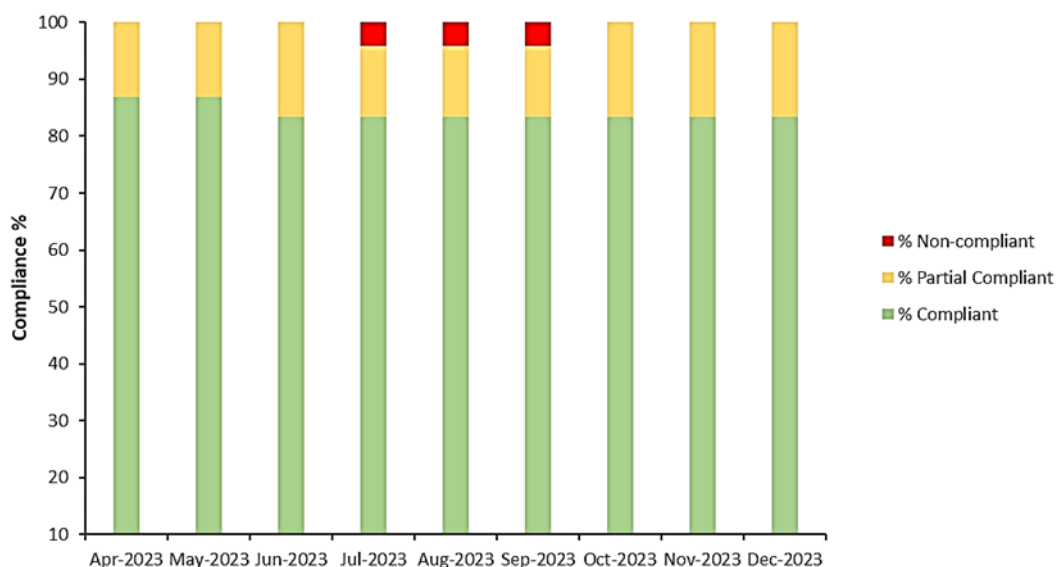
Figure 3.4. ADZ compliance for year 2 of ECO audits conducted by Anchor (April 2023 to December 2023).

In December 2023, 24 conditions of a possible 27 were auditable, which is equivalent to the auditable conditions for the November 2023 period (Table 3.2). During the audit period in November 2023, the ADZ remained at an overall compliance score of 83%. Partial compliance remained at 17% and 0% in non-compliance. This indicated that there has been no change in the compliance percentage compared to the previous audit conducted in November 2023 (Table 3.2, Figure 3.4).

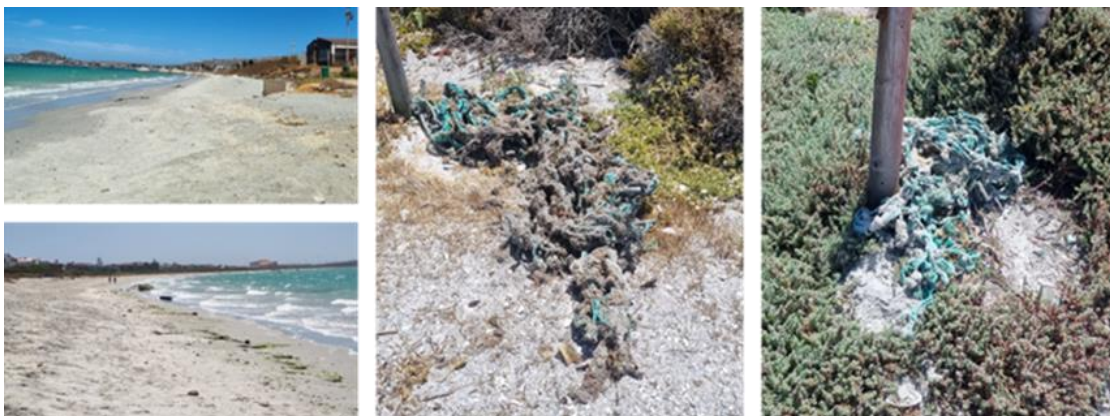
Figure 3.7. Small Bay beach inspection.

ECO beach inspection for Small Bay was conducted during the December 2023 audit (Figure 3.7). During the beach inspection, only cut ropes were observed on the beach.
