SALDANHA BAY AQUACULTURE DEVELOPMENT ZONE ENVIRONMENTAL CONTROL OFFICER SUMMARY REPORT 22

January 2024

Anchor Research & Monitoring (Pty) Ltd

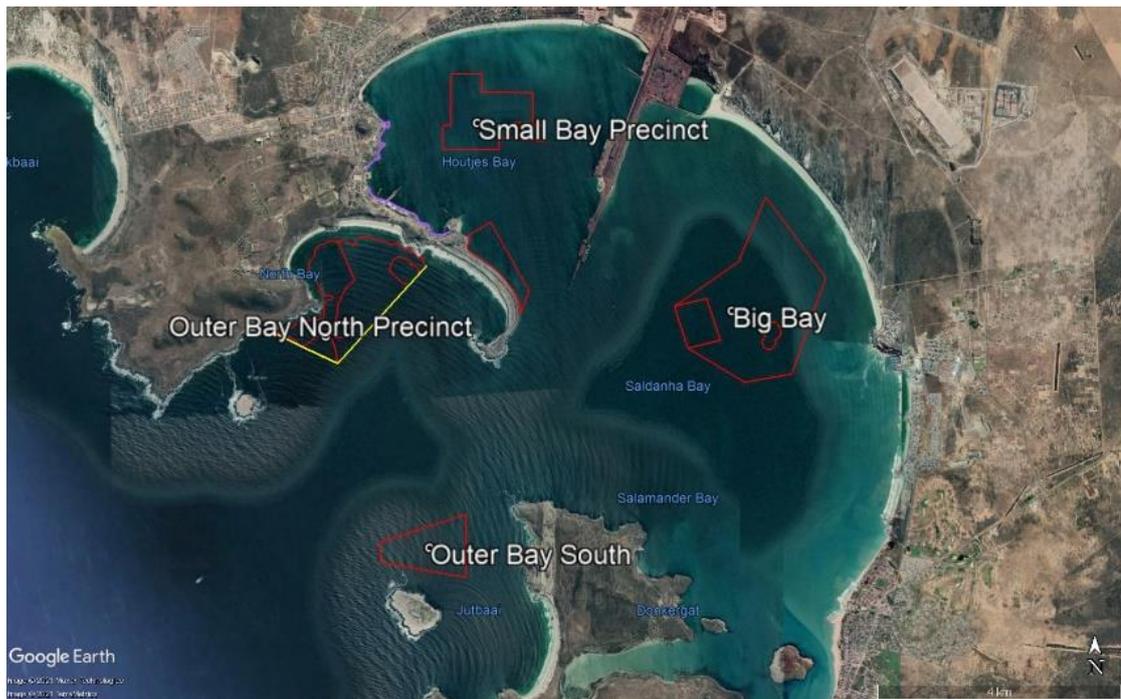
Figure 2.1. Saldanha Bay ADZ precincts.

The Saldanha Bay ADZ comprises 4 precincts, namely Small Bay (SB), Big Bay (BB), Outer Bay North (OBN), and Outer Bay South (OBS) (Figure 2.1). The BA Report summarised the scope for expansion in the ADZ and comprised a mix of finfish and bivalve farms (Table 2.2). Details of each existing lease are depicted in Figure 2.2 and Figure 2.3. Note that there are two lease areas in OBN that are unallocated and have been advertised for lease applications by Transnet Ports Authority (TNPA). Sea-based activities associated with aquaculture in the ADZ include:

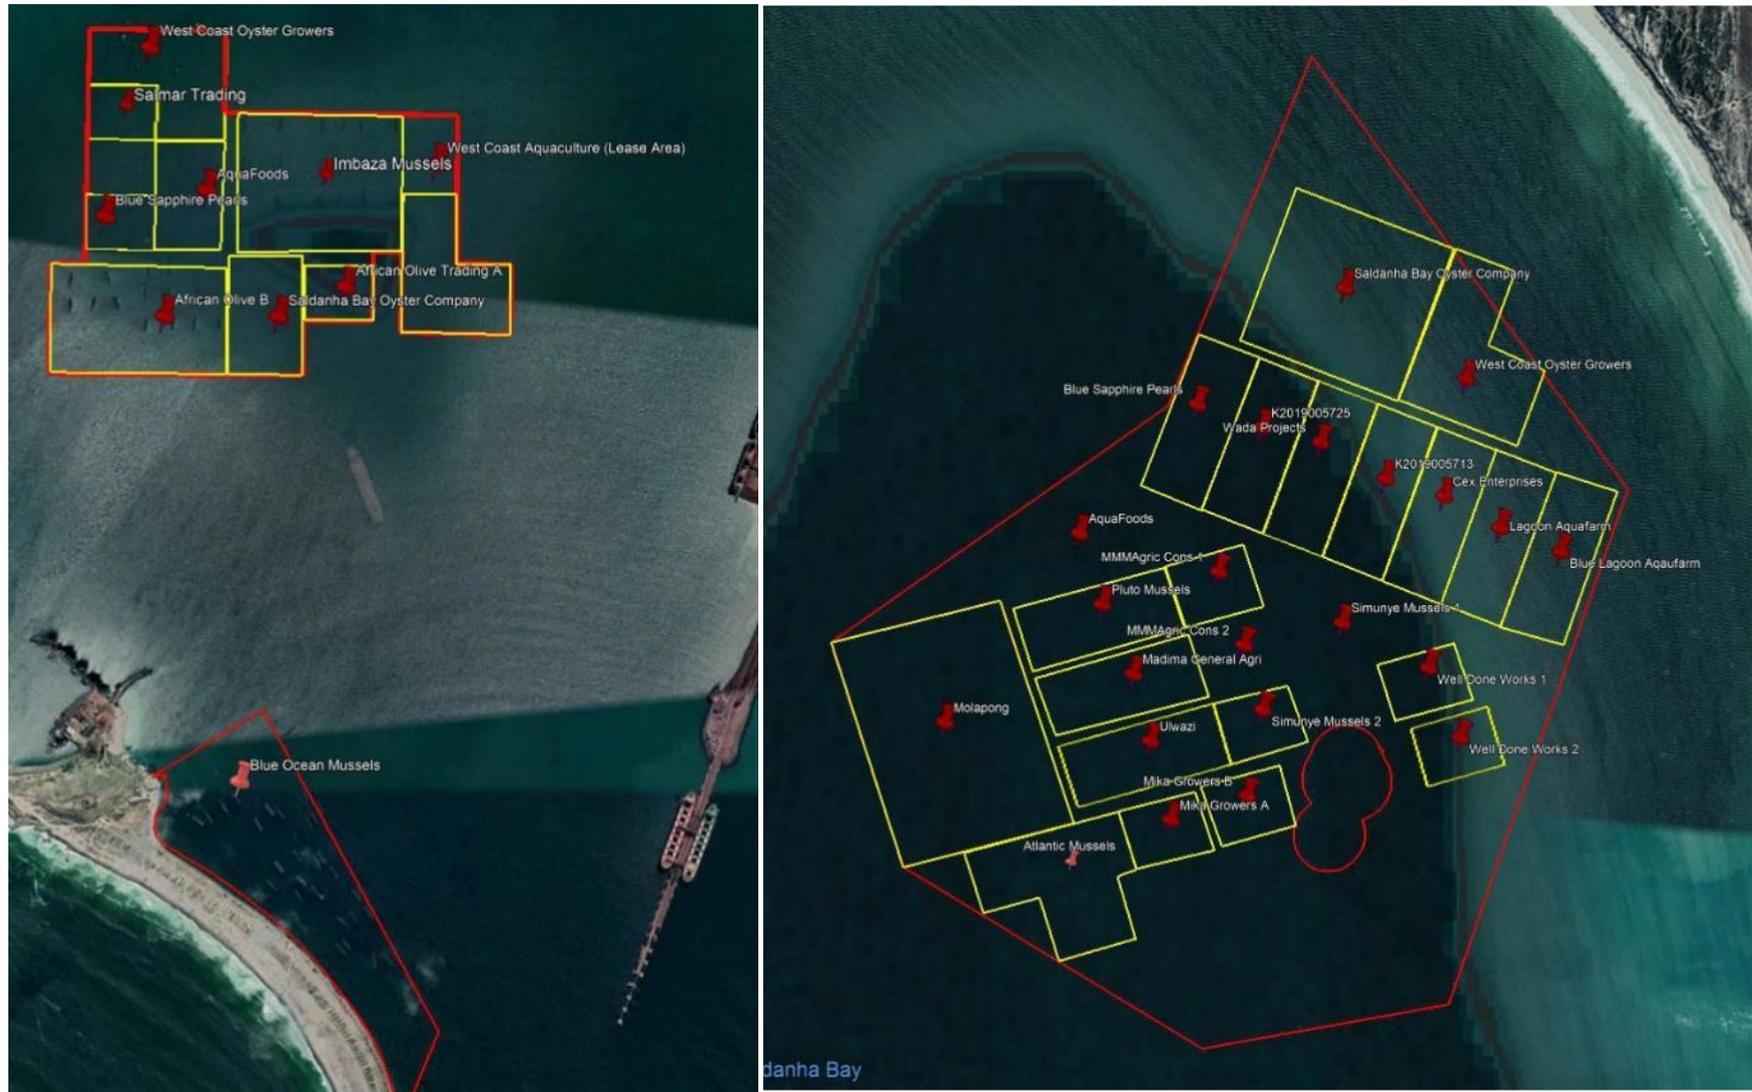
Figure 2.2. (Left) Bivalve culture in Small Bay (SB) and (right) mixed bivalve and finfish culture in Big Bay (BB).

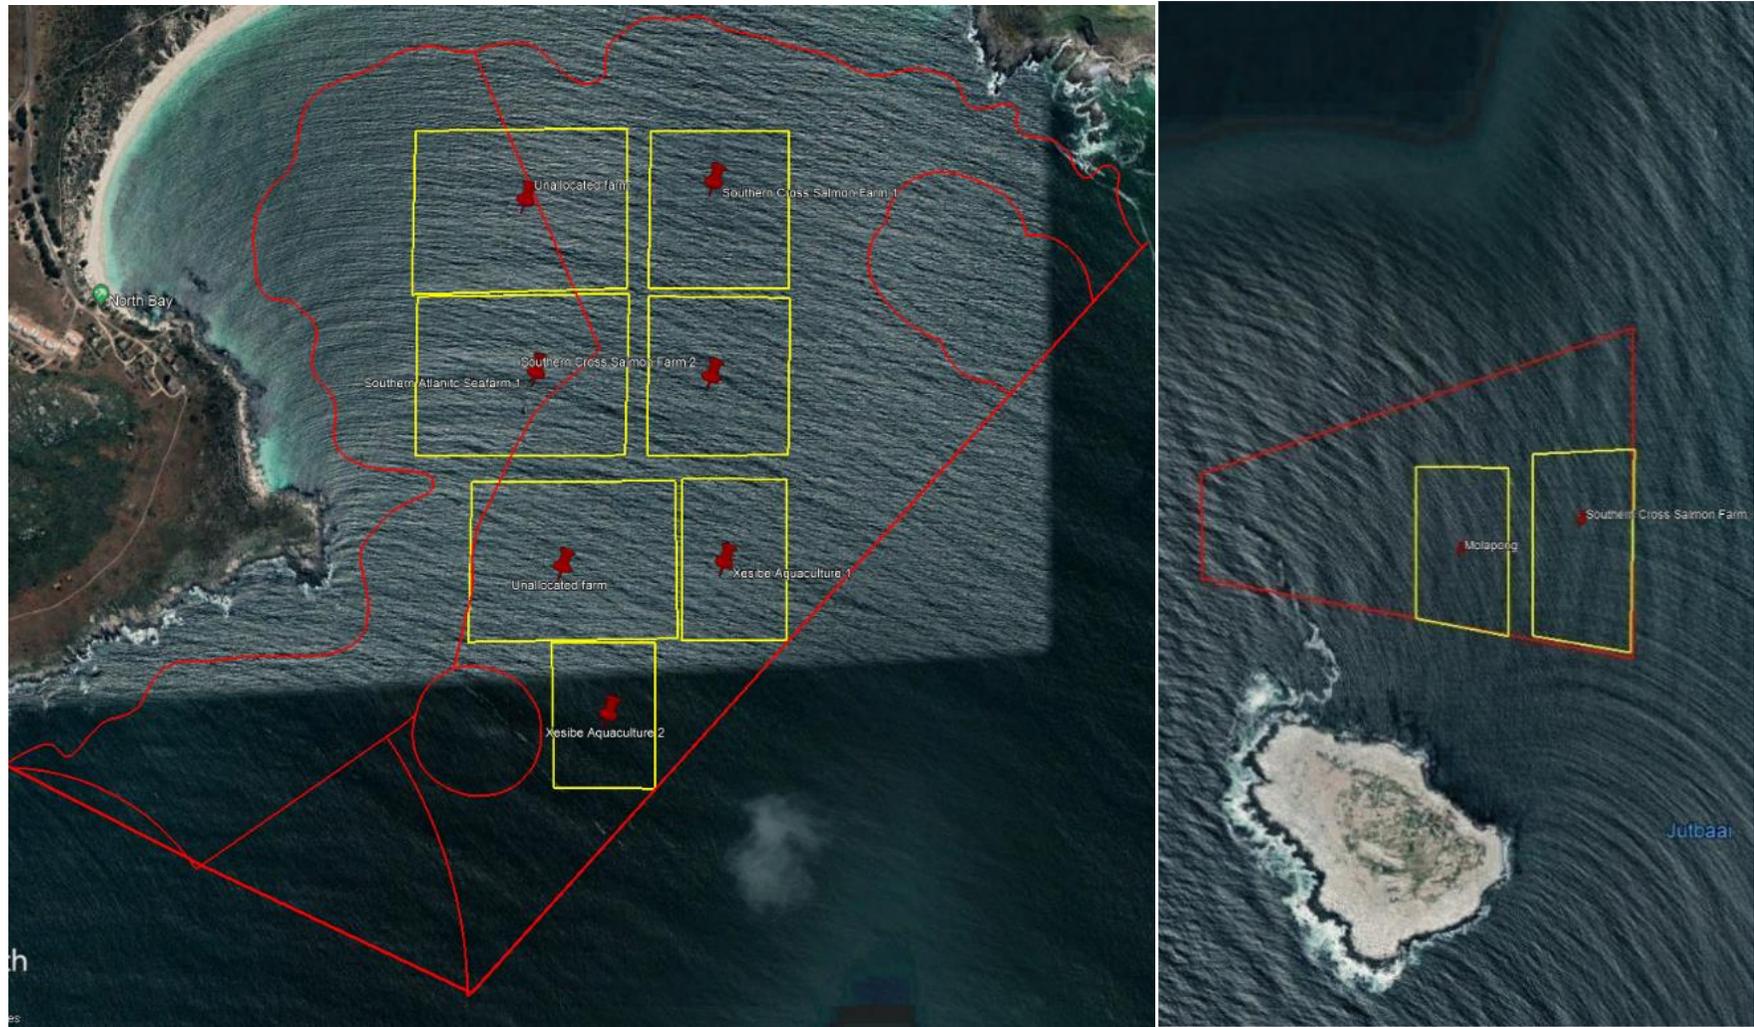
Figure 2.3. (Left) Bivalve culture in Outer Bay North (OBN) and (right) finfish culture in Outer Bay South (OBS).

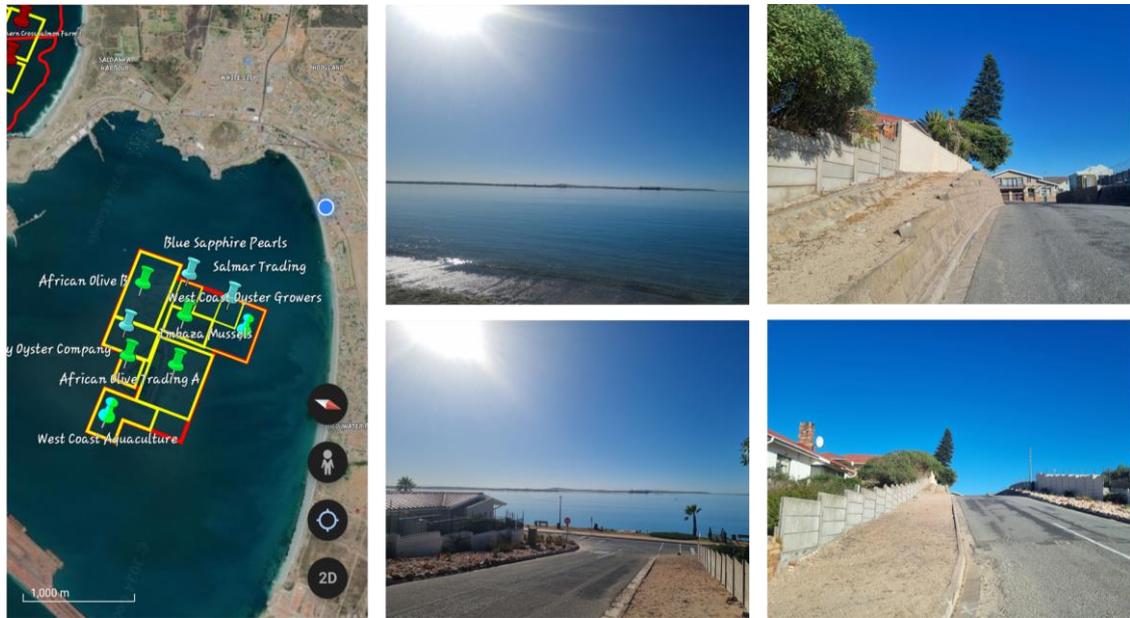
The Small Bay vantage point is positioned at 33°00'06.51 S, 17°56'57.75 E, at one of the farmer's residences in Saldanha (Figure 3.1). To optimise observation in the Big Bay precinct, the recommended vantage point is located at Langebaan, specifically Paradise Beach (33°2'6.35 S, 18°2'10.86 E) (Figure 3.2). In Outer Bay North, the vantage point is situated at coordinates 33°1'28.00 S, 17°56'57.30 E, near South African Maritime Services - Saldanha Sick Bay Pharmacy in Saldanha (Figure 3.3). This area is fenced, and one cannot freely access the beach as this is a SAS Saldanha Naval Base's property.

Figure 3.1. Live Google Earth pin of location of the vantage point (blue dot) photograph in relation to Small Bay farm licence area (yellow boundaries) (left). Even when closer to the beach (top middle), the farms in the small bay are not easily visible to the naked eye. The recommended vantage point for clearer observation is situated at one of the farmer's residences (top right, bottom middle, and right).

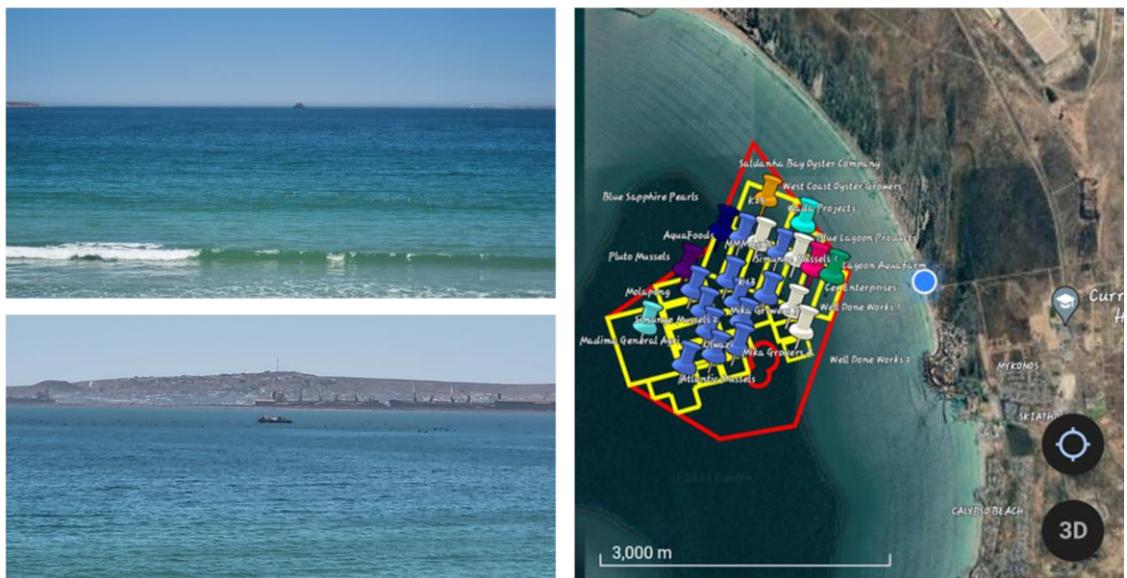
Figure 3.2. The recommended vantage point for clearer observation is situated at Langebaan, Paradise Beach (top and bottom left). Live Google Earth pin of location of the vantage point (blue dot) photograph in relation to Big Bay farm licence area (yellow boundaries) (right).

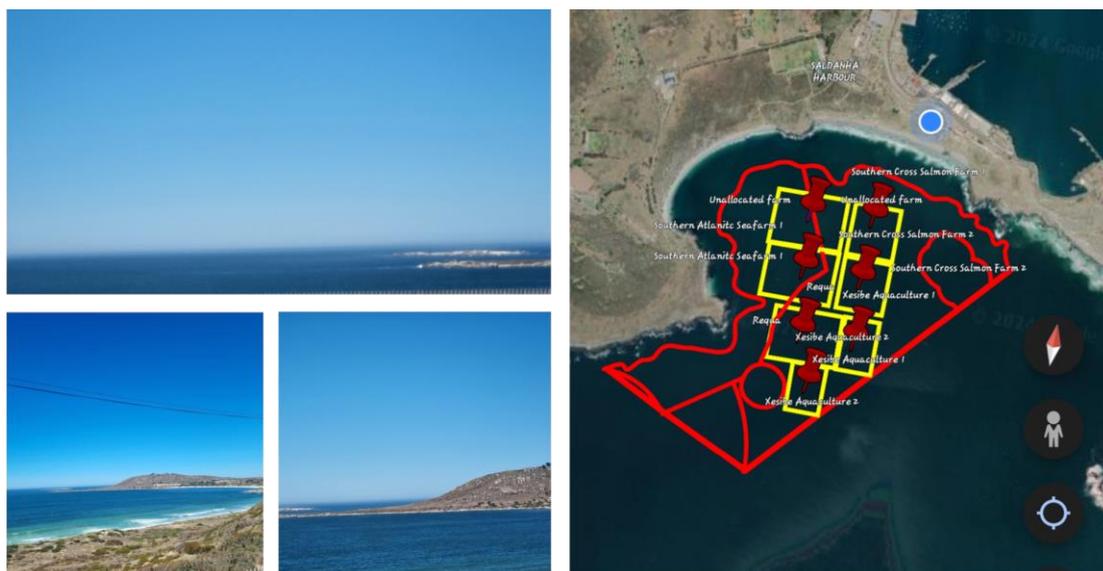
Figure 3.3. The recommended vantage point for clearer observation is situated near S.A.M.S - Saldanha Sick Bay Pharmacy in Saldanha (top and bottom left and middle). Live Google Earth pin of location of the vantage point (blue dot) photograph in relation to Outer Bay North farm licence area (yellow boundaries) (right).

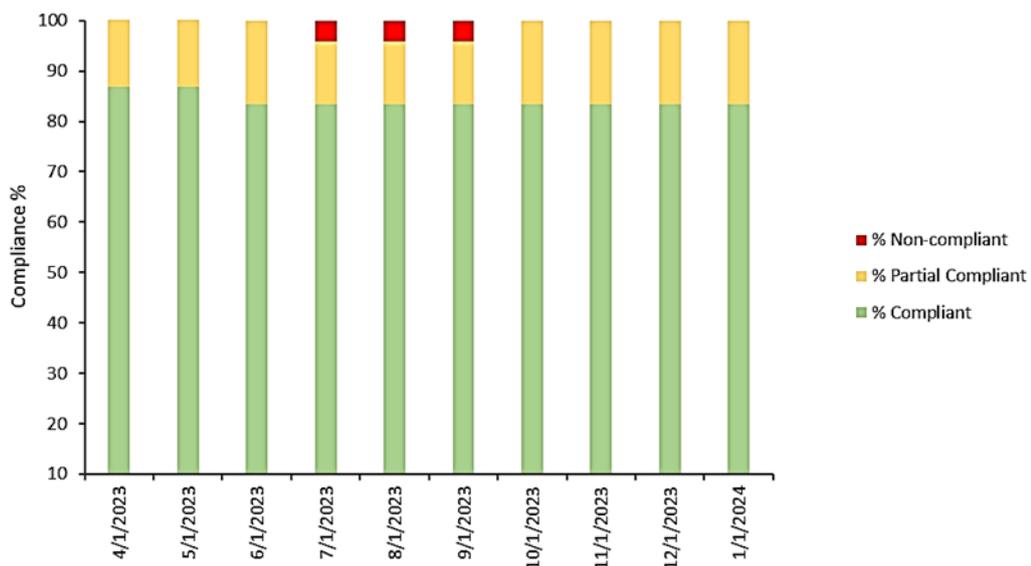
In January 2024, 24 conditions of a possible 27 were auditable, which is equivalent to the auditable conditions for the December 2023 period (Table 3.1). During the audit period in January 2024, the ADZ remained at an overall compliance score of 83%. Partial compliance remained at 17% and 0% in non-compliance. This indicated that there has been no change in the compliance percentage compared to the previous audit conducted in December 2023 (Table 3.1, Figure 3.4).

Figure 3.4. ADZ compliance for year 2 of ECO audits conducted by Anchor (April 2023 to January 2024).

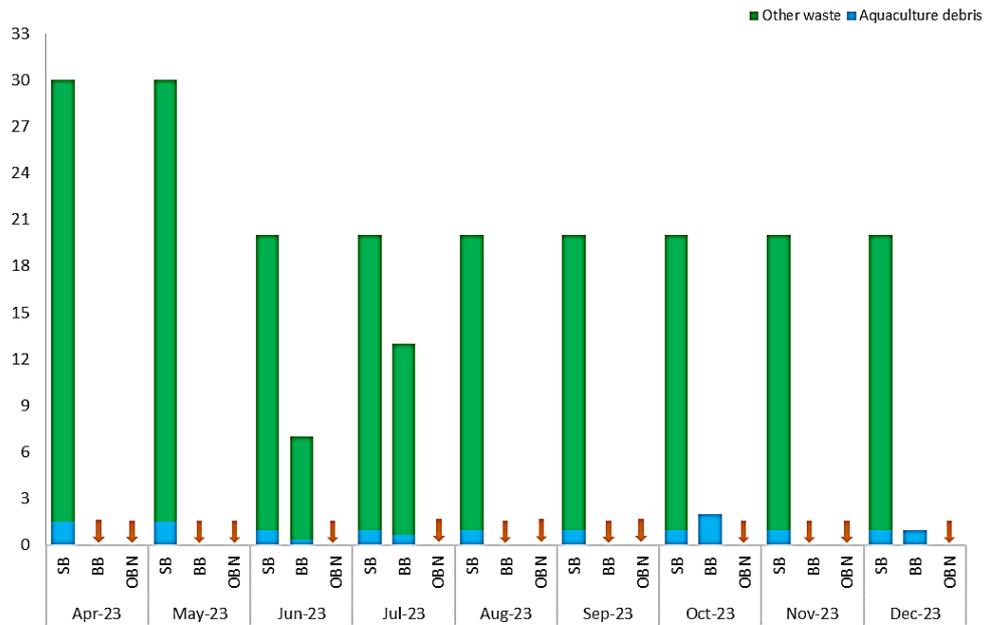
In Small Bay, the waste collected primarily consists of litter and general waste, with only a small portion originating from the aquaculture industry (Figure 3.5). On the other hand, in Big Bay, most of the waste collected from the beaches is composed of aquaculture floats, while a smaller portion is comprised of rope offcuts that are collected in refuse bags (Figure 3.6). However, no waste collection data or information regarding aquaculture floats has been provided or observed for Big Bay in April and May 2023. Beach clean ups in this precinct resumed during June and July 2023, but ceased again during August, and September 2023. A Beach clean-up was conducted in December 2023. There were about 49 floats that were collected along with beach waste gathered during November 2023.

Figure 3.5. Waste collected in refuse bags from beaches in the various precincts. Total waste collected and portion of waste constituting aquaculture debris is presented. For the period of January 2023 to May 2023, no data has been provided for the Big Bay and Outer Bay North precincts (orange arrows). Beach clean ups were not conducted in August, September, and November 2023 for Big Bay. However, there is data available for the month of June, July, October and December 2023, but only for the Big Bay precinct.

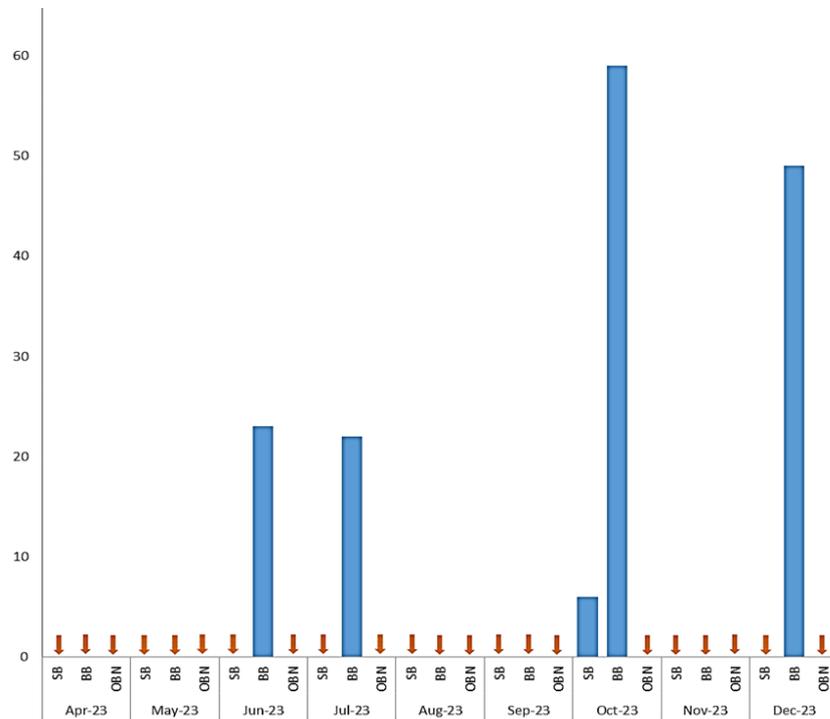
Figure 3.6. Floats collected from beaches in the various precincts. The absence of data is not attributed to the lack of floats, but rather to the absence of reporting.

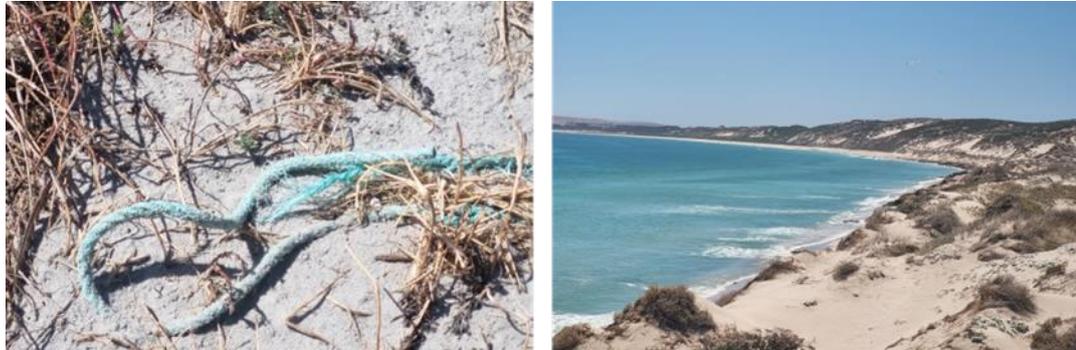
Figure 3.7. Small Bay beach inspection.

ECO beach inspection for Paradise Beach in the Big Bay was conducted during the January 2024 audit (Figure 3.7). During the beach inspection, very few cut ropes were observed on the beach.
