ENVIRONMENTAL AUDIT REPORT

MINING RIGHT HOLDER:	National Portland Cement Company (Pty) Ltd
OPERATION NAME:	Saldanha Quarry
REPORT NUMBER:	AFS-SAL_008-20
DATE:	October 2020
REPORT STATUS:	Final

REPORT COMPILED BY:
UMHLABA ENVIRONMENTAL CONSULTING CC
Andrew Nicholson (EAP Reg 2019-716)

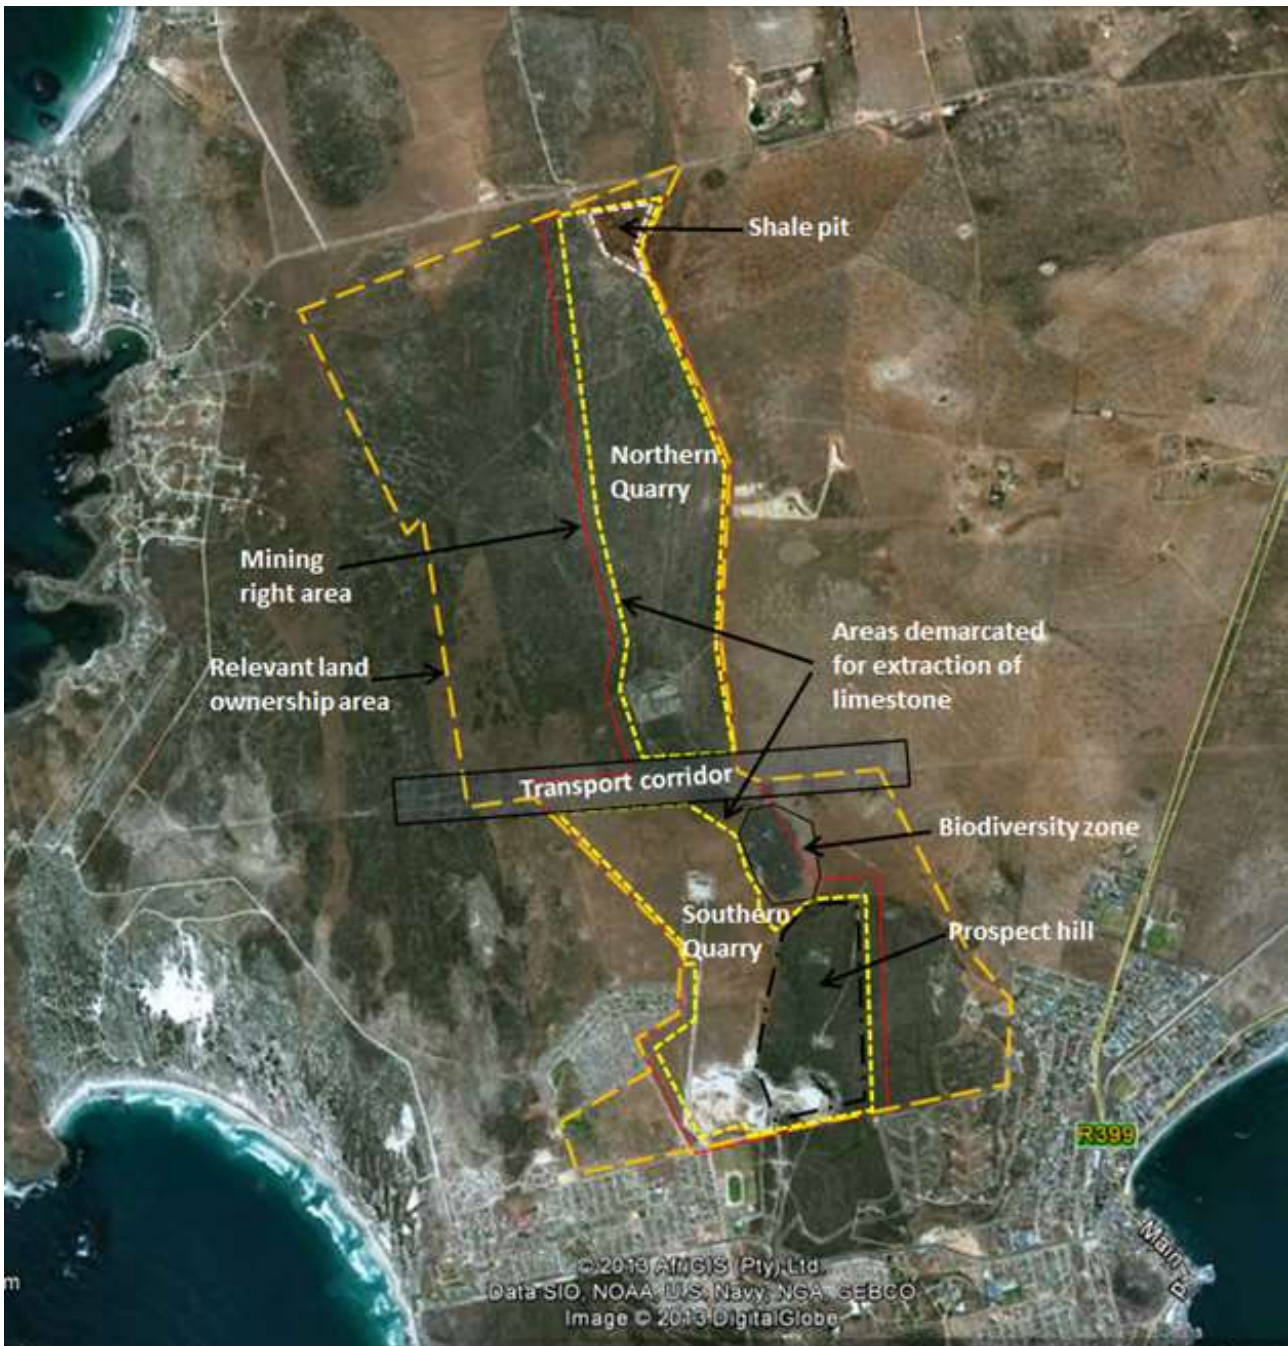
Figure 2: Various mining areas within the mining right boundary

- **Phase 2 (~2021 onwards):** *During 2021 AfriSam is anticipating to commission a clinker manufacturing facility. This clinker manufacturing facility is anticipated to reach full capacity by 2024. Once constructed, two of the main raw materials for the clinker will be the limestone and shale from the Saldanha quarry. During this phase limestone will be used as a primary material for clinker manufacturing and as an extender. Mining of limestone will take place from both the southern and the northern quarry. A shale pit will be generated in the northern quarry.”*

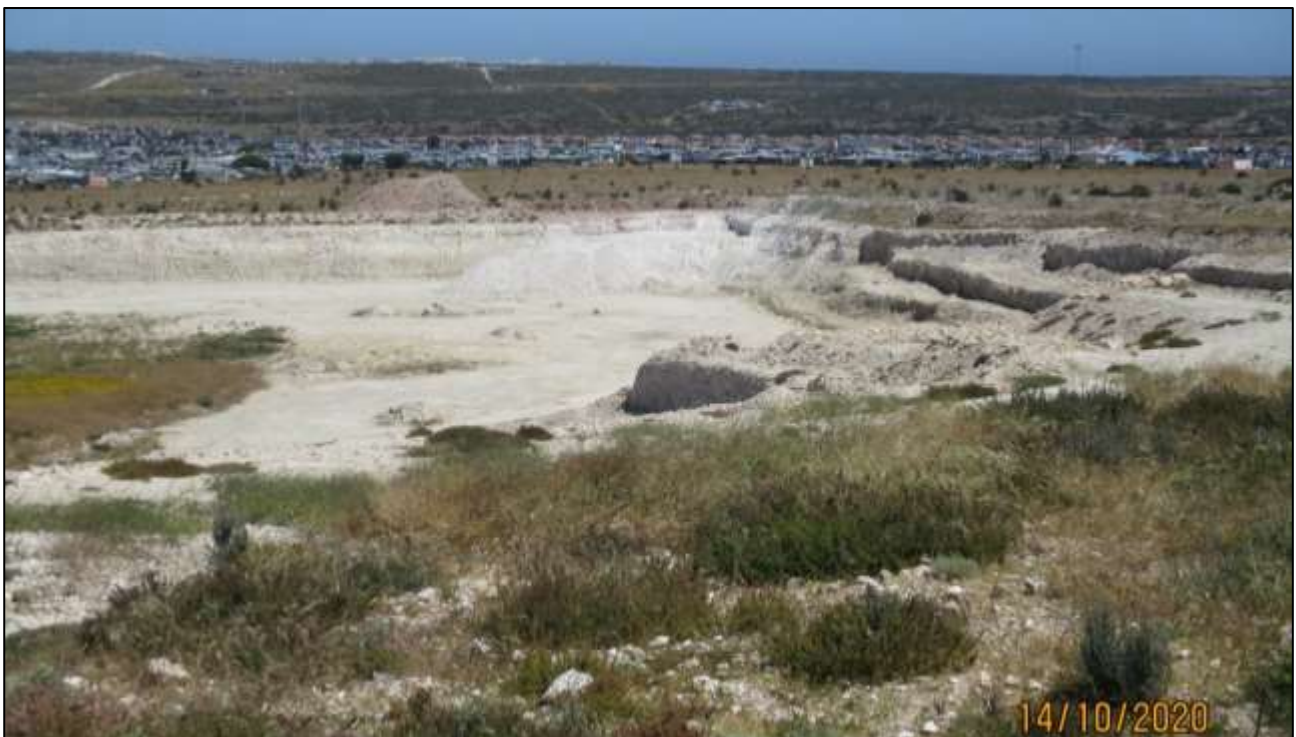
Photograph 1: Current mining area in the low sensitive area of the southern quarry

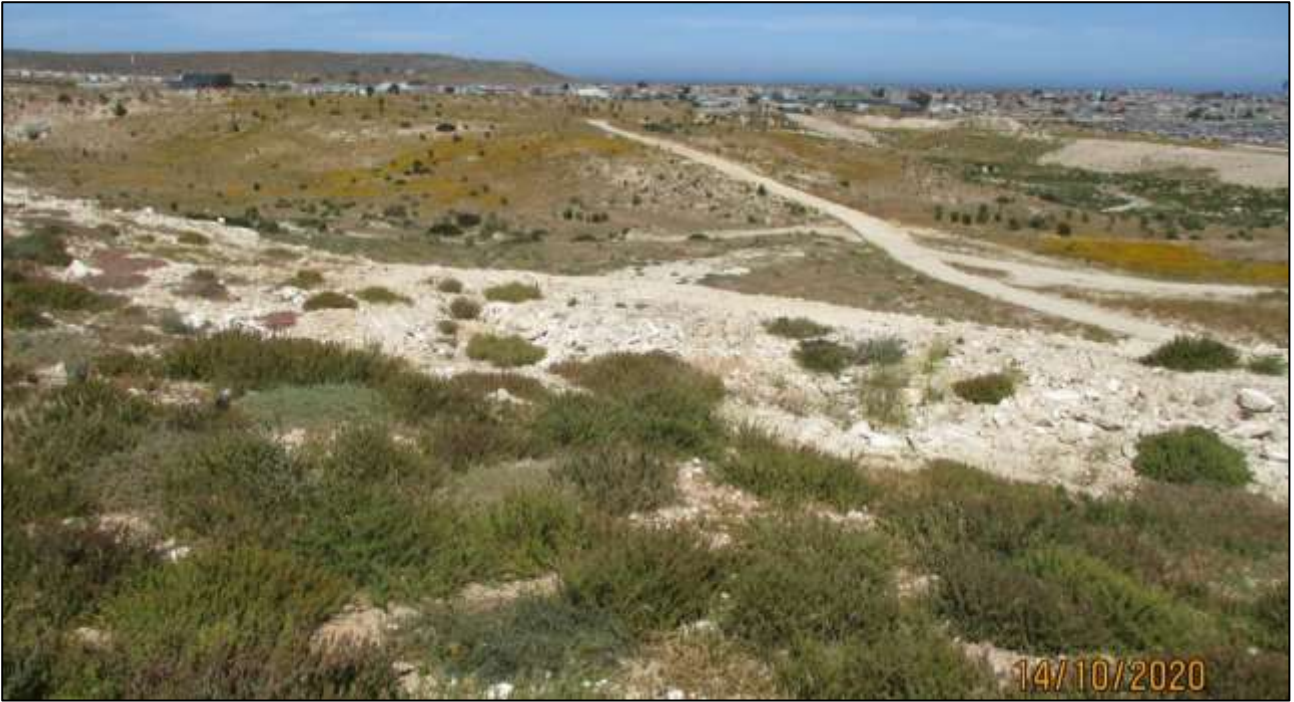
Photograph 2: Evidence of both historical and recent concurrent rehabilitation activities

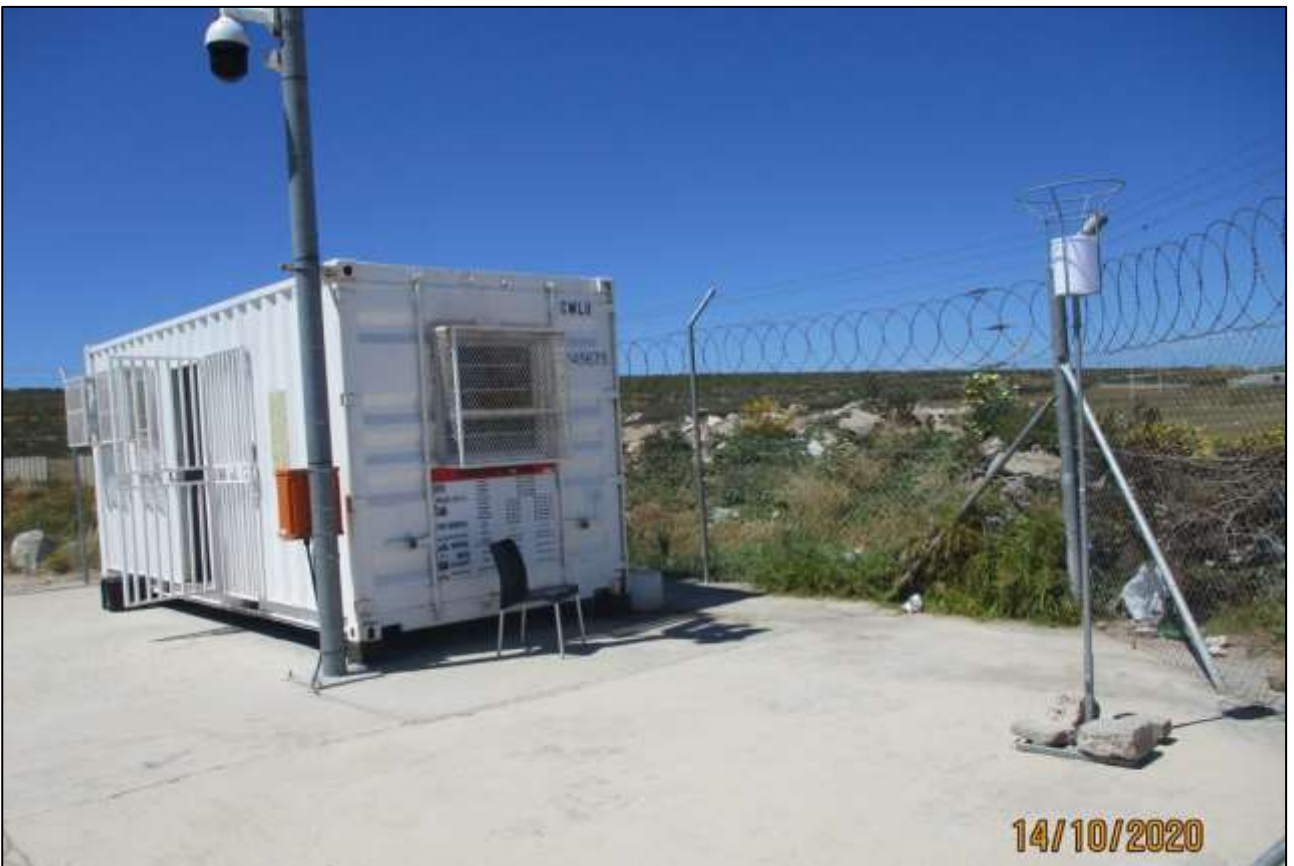
The mobile container is serviced with municipal water and electrical connections and has a small septic tank for ablution requirements which is emptied as and when needed.

Photograph 3: Full extent of infrastructure within the mining right area.
