SALDANHA BAY AQUACULTURE DEVELOPMENT ZONE (ADZ)

ENVIRONMENTAL CONTROL OFFICER (ECO)

MONTHLY SUMMARY REPORT 11

February 2023

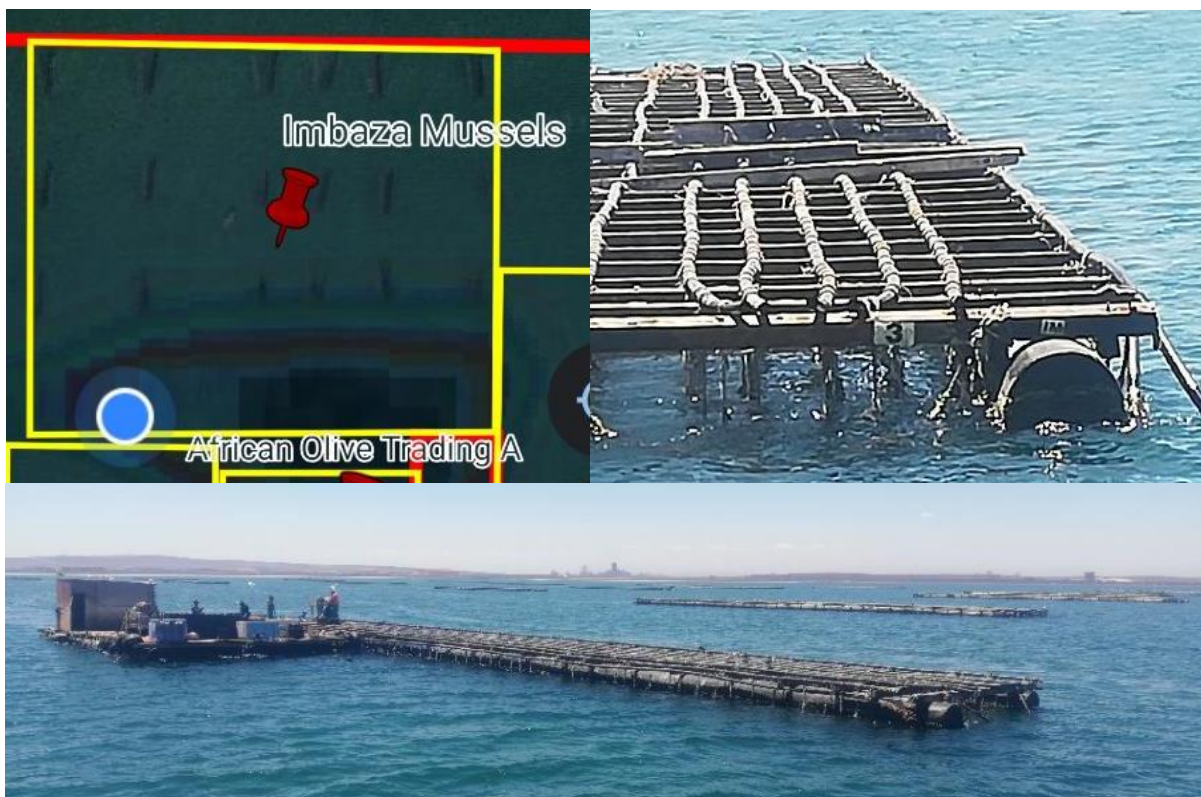
3.5.1.1 Imbaza Mussels compliance photographs

Figure 5. (Top left) Live Google Earth pin of location of compliance photograph in relation to Imbaza Mussels, Small Bay licence area (yellow boundaries). (Top right) raft in good condition and displaying Imbaza unique marker. (Bottom) Imbaza rafts are in good condition, laid out with suitable space between them, and have good floatation.

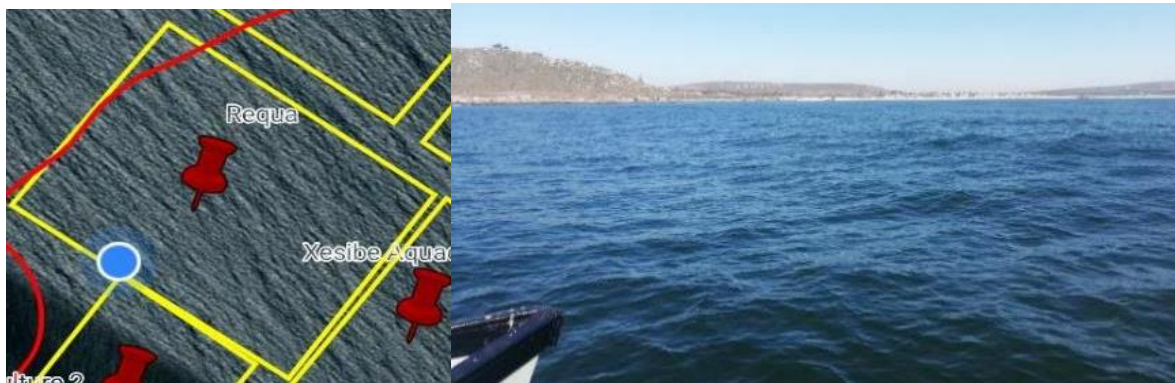
3.5.1.2 Requa Enterprises compliance photographs

Figure 6. (Left) Live Google Earth pin of location of compliance photograph in relation to Requa, Outer Bay North licence area (yellow boundaries). (Right) Infrastructure has sunken on the farm and none is visible on the surface of the water.

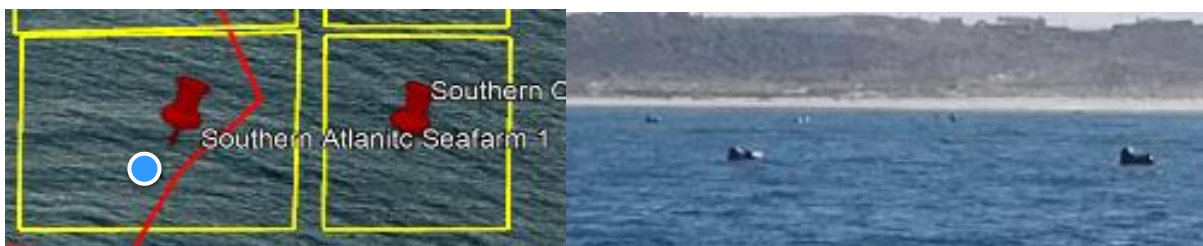
3.5.1.3 SASF 1 (OBN) compliance photographs

Figure 7. (Left) Live Google Earth pin of location of compliance photograph in relation to SASF1, Outer Bay North licence area (yellow boundaries). (Right) Toplines removed from SASF1 as required by the Section 28 issued against SASF. Floats attached to mooring blocks remain and are suitably marked with unique identifiers.

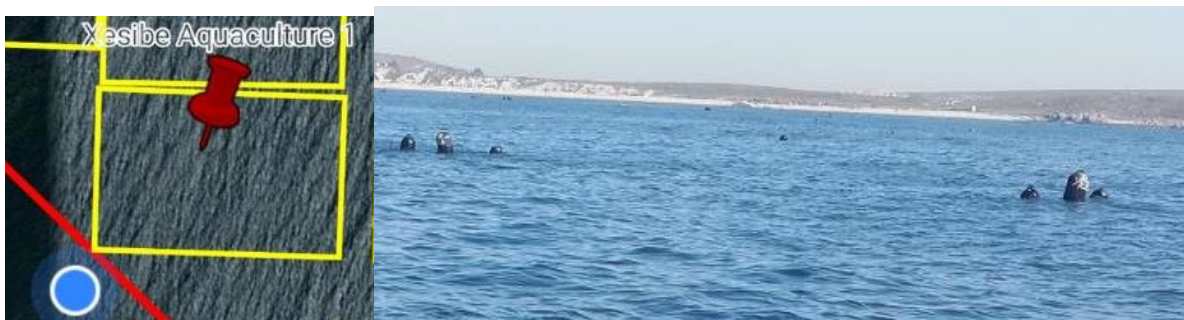
3.5.1.4 Xesibe Aquaculture compliance photographs

Figure 8. (Left) Live Google Earth pin of location of compliance photograph in relation to Xesibe, Outer Bay North licence area (yellow boundaries). (Right) Xesibe farm showing lines are taught, straight, suitably marked with unique identifiers, and lines are not sinking.

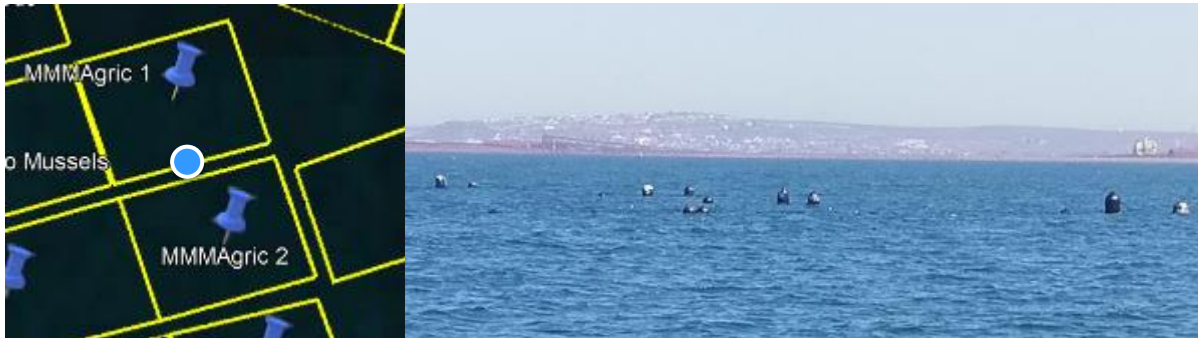
3.5.1.5 *MMMAgri Consult compliance photographs*

Figure 9. (Left) Live Google Earth pin of location of compliance photograph in relation to MMMAgri, Big Bay licence area (yellow boundaries). (Right) MMMAgri farm showing lines are taught, straight, suitably marked with unique identifiers, and lines are not sinking.

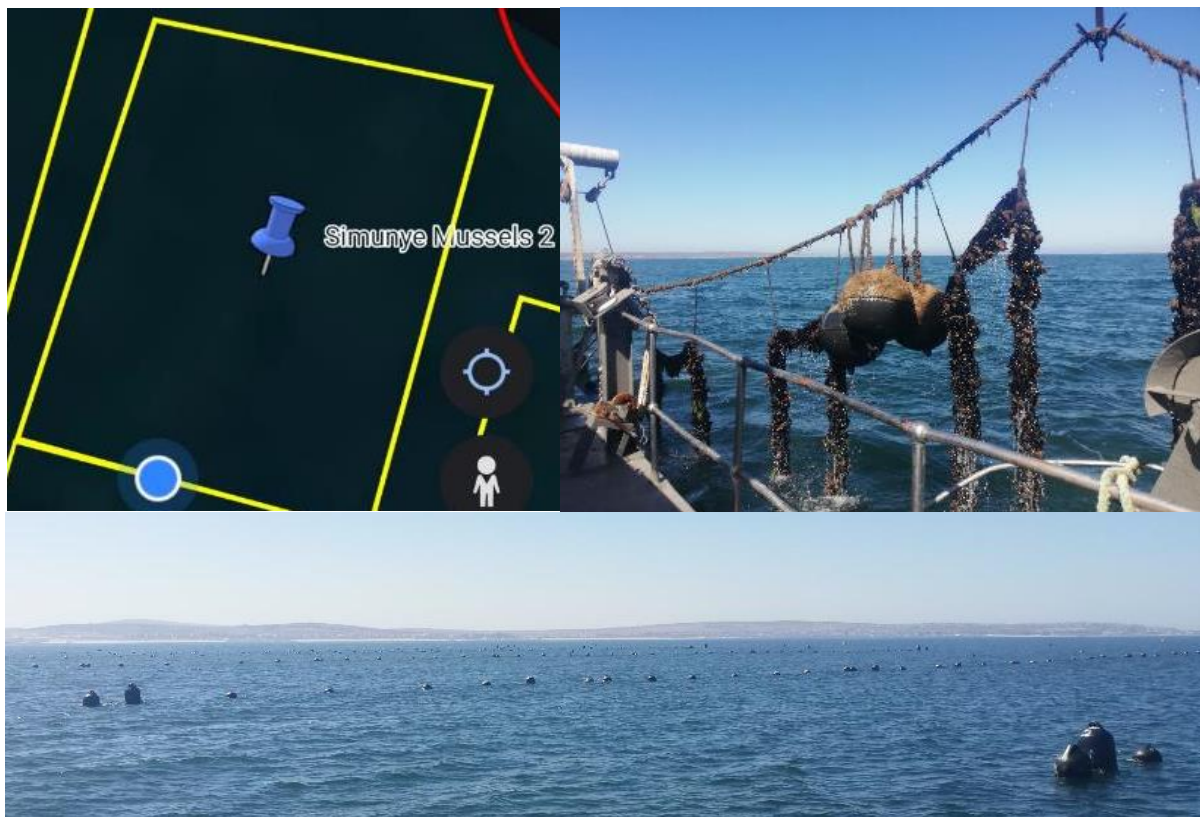
3.5.1.6 *Simunye Mussels compliance photographs*

Figure 10. (Top left) Live Google Earth pin of location of compliance photograph in relation to Simunye Mussels, Big Bay licence area (yellow boundaries). (Top right) Mussel production line with varying sizes of mussels. (Bottom) Simunye farm showing lines are taught, straight, suitably marked with unique identifiers, and lines are not sinking.

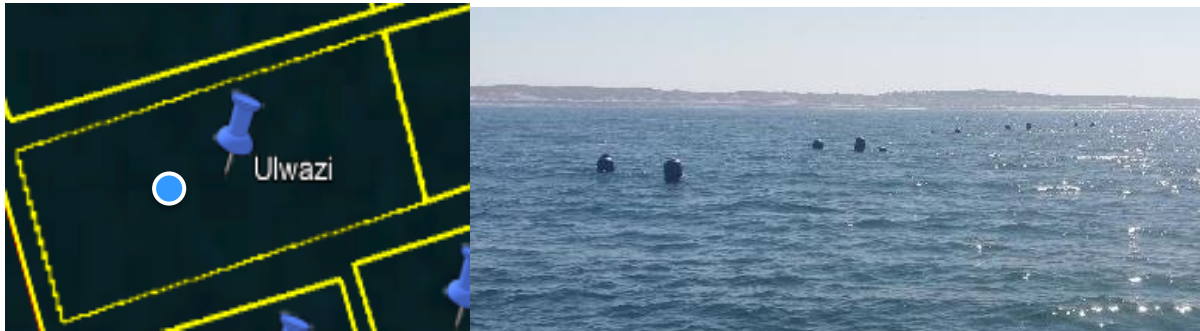
3.5.1.7 *Ulwazi Kukutya compliance photographs*

Ulwazi Kukutya	Big Bay	Mussels	2023/02/10	4 lines in water, lines empty of product, all lines straight, taugt, suitable space between longlines, floats marked with unique identifiers and lines not sinking (Figure 11).
Southern Atlantic Sea Farms 2 (SASF2)	Big Bay	Mussels	2023/02/10	All top lines have been removed from water per requirement of the Section 28 issued by DFFE Aquaculture Authorisations. Floats demarcating mooring blocks remain in water and are suitable marked with unique identifiers (Figure 12).

Figure 11. (Left) Live Google Earth pin of location of compliance photograph in relation to Ulwazi, Big Bay licence area (yellow boundaries). (Right) Ulwazi farm showing lines empty of product, all lines straight, taught, suitable space between longlines, floats marked with unique identifiers and lines not sinking.

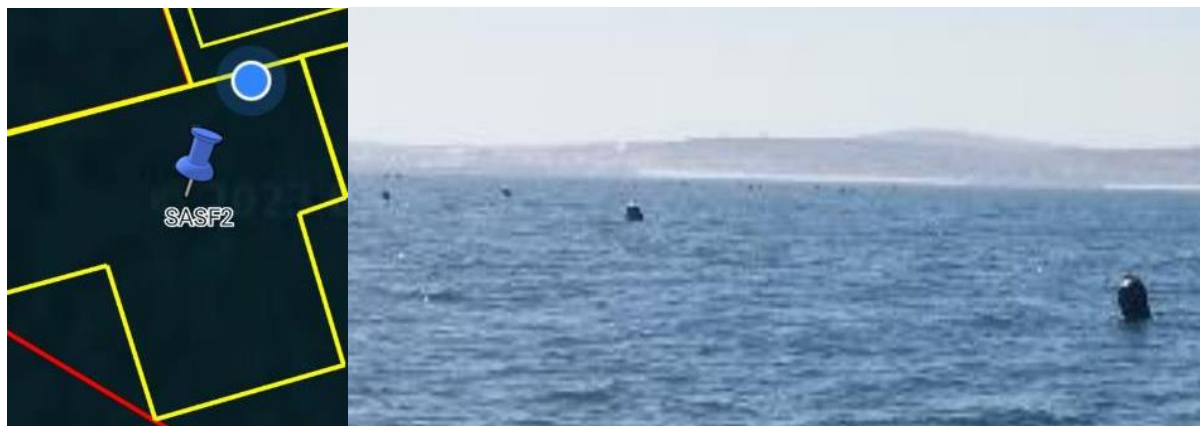
3.5.1.8 *SASF2 compliance photographs*

Figure 12. (Left) Live Google Earth pin of location of compliance photograph in relation to SASF2, Big Bay licence area (yellow boundaries). (Right) Toplines removed from SASF2, floats attached to mooring blocks remain and are suitably marked with unique identifiers.

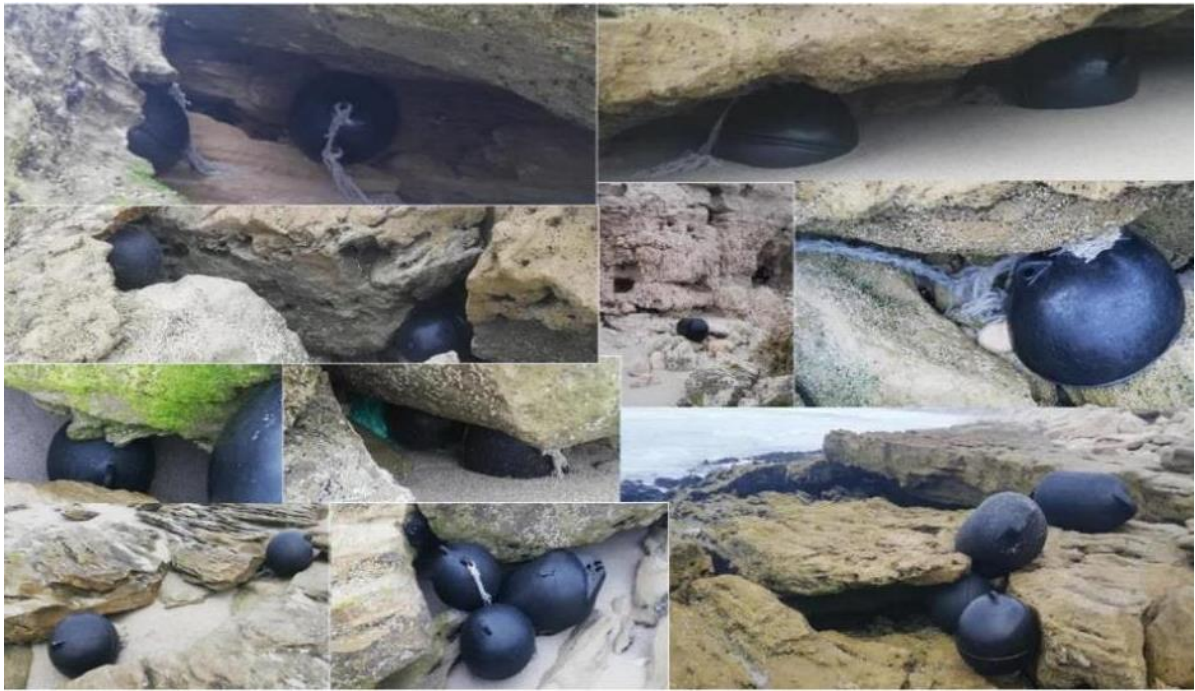
Floats from the mussel industry were the main contributor to aquaculture debris, observed on Spreeuwalle beach in January 2023. These floats were observed along the beach, in between the rocks and trapped under rocky over-hangs (Figure 13 and Figure 14). Floats and crates from the oyster industry also contributed to the total volume of aquaculture debris on Spreeuwalle beach (Figure 15 and Figure 16). An entire mussel longline with droppers was also observed on Spreeuwalle beach (bottom left Figure 16).

Figure 13. Aquaculture debris consisting of floats and ropes from SASH group, observed under rocks and on the beach at Spreeuwalle in January 2023.

During the January 2023 audit period, extensive aquaculture debris was observed on main receiving beach of Big Bay (Spreeuwalle beach) (see Table 12, Section 3.5.5.1, and Figure 13 to Figure 16). Eight operators were identified as being responsible for the aquaculture debris on the beach (three from the oyster industry and five from the mussel industry). Operators are responsible for removing aquaculture debris that enters the environment in accordance with the EMPr (table 5-2: sections 29, 31 and 32). The ECO provided Operators an opportunity to rectify the matter and avoid being issued with a notice of non-compliance. Operators were notified of the aquaculture debris on 24 January 2023 and the ECO requested that an Action Plan for removing the debris be developed and sent to the ECO within 1 business week (on 31 January 2023). Furthermore, the ECO requested that Operators commence clean-up activities so that progress may be seen by 9 February 2023 (3.5 business weeks from date of notification). SASH volunteered to conduct beach inspections and clean-ups in September 2022 as they have majority interest in Big Bay, and because SASH were responsible for the majority of the waste observed on Spreeuwalle beach. The ECO therefore recommended that Ernie Malan (of SASH group) co-ordinate the development of the Action Plan with the other responsible farmers and in consultation with Vos Pienaar (in his capacity as co-chairperson of BSASA).

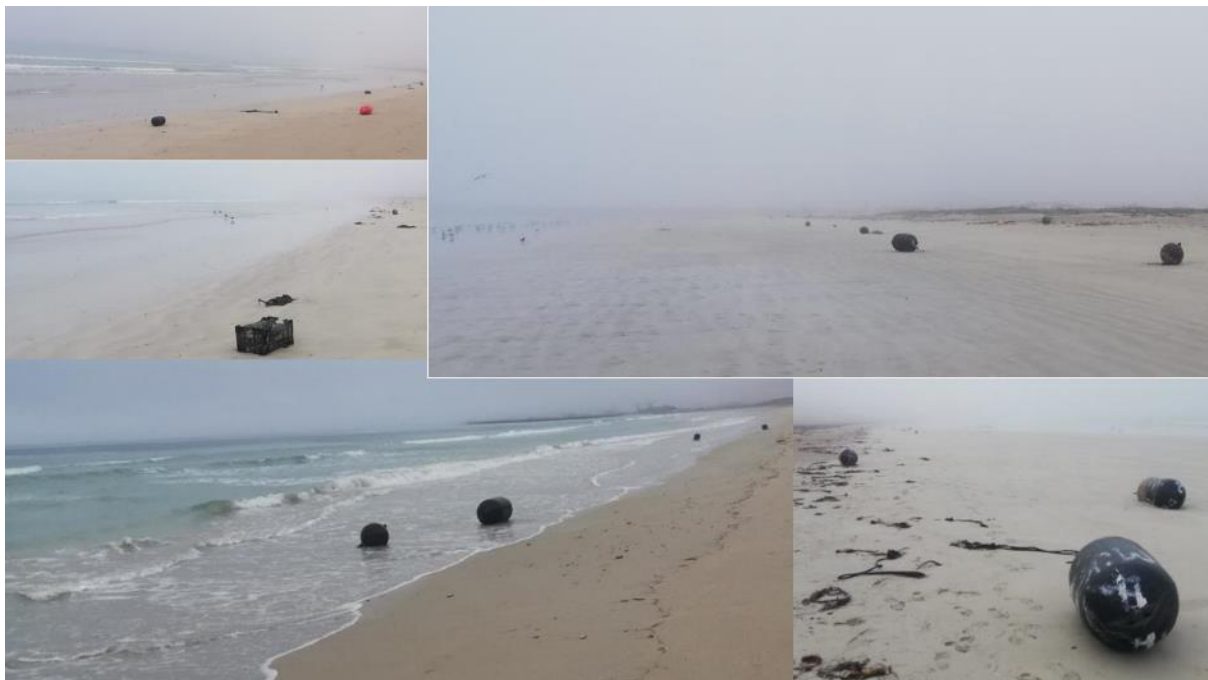
Figure 14. Floats and crates washed ashore from mussel and oyster industries on Spreeuwalle beach observed in January 2023.

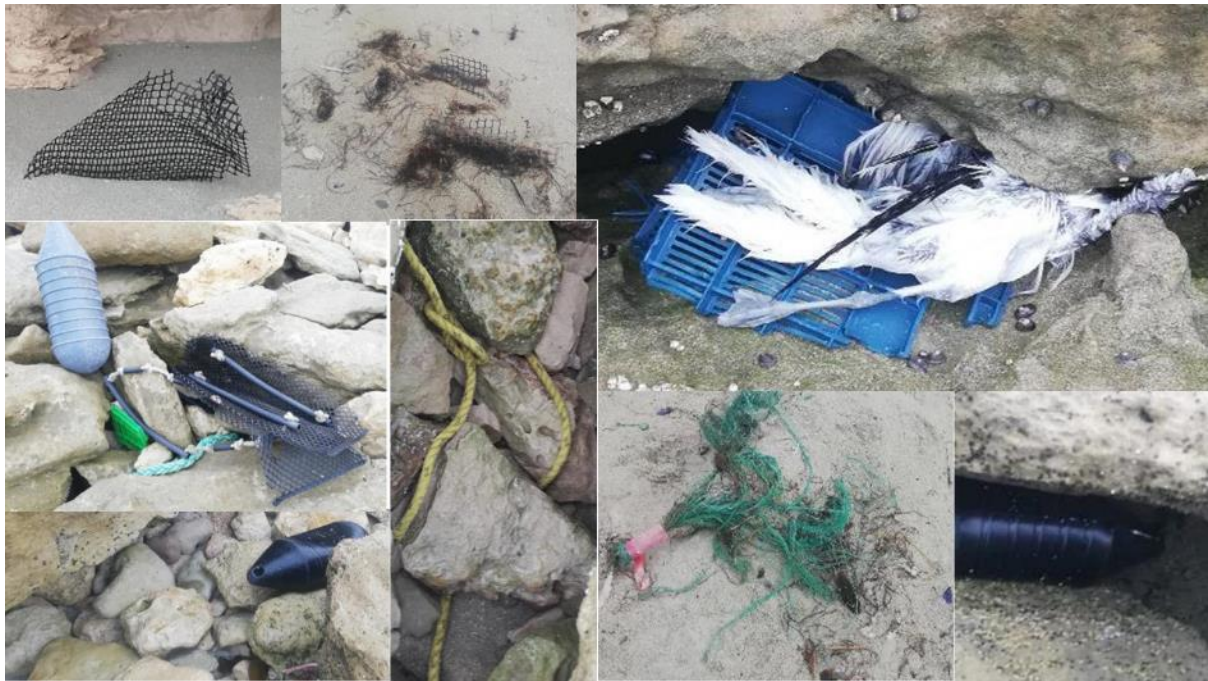
Figure 15. Ropes, crates, floats, and other aquaculture debris belonging to the oyster industry on Spreeuwalle beach in January 2023. This debris was observed on the beach as well as trapped under rocks and in crevices.

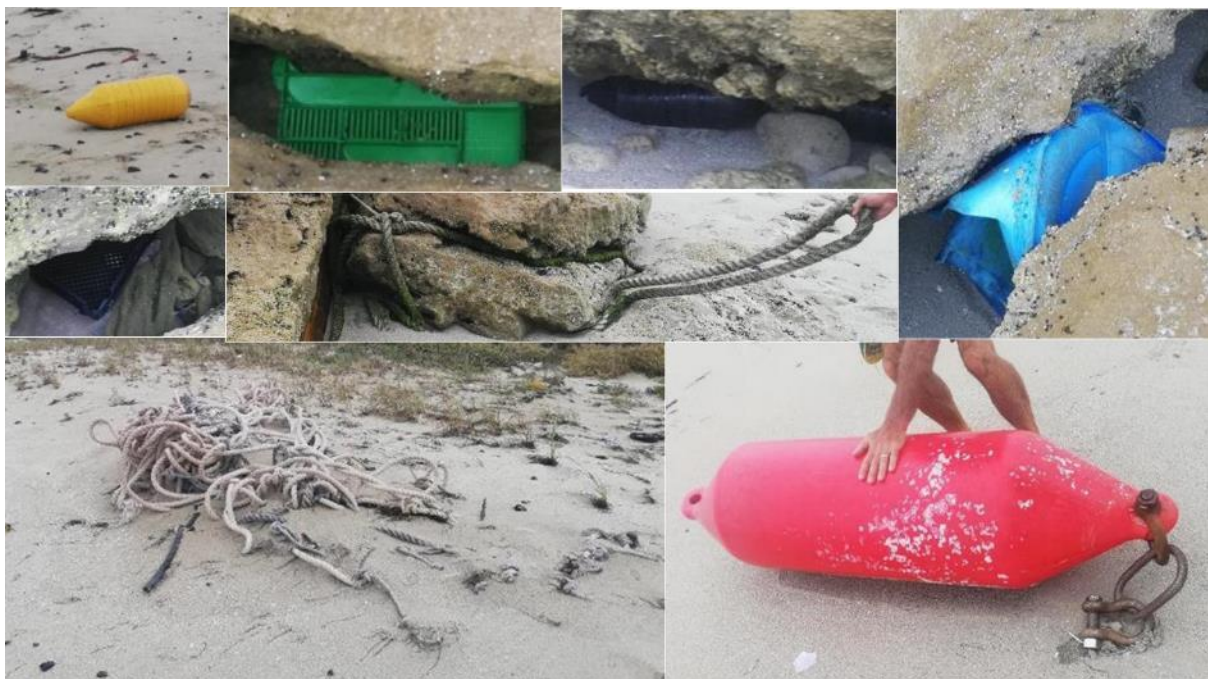
Figure 16. Aquaculture debris on Spreeuwalle beach including ropes, floats, and crates from the mussel and oyster industry observed in January 2023.

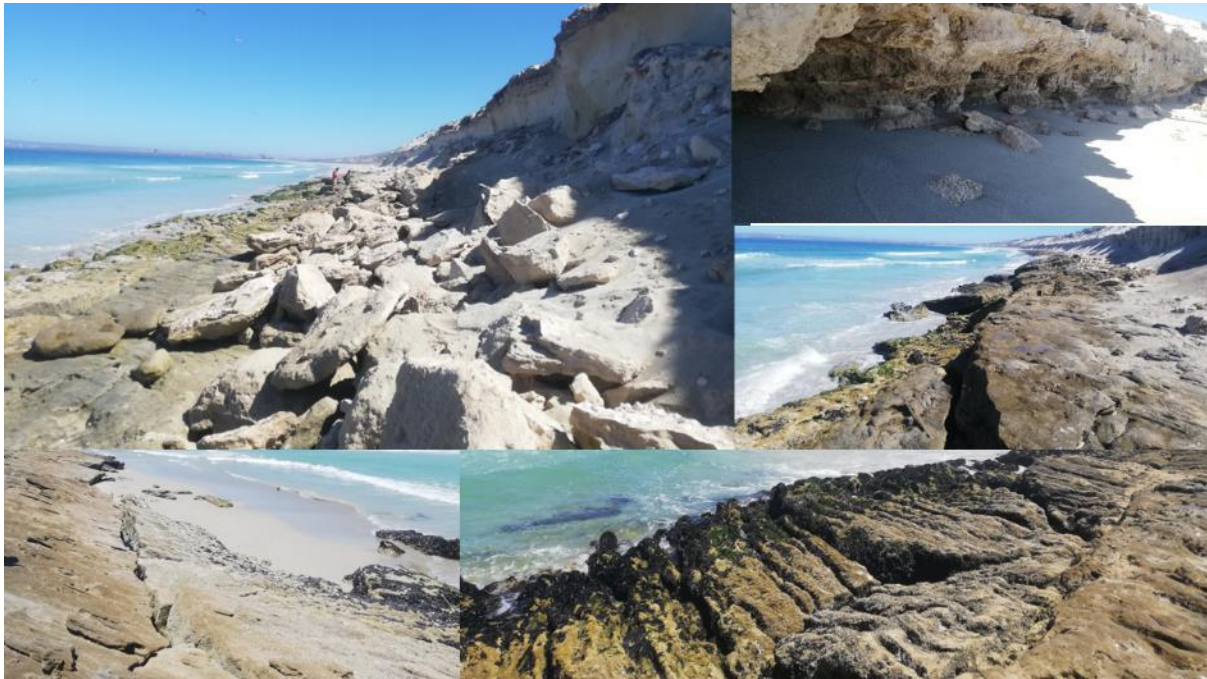
Clean-up activities occurred on Spreeuwalle beach between January and February 2023 and aquaculture debris was removed from both beaches and from under rocks and rocky over-hangs (Figure 17 and Figure 18).

Figure 17. Rocky areas had been predominantly cleared of floats and other aquaculture debris in February 2023.

Although a written Action Plan was not provided to the ECO, the Operators communicated their planned clean-up activities telephonically and via email and achieved the desired outcome of removing aquaculture debris from Spreeuwalle beach as required by the EMPr. At the February 2023 inspection of Spreeuwalle Beach (conducted on 9 February 2023), the ECO observed that an intensive beach clean-up effort had occurred and over 100 floats had been removed (see Table 12, Section

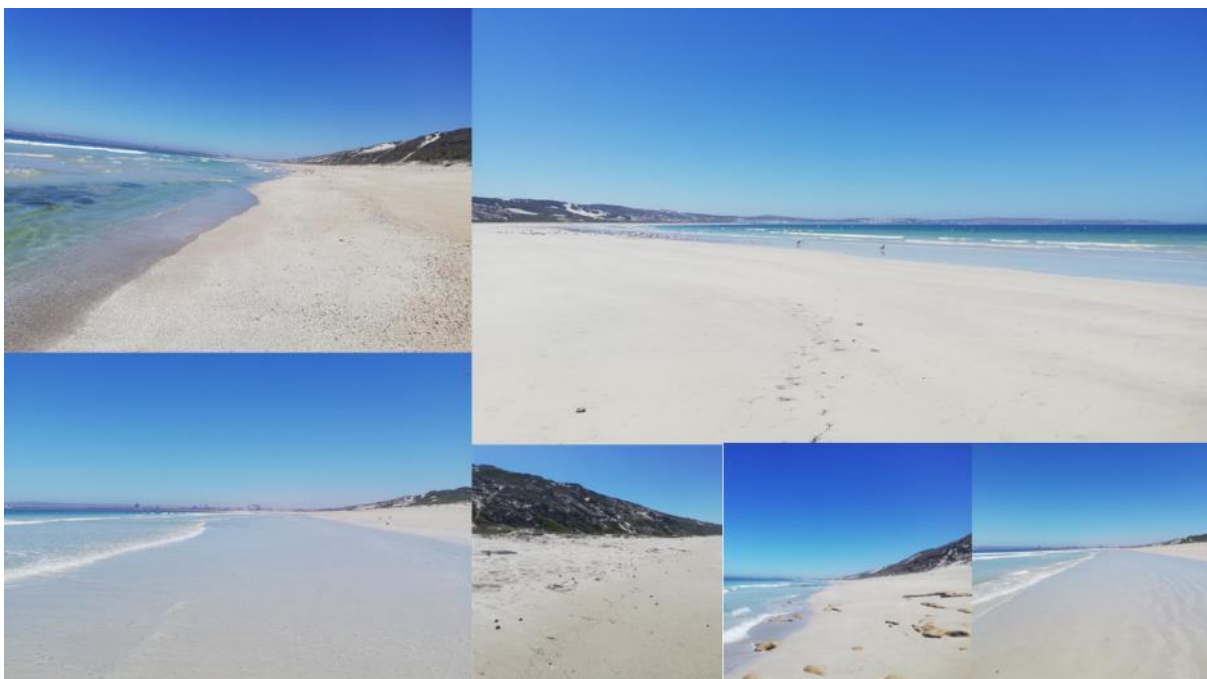
Figure 18. Beaches were observed to be mostly free of floats, ropes, and other aquaculture debris in February 2023.

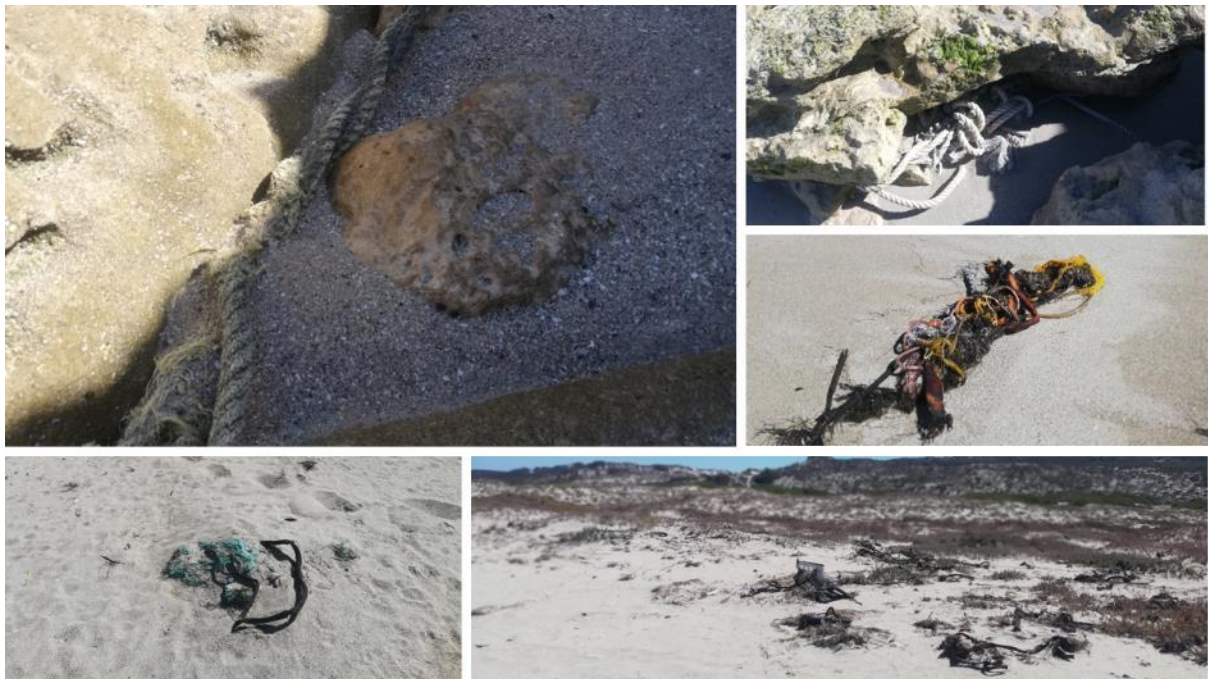
Figure 19. Various ropes and aquaculture debris from Mussel and Oyster industry.

3.5.5.2, and Figure 17 and Figure 18). The eight Operators responsible for contributing to the waste observed in January 2023, their waste contribution in January, and their new waste contribution in February 2023 after clean-up efforts are presented in Table 12. Spreeuwalle beach is challenging to clean as the beach can only be cleaned at spring low tide (once every 2 weeks), and with no access roads, primary access is through the surf. Operators are to be commended for the clean-up efforts and are encouraged to continue monitoring Spreeuwalle and removing aquaculture debris.

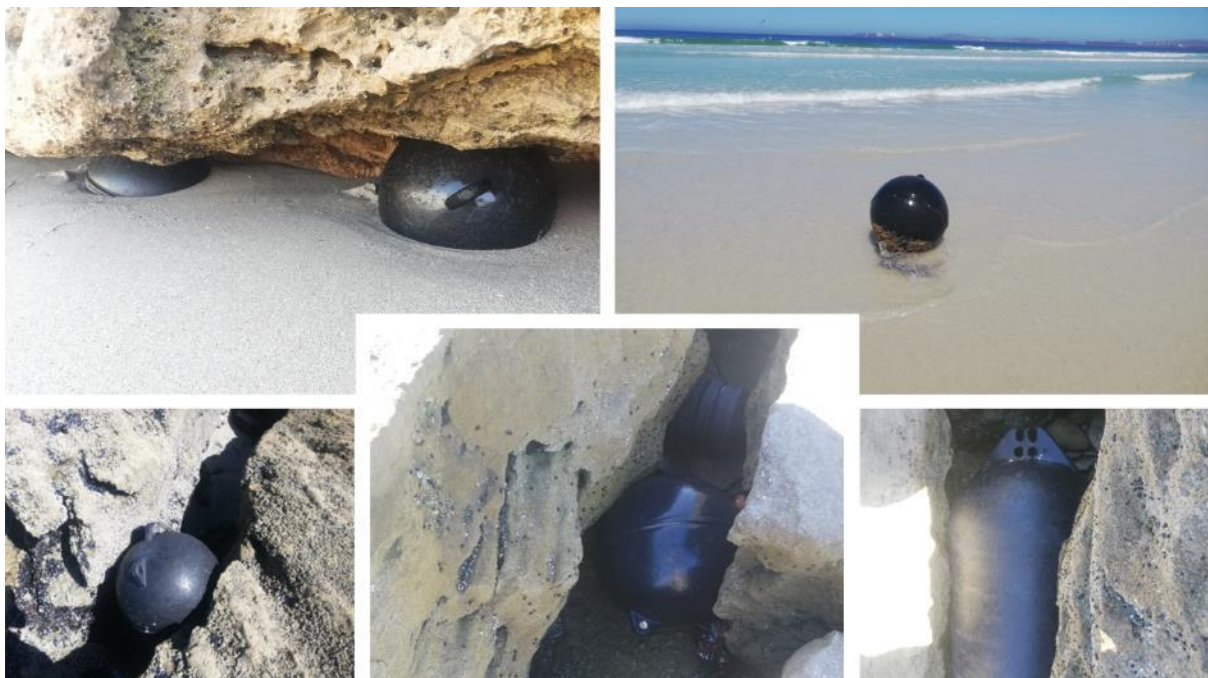
Figure 20. Floats from SASH group remaining on Spreeuwalle beach in February 2023.

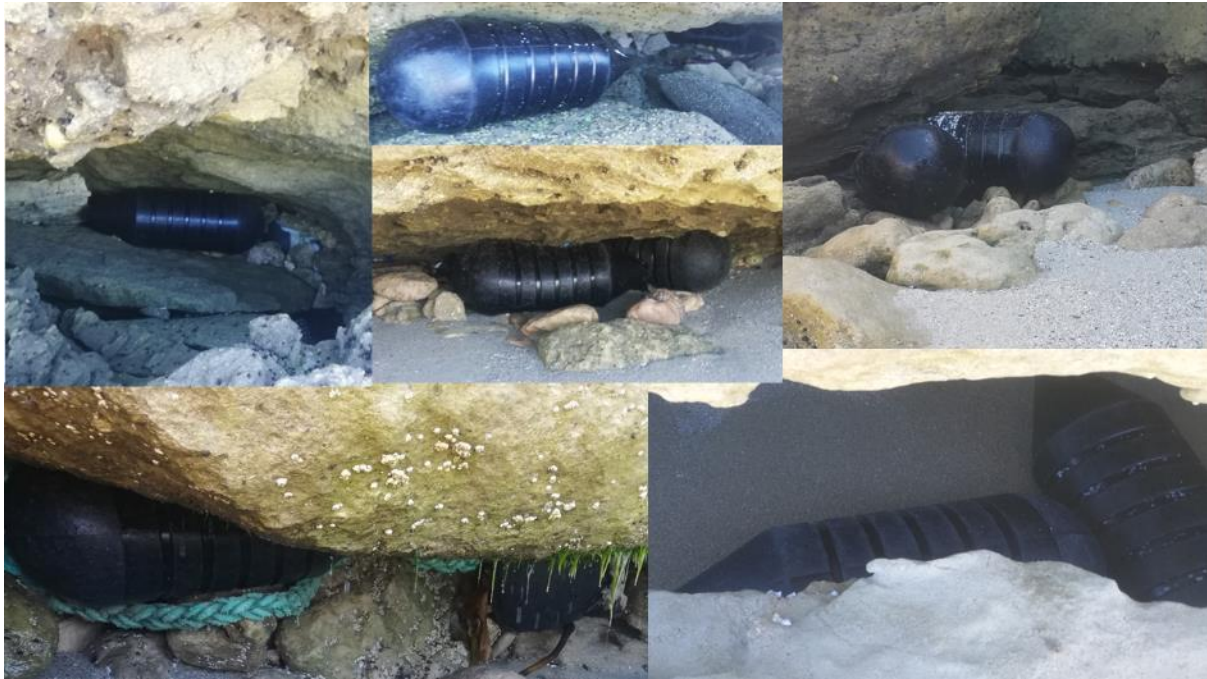
Figure 21. Floats from either BLP or Lagoon Aqua on Spreuwalle beach in February 2023.

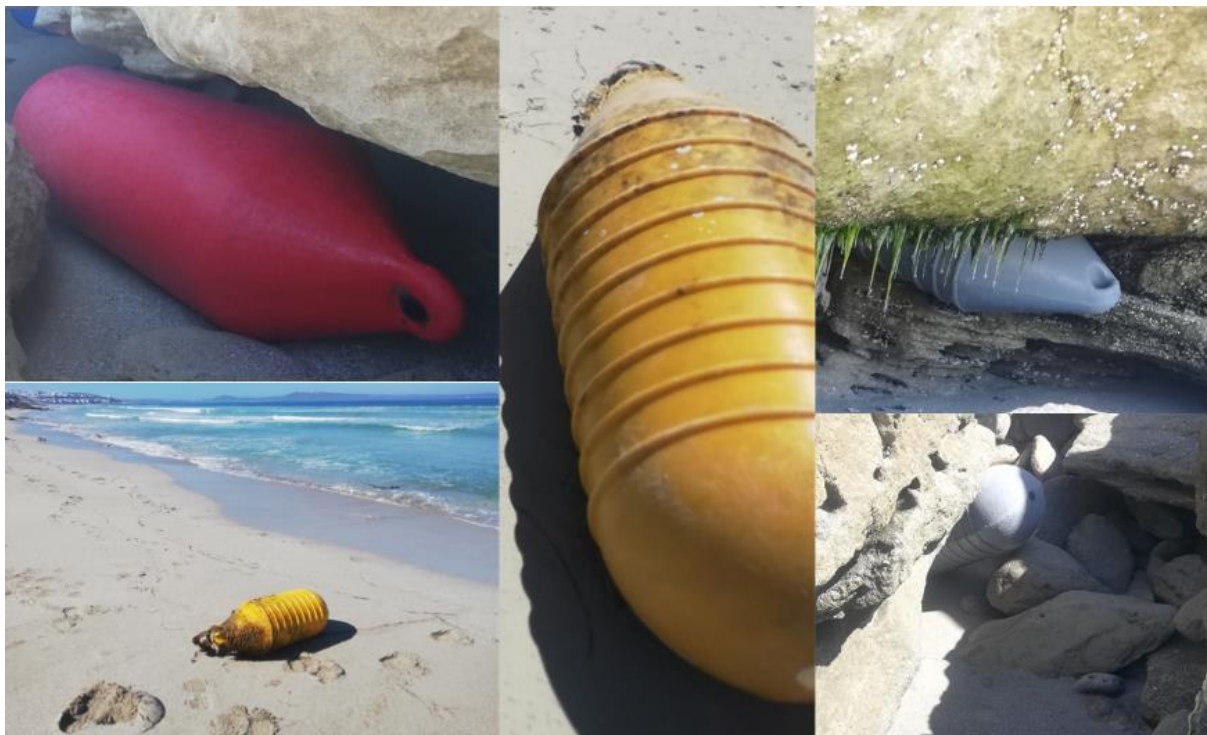
Figure 22. Floats from SBOC on Spreuwalle beach in February 2023.

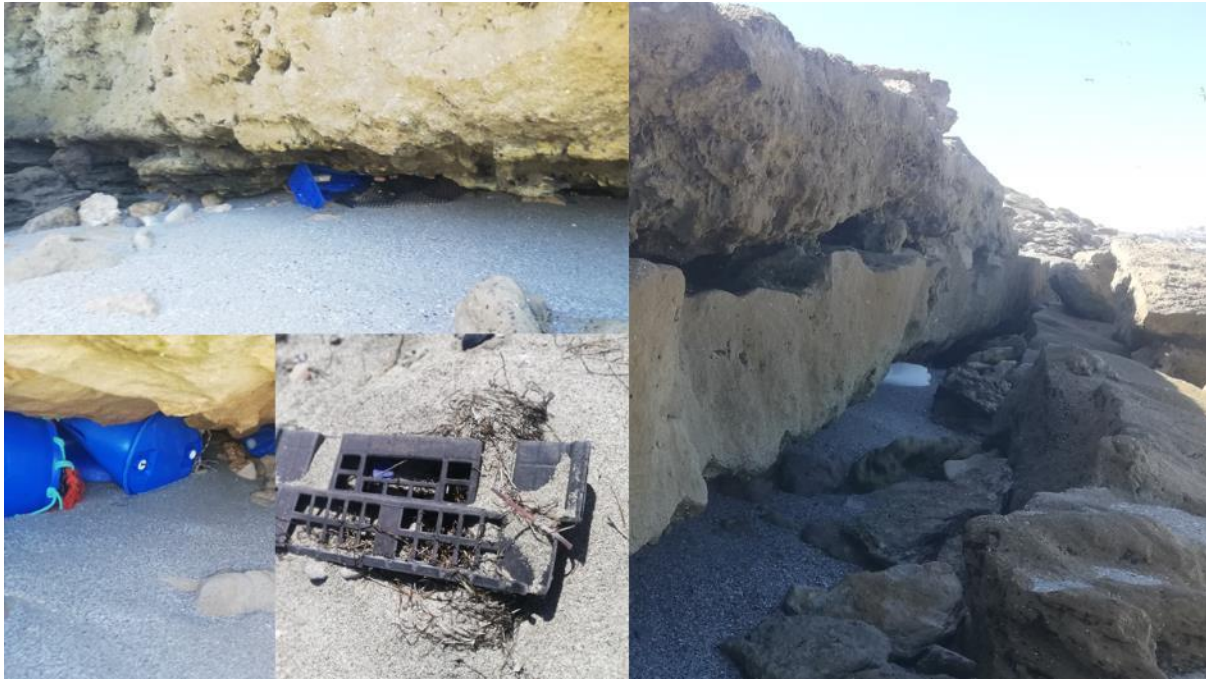
Figure 23. Floats and crates from WCOG on Spreeuwalle beach in February 2023.
