SALDANHA BAY AQUACULTURE DEVELOPMENT ZONE (ADZ)

ENVIRONMENTAL CONTROL OFFICER (ECO)

MONTHLY SUMMARY REPORT 8

November 2022

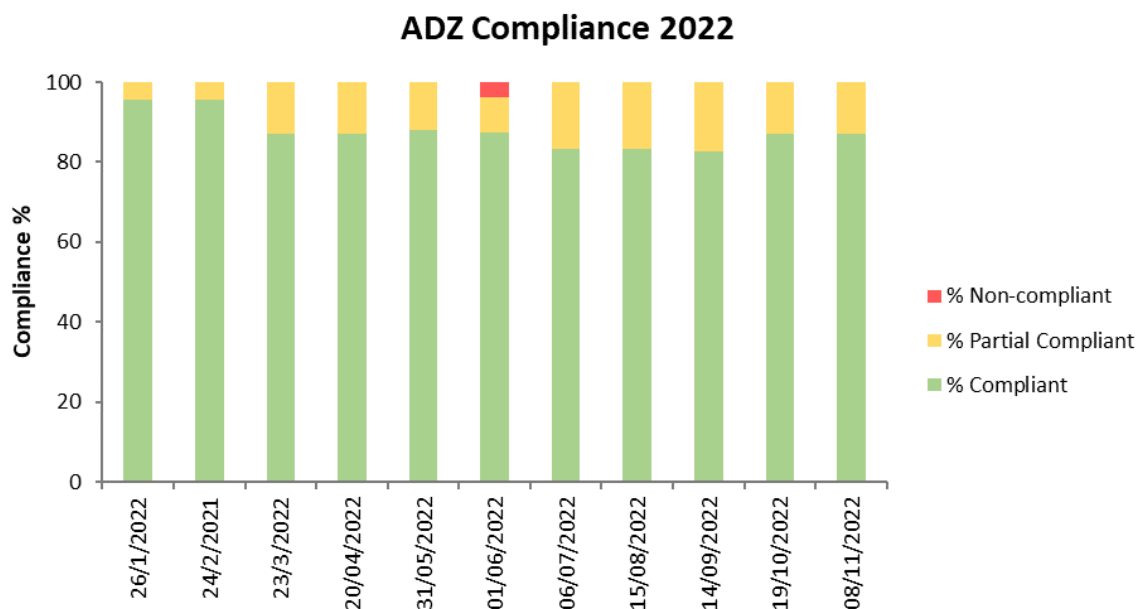
Figure 4. Compliance percentage for ADZ management over time, 2022.

This report details ADZ-level compliance on operational phases and the monitoring measures as per Table 5-1 and Table 7-2 of the ADZ EMPr. The ADZ scored an overall compliance of 87% for the audit period of November 2022 indicating **no change** in compliance percentage since the previous audit in October 2022 (Table 5, Figure 4). Although no change in compliance was observed there was progress towards improving the status of three partial compliances (see section 2.1 above for detail). The ADZ has maintained a high level of compliance (>80%) with the audit standard for 2022 and the Operators and Management team should be commended.

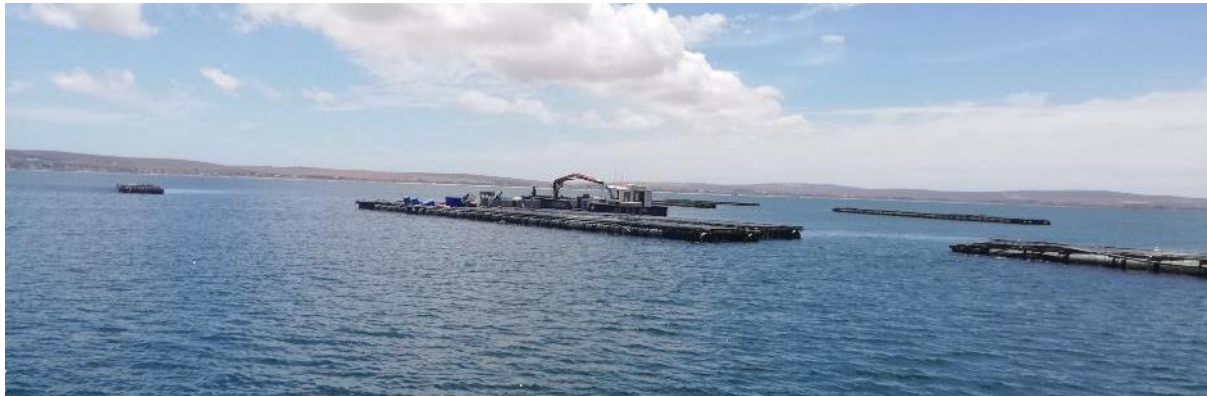
Figure 5. BOM rafts predominantly parallel to the prevailing current and swell which reduces risk of damage and environmental incidents.

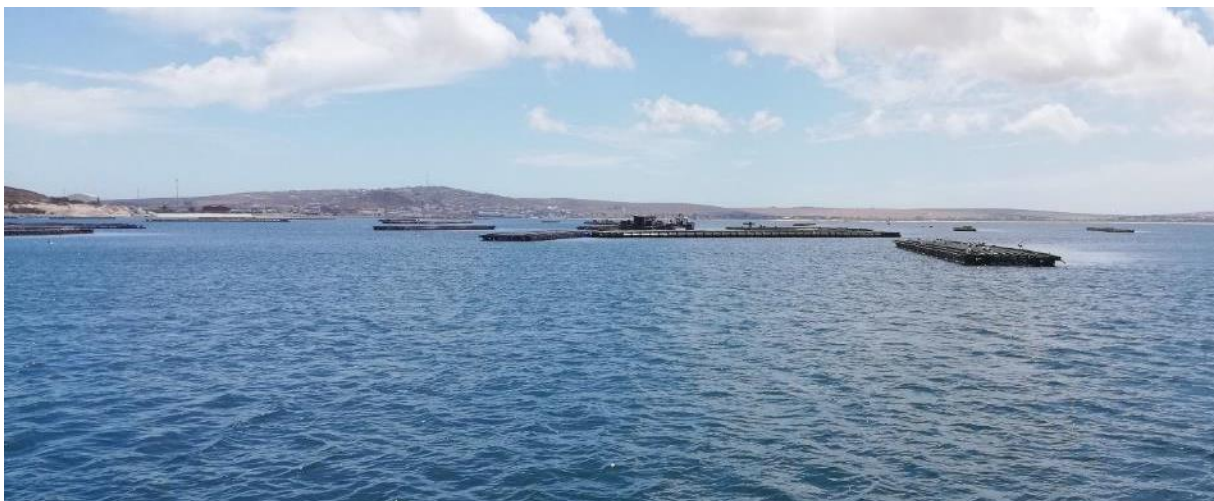
Figure 6. BOM rafts showing three that are still perpendicular to the prevailing current and swell which increases risk of damage and environmental incident.

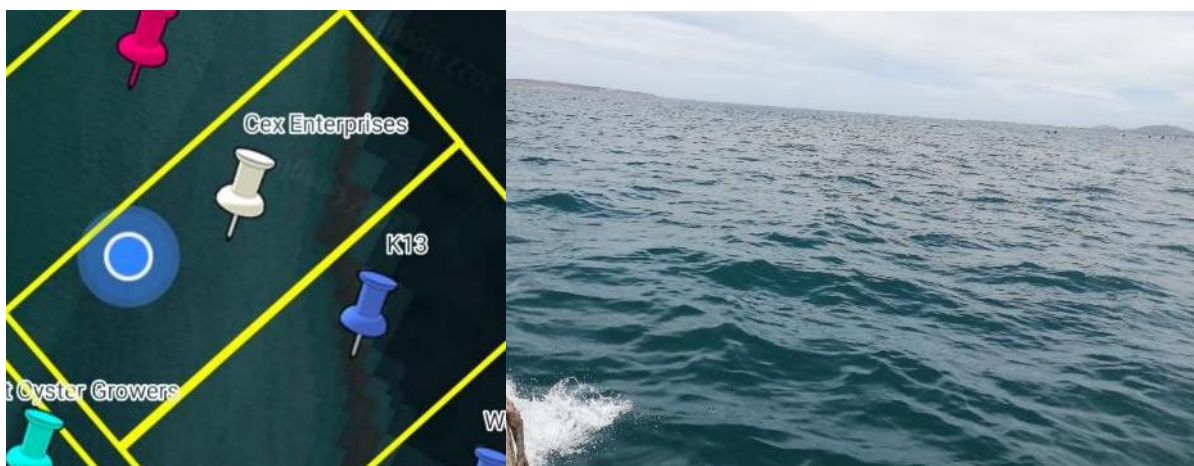
Figure 7. (Left) Live Google Earth pin of location of compliance photograph in relation to CEX Enterprises licence area (yellow boundaries). (Right) There are no lines present on farm as they have not commenced farming activities.

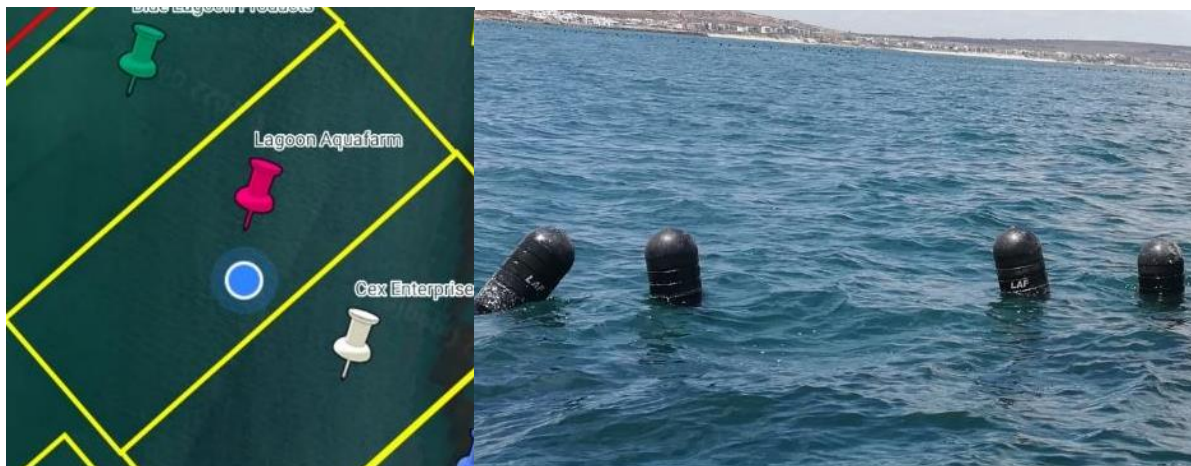
Figure 8. (Left) Live Google Earth pin of location of compliance photograph in relation to Lagoon Aqua licence area (yellow boundaries). (Right) Infrastructure in the water. Note the unique identifiers on the infrastructure.

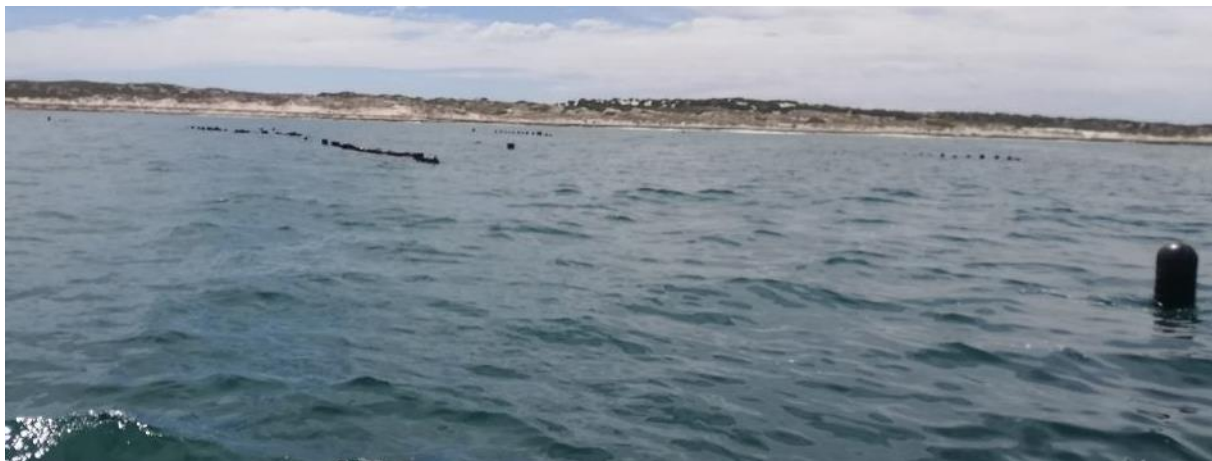
Figure 9. Lagoon Aqua with infrastructure in the water. One line was very slack and another line was overloaded and sinking.

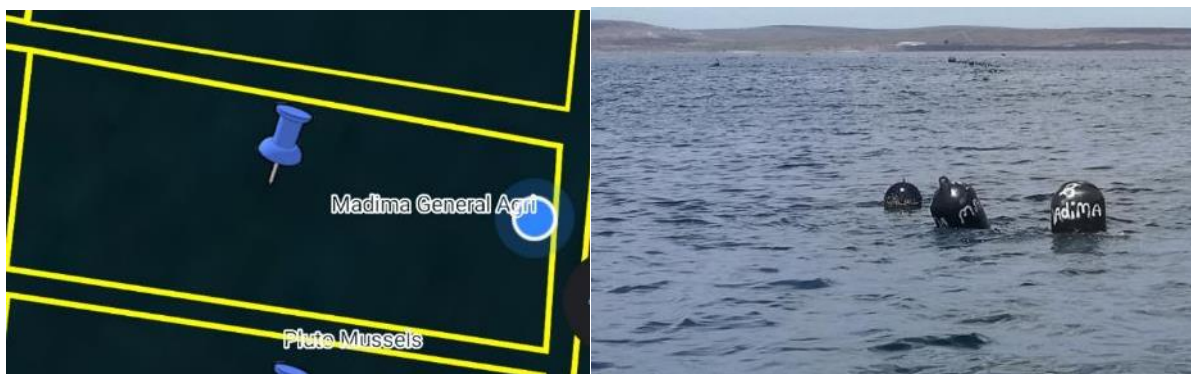
Figure 10. (Left) Live Google Earth pin of location of compliance photograph in relation to Madima licence area (yellow boundaries). (Right) Infrastructure are marked with unique identifiers, lines are taught and not overloaded.

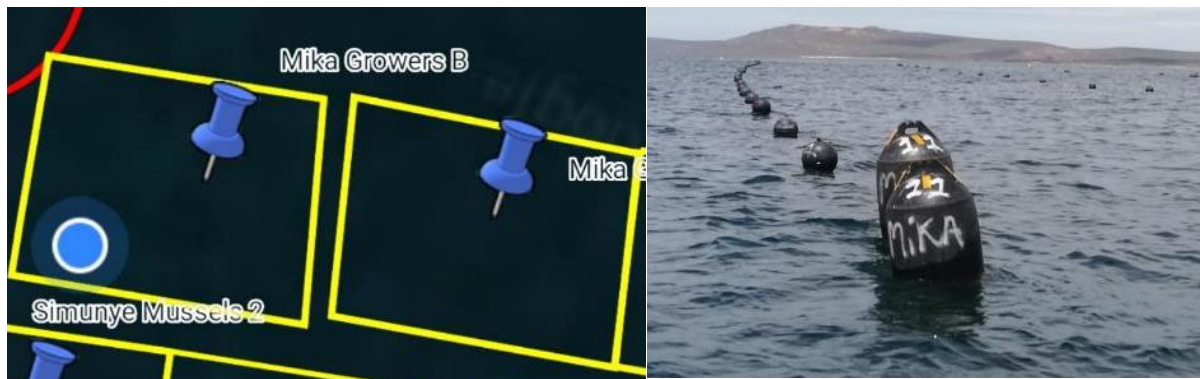
Figure 11. (Left) Live Google Earth pin of location of compliance photograph in relation to Mika licence area (yellow boundaries). (Right) Infrastructure marked with unique identifiers. Lines are not overloaded and predominantly taught.

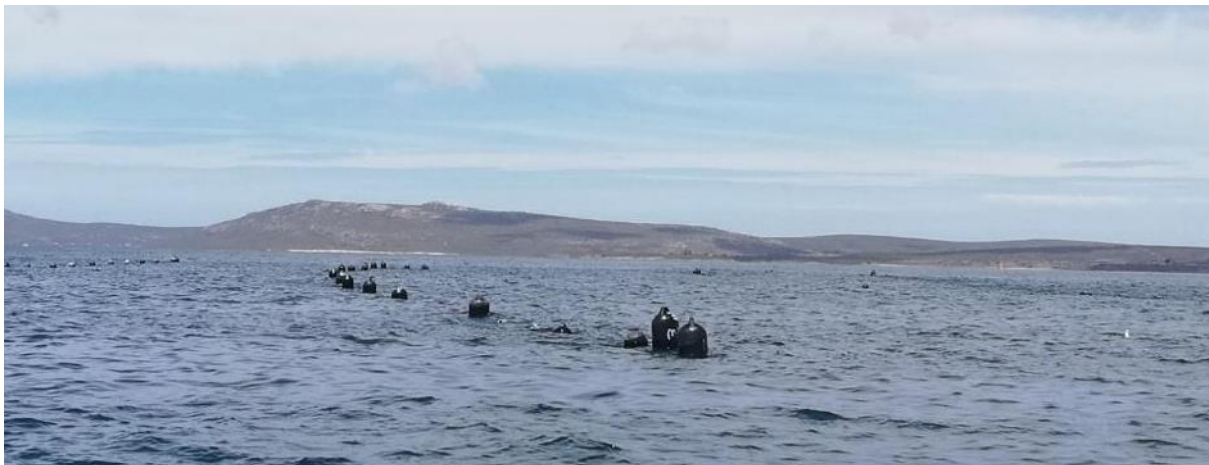
Figure 12. Mika line 3 bowed and slack indicating that the mooring has shifted and needs to be moved back to its original position.

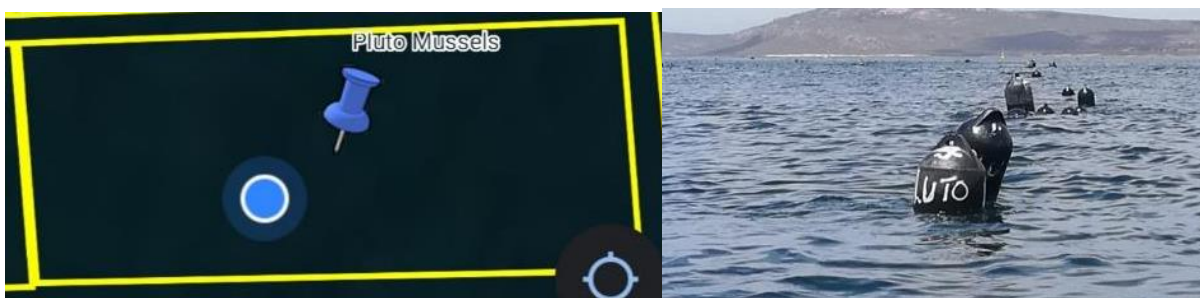
Figure 13. (Left) Live Google Earth pin of location of compliance photograph in relation to Pluto licence area (yellow boundaries). (Right) Lines are taught, no overloaded, and infrastructure is marked with unique identifiers.

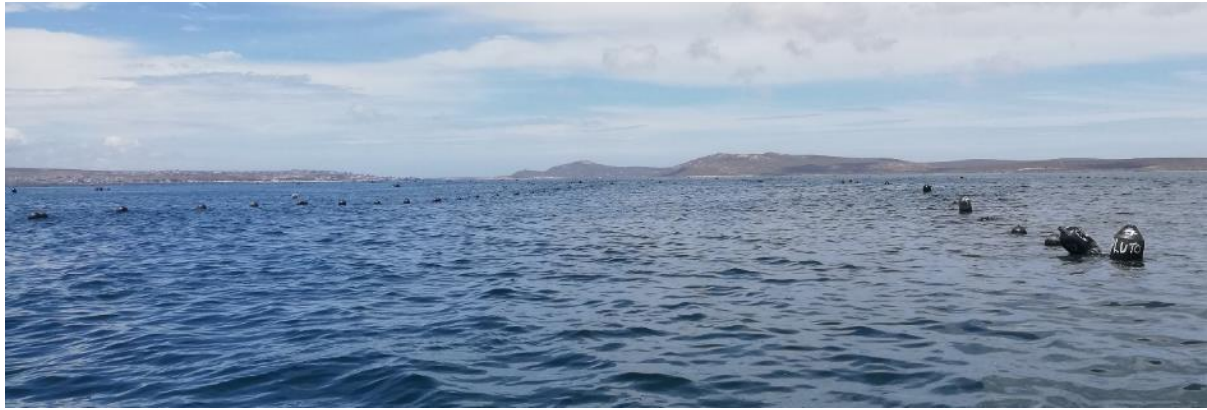
Figure 14. Pluto farm lines are taught, not overloaded and infrastructure marked with unique identifiers.

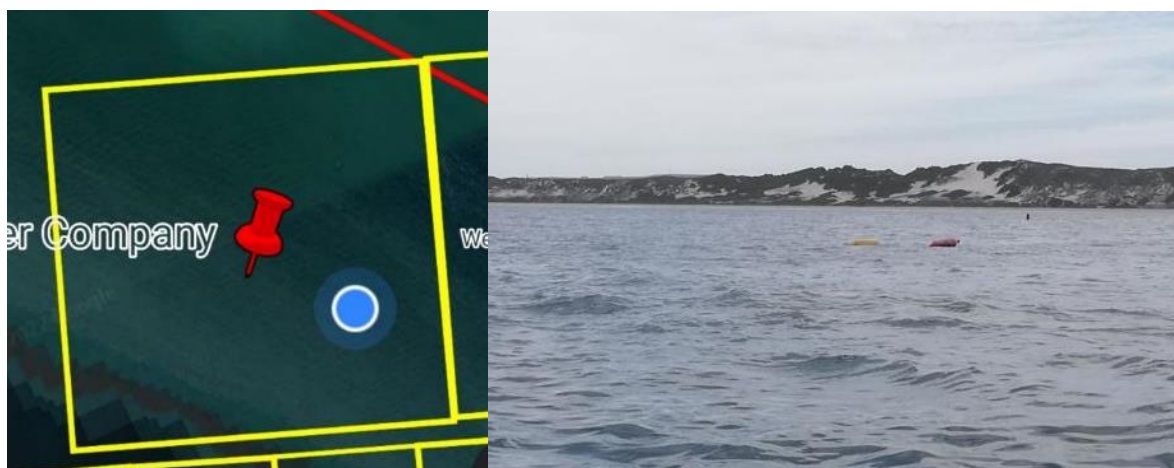
Figure 15. (Left) Live Google Earth pin of location of compliance photograph in relation to SBOC Big Bay farm licence area (yellow boundaries). (Right) Buoys have been cleaned of biofouling and mooring markers are now floating on the surface.

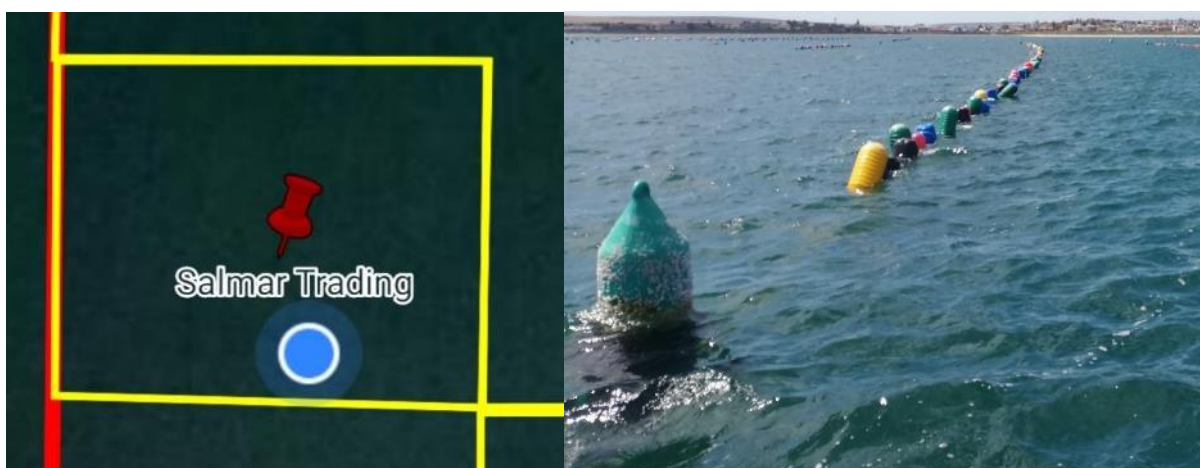
Figure 16. (Left) Live Google Earth pin of location of compliance photograph in relation to Salmar farm licence area (yellow boundaries). (Right) Lines are taught lines and not overloaded. However, the blue drum floats are not consistent with Salmar's unique identifiers.

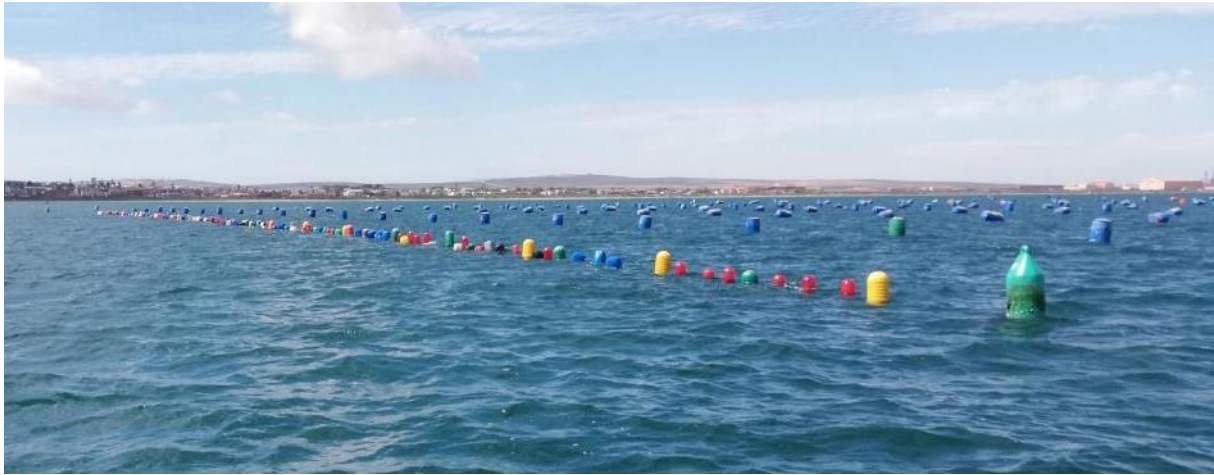
Figure 17. Salmar farm lines are taught lines and not overloaded. However, blue drum floats are present and not consistent with Salmar’s unique identifiers.

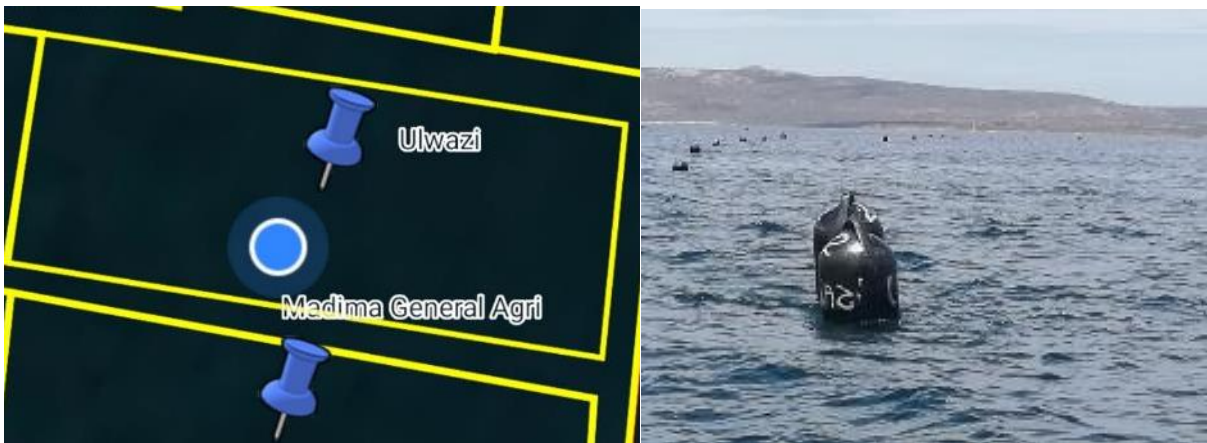
Figure 18. (Left) Live Google Earth pin of location of compliance photograph in relation to Ulwazi Kukutyu licence area (yellow boundaries). (Right) Empty lines in water. Lines are taught and marked with unique identifiers.

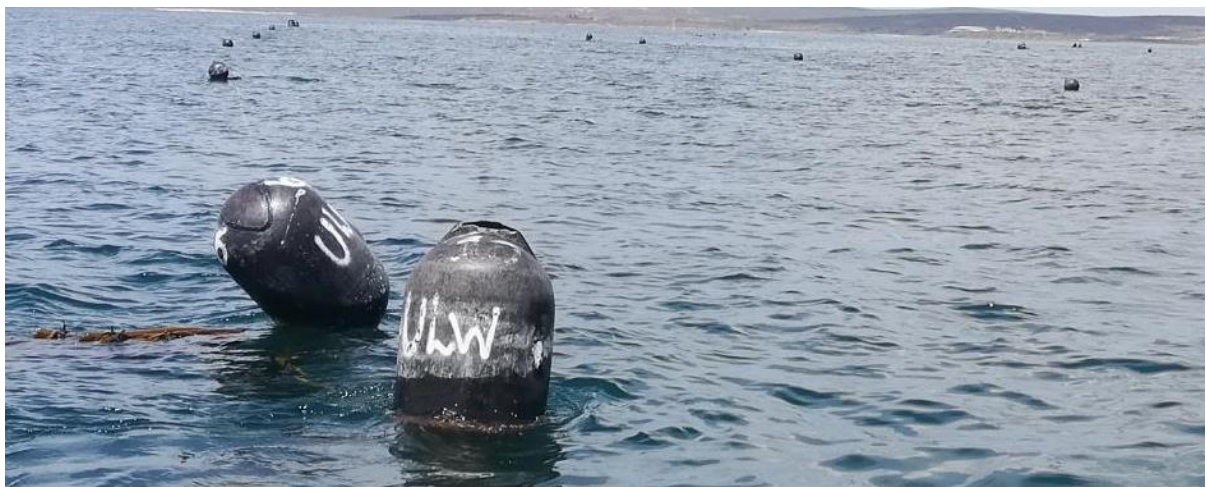
Figure 19. Line 6 on Ulwazi farm that is empty of product, suitably marked with unique identifiers and straight.

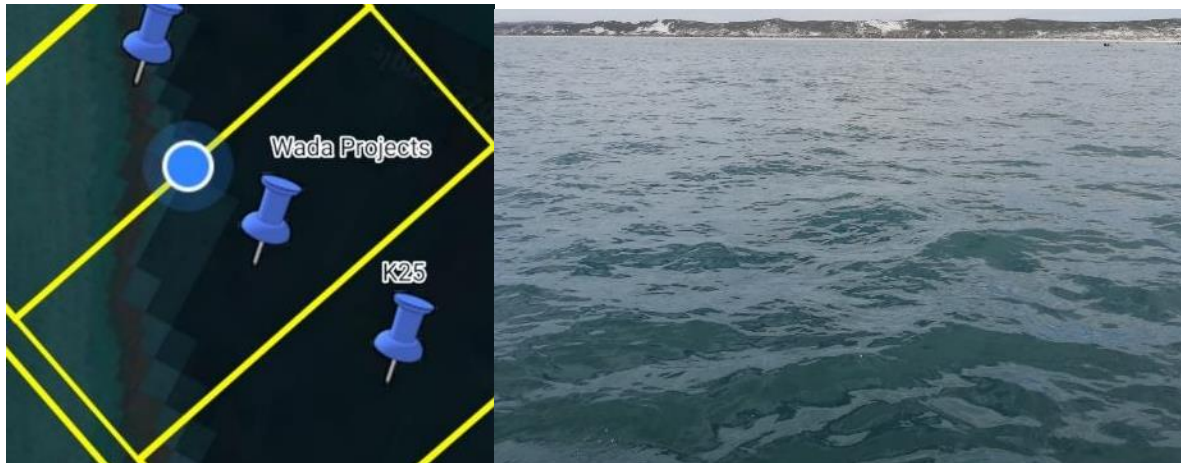
Figure 20. (Left) Live Google Earth pin of location of compliance photograph in relation to Wada Projects licence area (yellow boundaries). (Right) No lines present on farm as they have not commenced with farming activities.

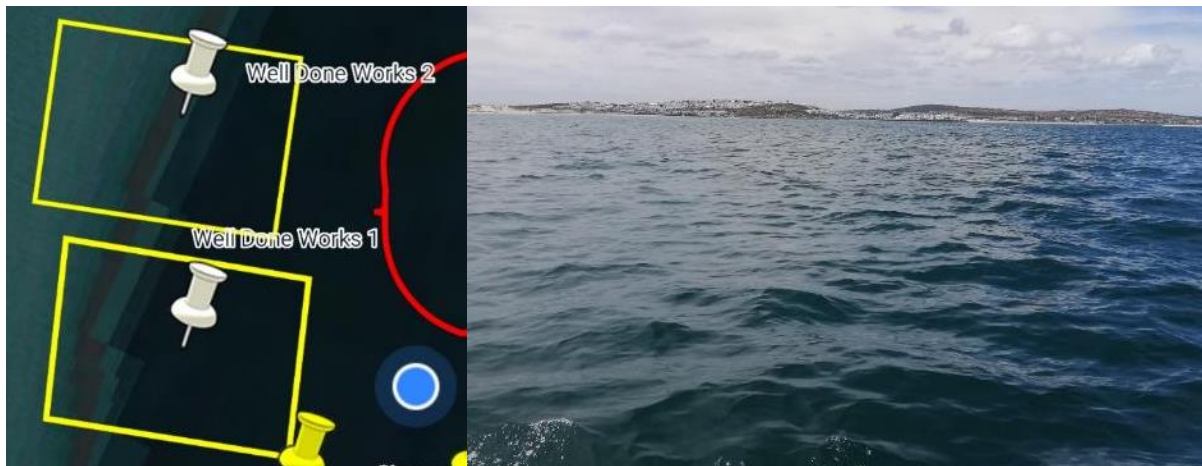
Figure 21. (Left) Live Google Earth pin of location of compliance photograph in relation to Well Done Works licence area (yellow boundaries). (Right) No lines present on farm as they have not commenced with farming activities.
