SALDANHA BAY AQUACULTURE DEVELOPMENT ZONE (ADZ)

ENVIRONMENTAL CONTROL OFFICER (ECO)

MONTHLY SUMMARY REPORT 12

March 2023

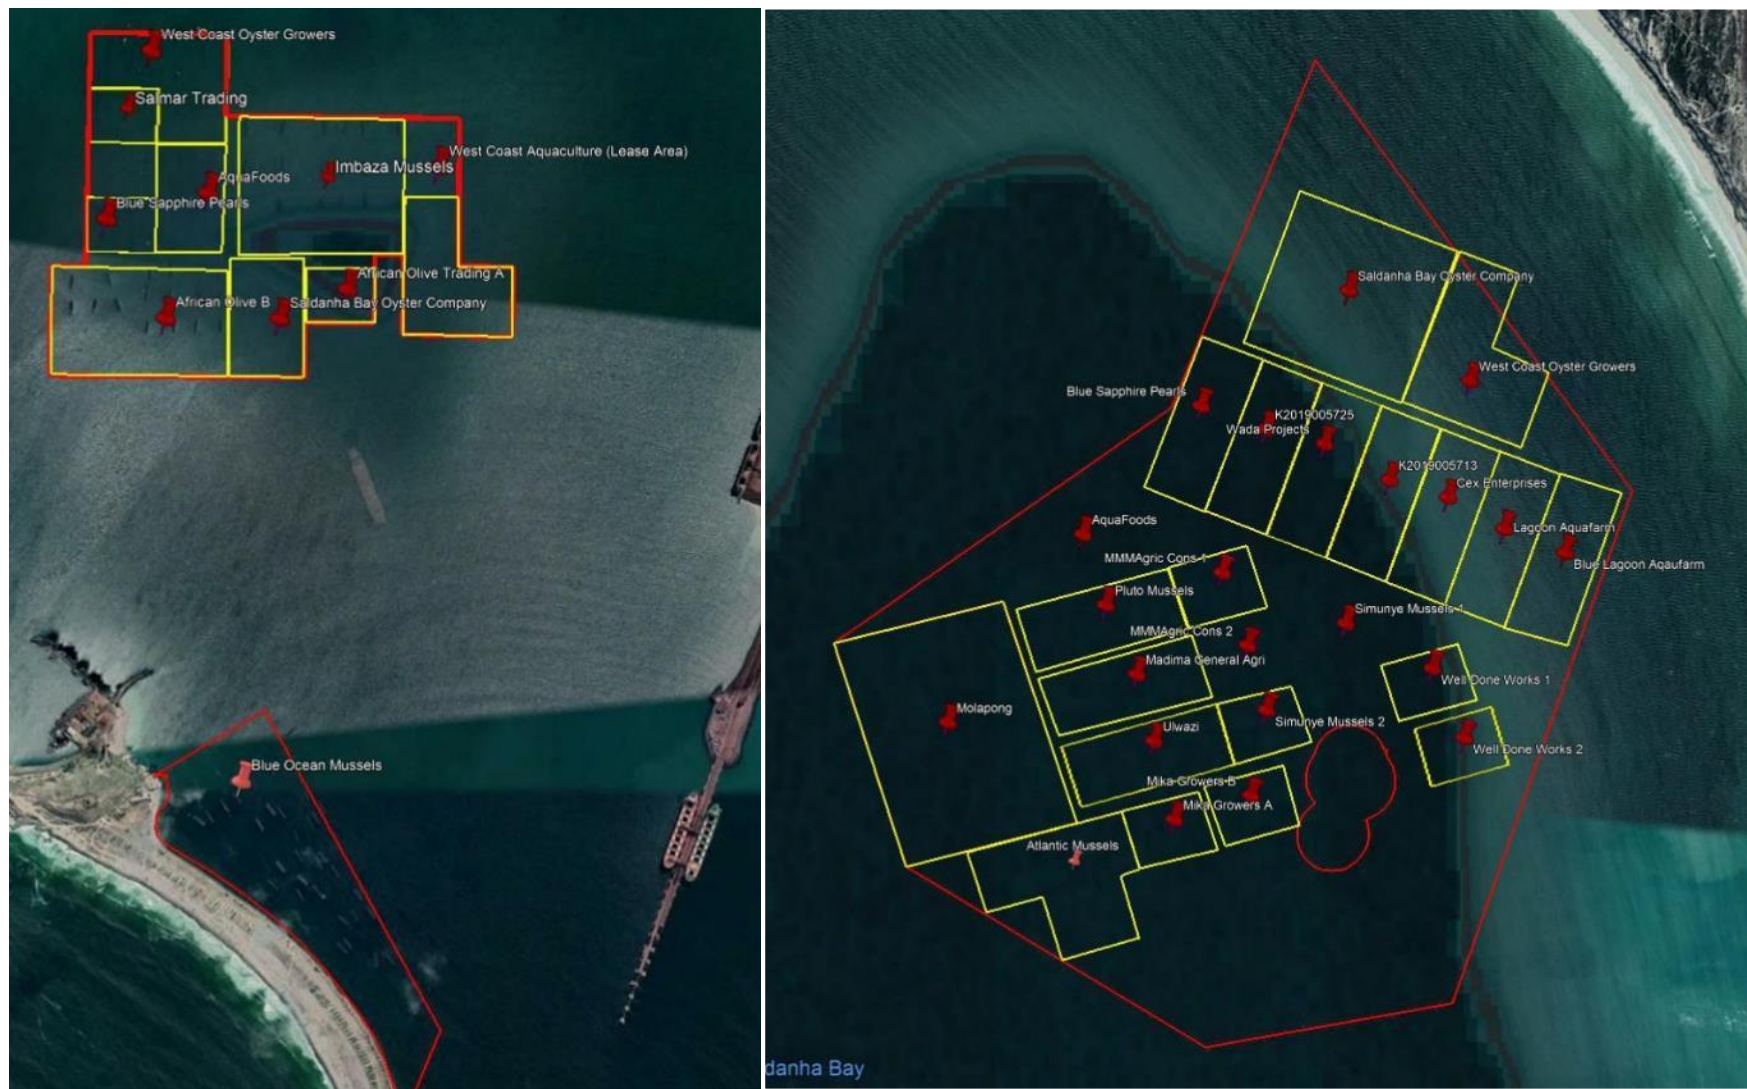
Figure 2. (Left) Bivalve culture in SB and (right) mixed bivalve and finfish culture in BB.

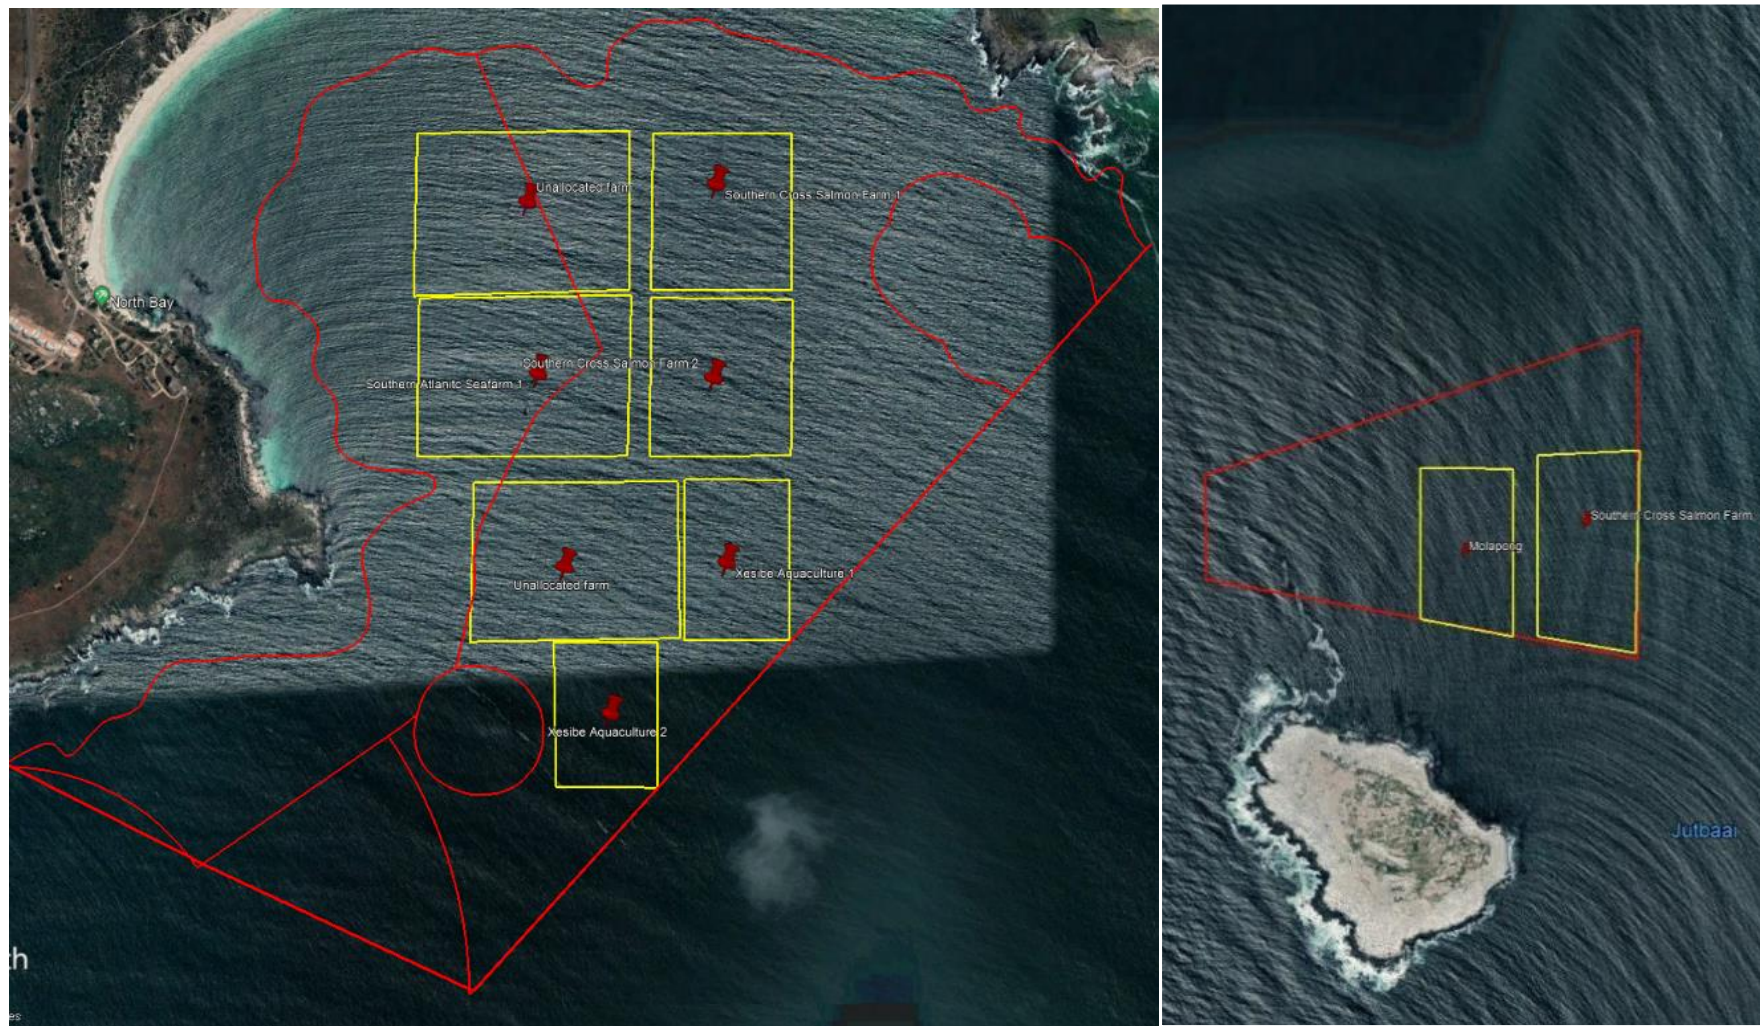
Figure 3. (Left) Bivalve culture in OBN and (right) finfish culture in Outer Bay South.

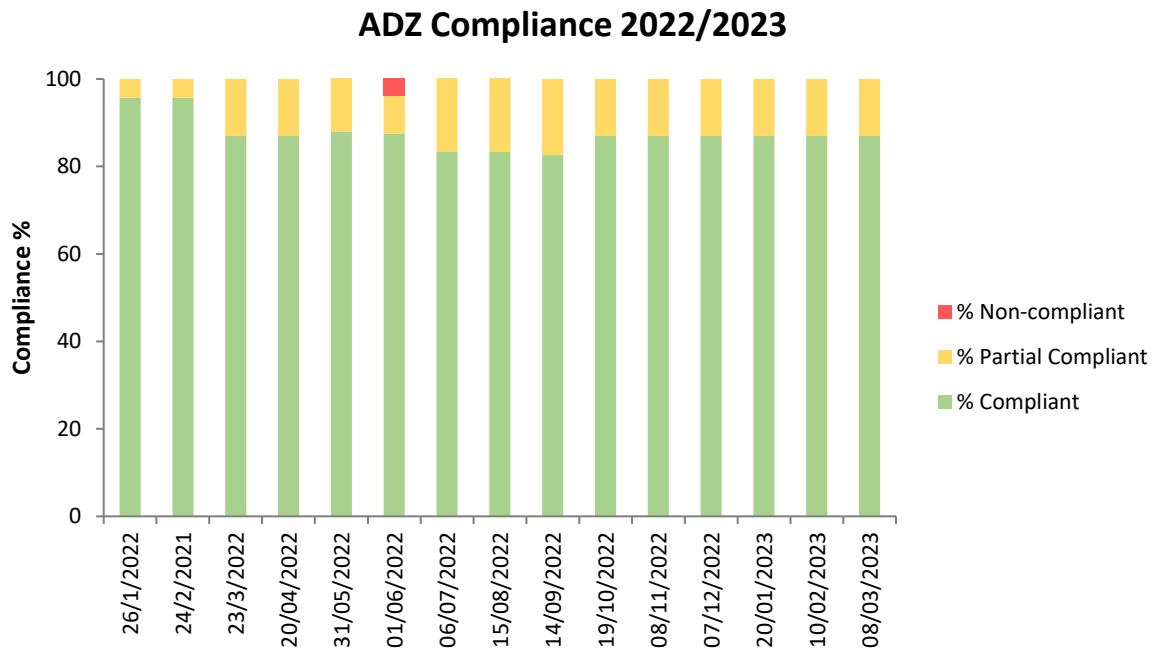
The ADZ scored an overall compliance of 87% for the audit period of March 2023 indicating **no change** in compliance percentage since the previous audit in February 2023 (Table 5, Figure 4). Although no change in compliance was observed there was progress towards improving the status of three partial compliances (see Section 3.2). The ADZ has maintained a high level of compliance (>80%) with the audit standard from January 2022 to March 2023, and the management team should be commended.

Figure 4. ADZ compliance over time from January 2022 to March 2023.

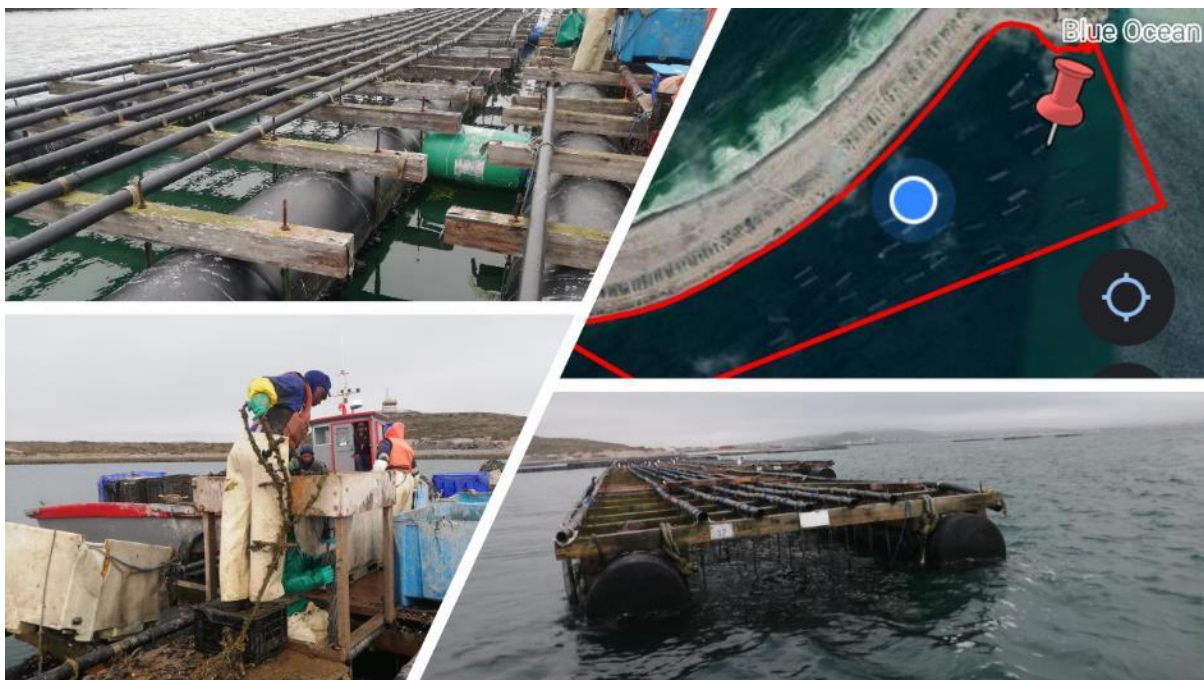
Figure 5. (Top left) BOM rafts in good condition but lashed together while awaiting their own moorings; green drums placed between rafts to reduce damage by rafts buffeting against one another. (Top right) Live Google Earth pin of location of compliance photograph in relation to BOM, Small Bay licence area (red boundaries). (Bottom left) Operators seeding droppers with mussels. (Bottom right) Raft 17 in good condition, facing the prevailing current and swell, suitably marked, and on its own moorings.

To separate rafts lashed to one another, mooring blocks need to be moved and repositioned. The existing mooring blocks are embedded to the ocean floor, which represents a challenge to repositioning. However, new mooring blocks have been sourced. Procuring the chain required to attach rafts to the mooring blocks is the current challenge as new chain is very costly but, BOM are investigating their options. To reduce buffeting impact between rafts, prevent further damage, and reduce the risk of environmental incident, 25 litre drums have been placed between the rafts to act as fenders.

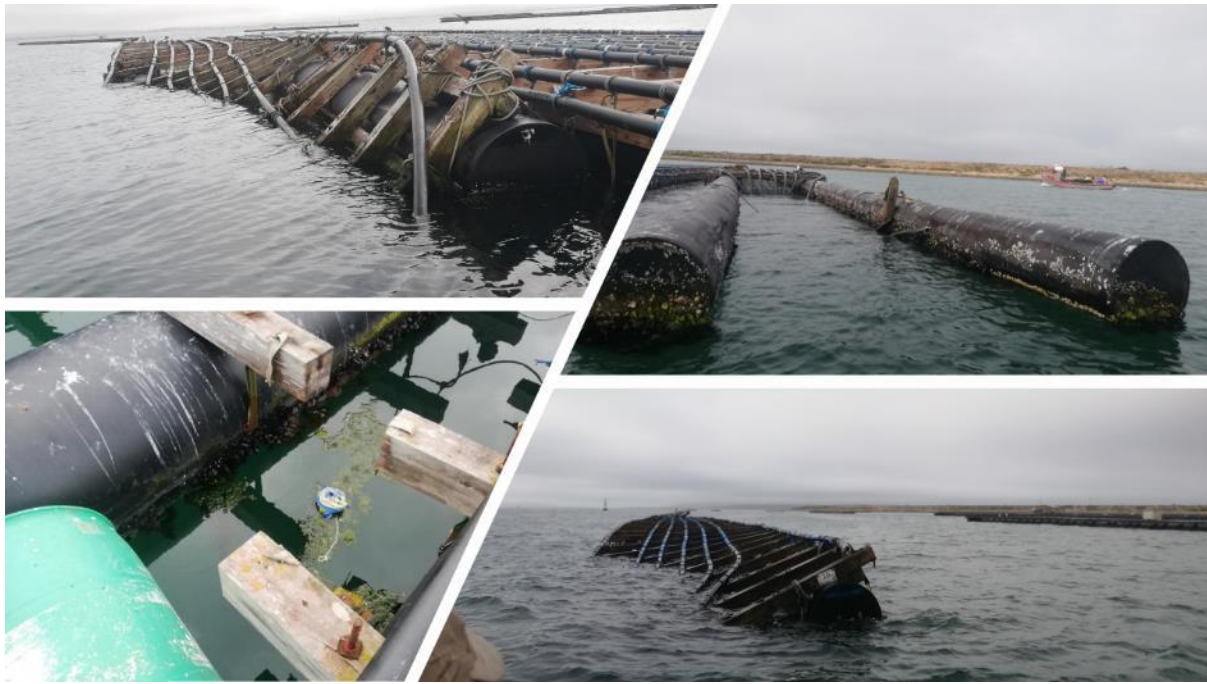
Figure 6. (Top) Raft 14 sinking and half of the cross beams are missing. (Bottom left) Some litter observed to be discarded by operators. (Bottom right) Raft 16 sinking.

At the March 2023 site inspection, raft 16 was observed to be sinking. The level to which the raft had sunken overnight suggests a vessel or some other external force impacting the raft resulting in its state, rather than wear and tear (which would result in the raft slowly sinking over time). The BOM team are investigating the matter and raft 16 will need to be rebuilt.

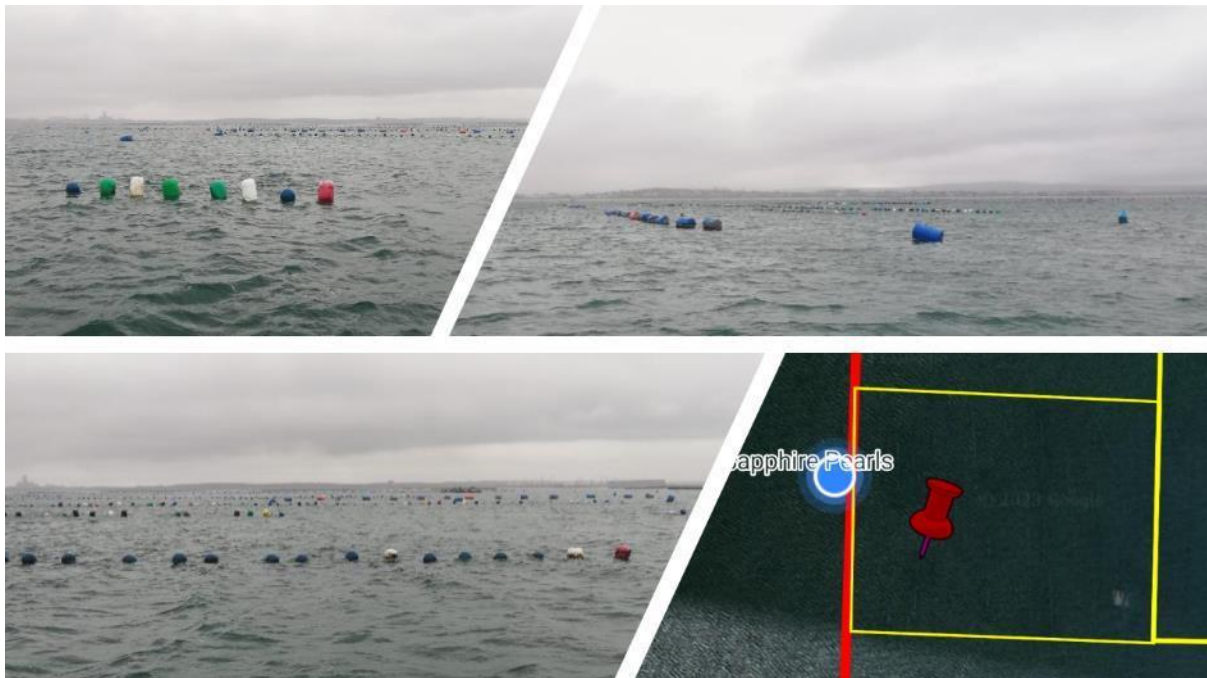
Figure 7. (Top and bottom left) oyster lines on BSP Small Bay site are suitably loaded, but not all floats conform to the unique identifiers for BSP (red and yellow floats to be removed). (Top right) Mussel lines on BSP Small Bay site are taught, straight and suitably loaded. (Bottom right) Live Google Earth pin of location of compliance photograph in relation to BSP, Small Bay licence area (yellow boundaries).

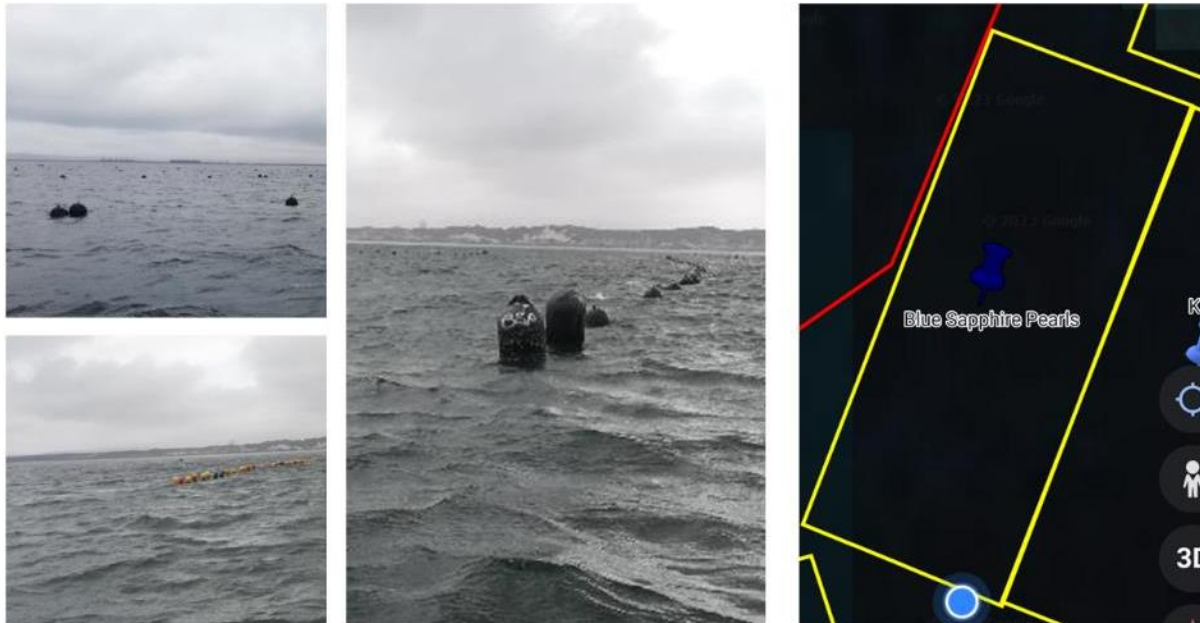
Figure 8. (Top left) BSP Small Bay mussel lines in water, lines not overloaded or sinking. (Bottom left) Oyster line in water, end floats are sunken, and one line has completely sunken. (Middle) Mussel lines, end floats suitably marked, lines are taught, straight and not overloaded. (Right) Live Google Earth pin of location of compliance photograph in relation to BOM, Small Bay licence area (yellow boundaries).

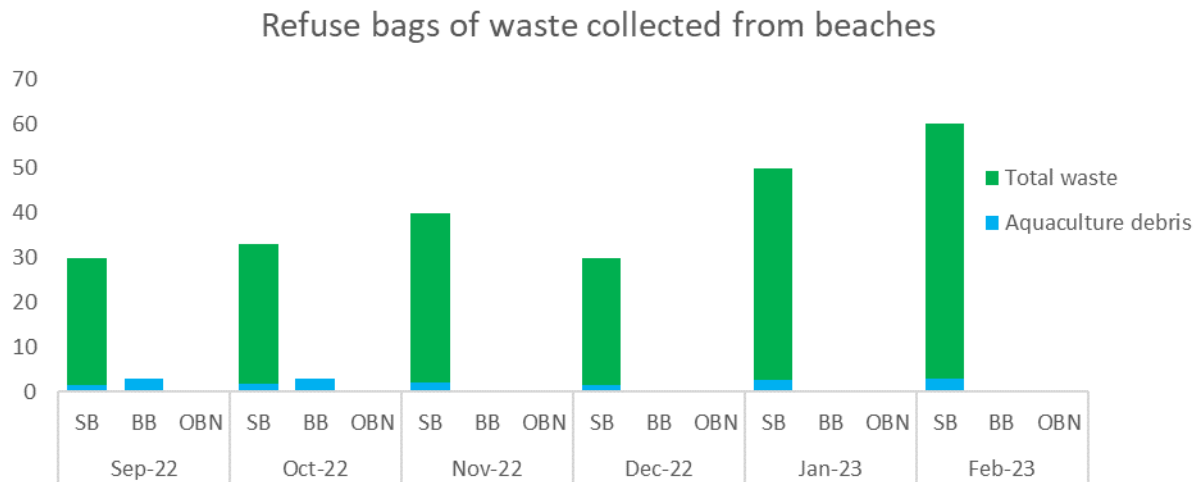
Figure 9. Waste collected in refuse bags from beaches in the various precincts. Total waste collected and portion of waste constituting aquaculture debris is presented.

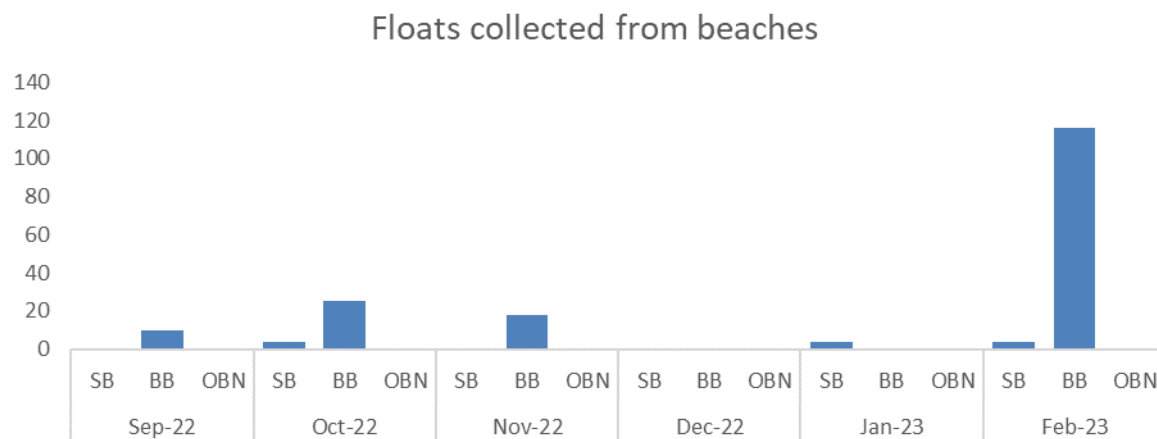
Figure 10. Floats collected from beaches in the various precincts from September 2022 to February 2023.
