SALDANHA BAY AQUACULTURE DEVELOPMENT ZONE (ADZ)

ENVIRONMENTAL CONTROL OFFICER (ECO)

MONTHLY SUMMARY REPORT 13

April 2023

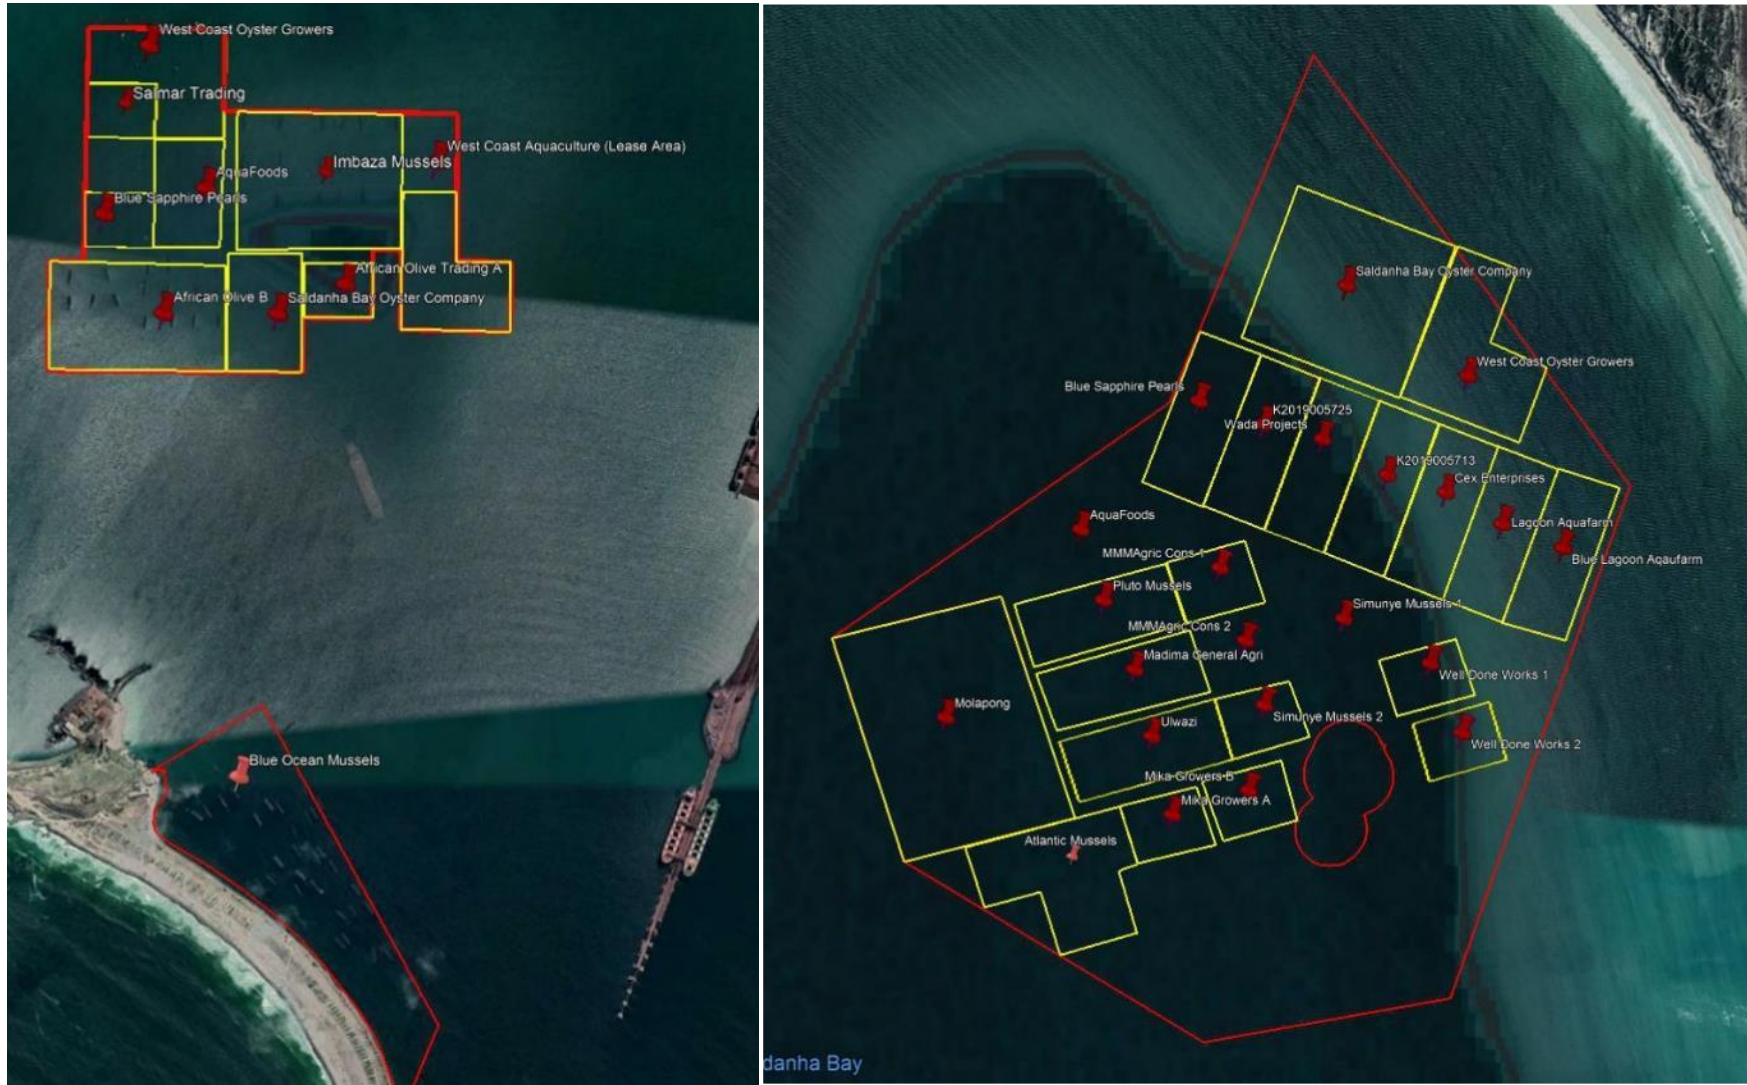
Figure 2. (Left) Bivalve culture in SB and (right) mixed bivalve and finfish culture in BB.

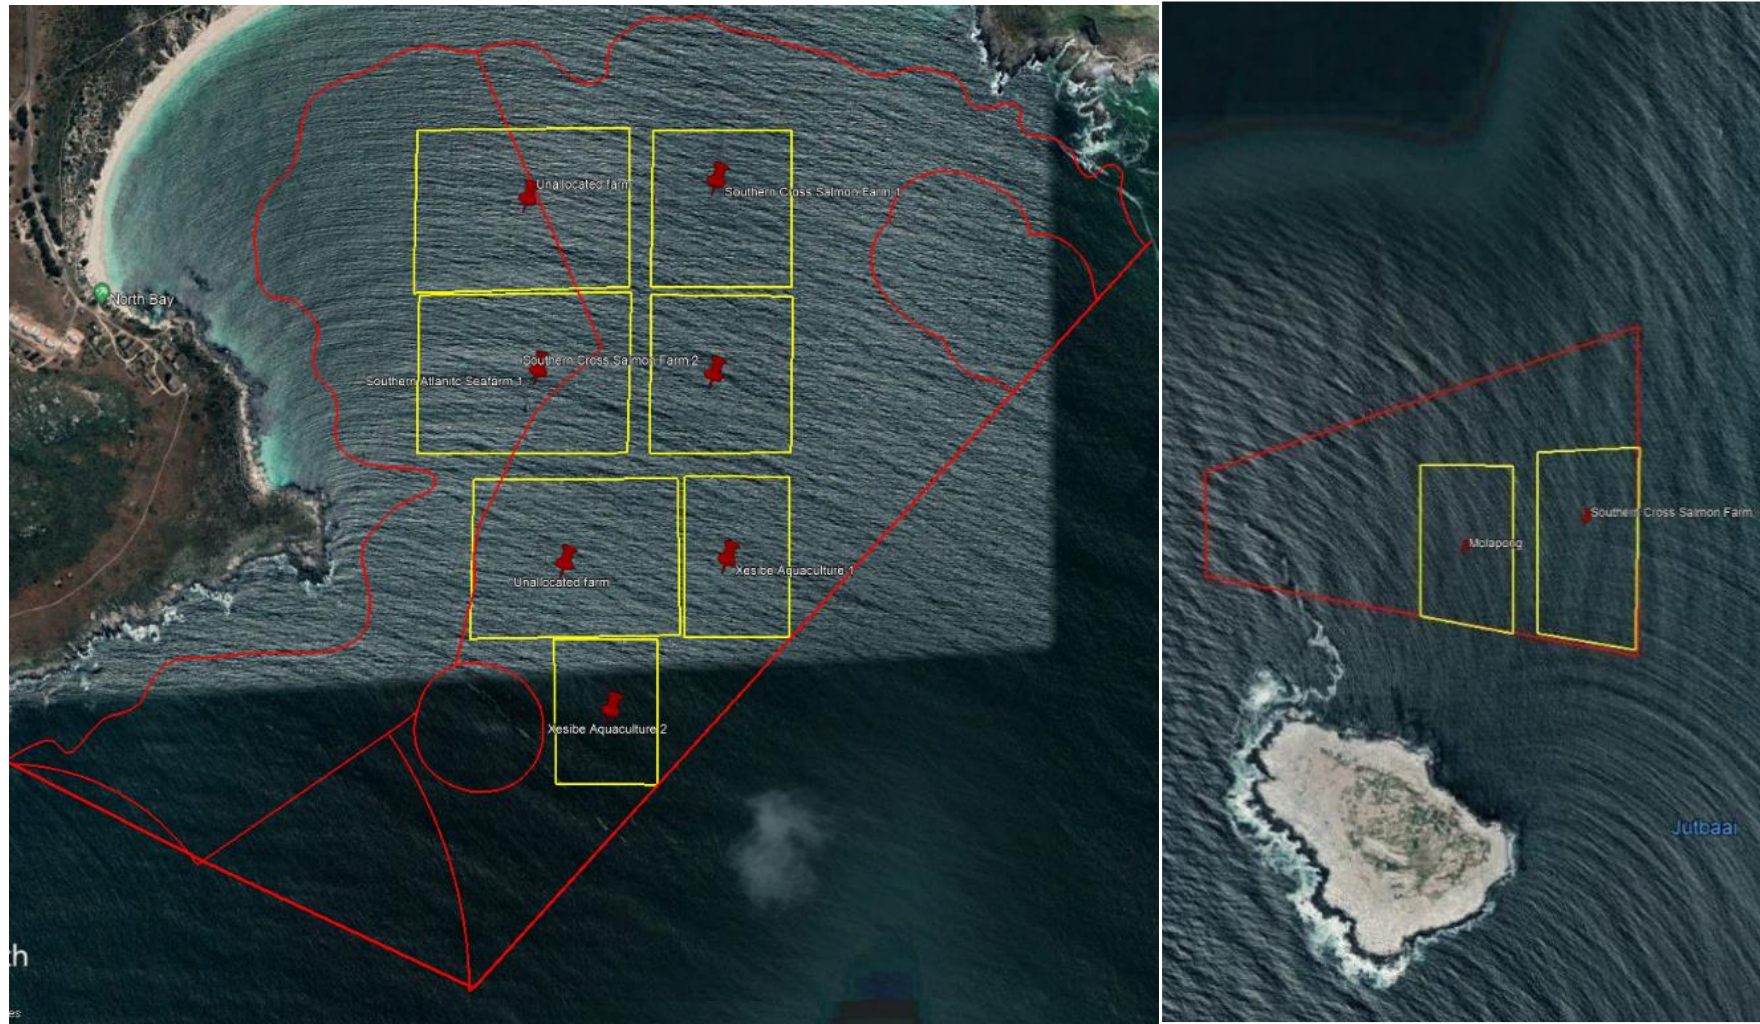
Figure 3. (Left) Bivalve culture in OBN and (right) finfish culture in Outer Bay South.

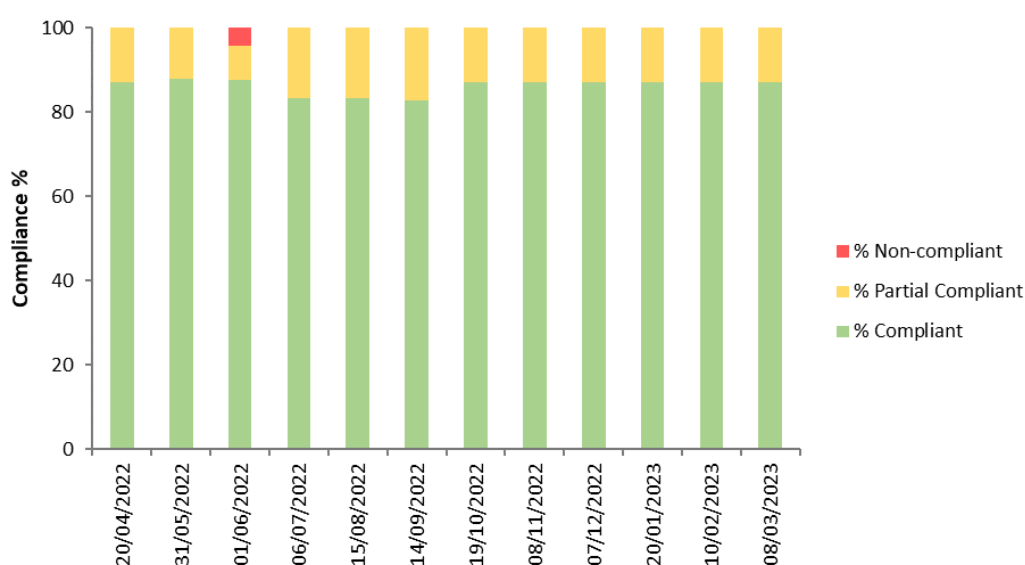
During the first year of ECO audits conducted by Anchor (April 2022 – March 2023) the ADZ maintained a high level of compliance (>83%) with the audit standard, and the management team should be commended (Figure 4).

Figure 4. ADZ compliance over 2022/2023 year of ECO audits conducted by Anchor (April 2022 to March 2023).

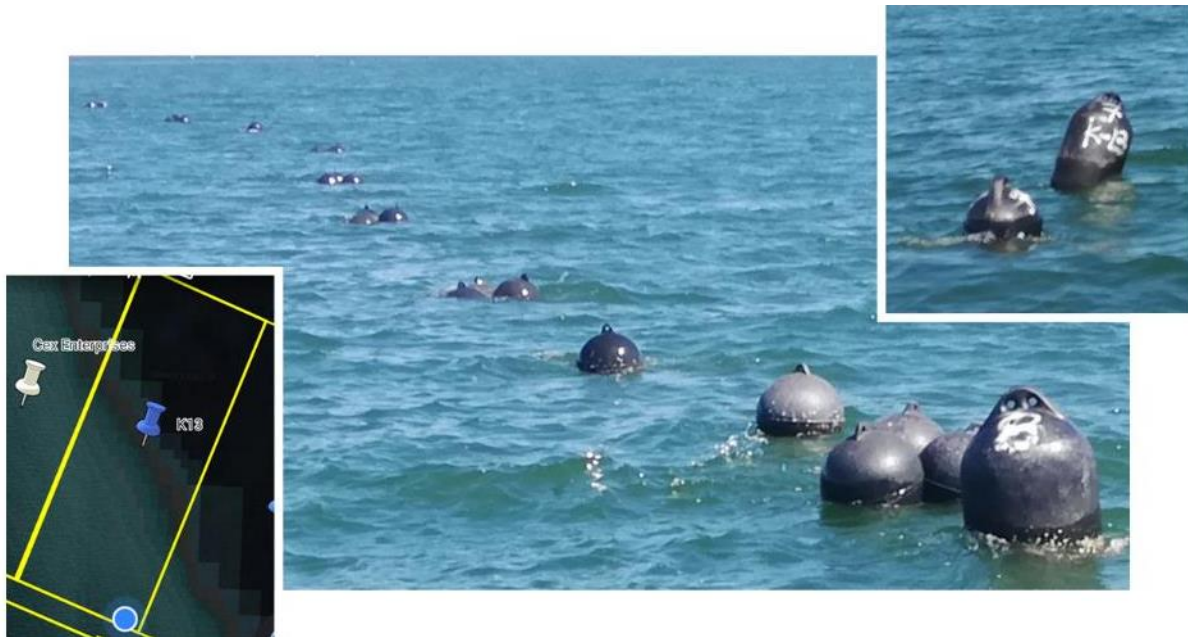
3.5.1.1 K13 — Compliance photographs

Farm name	Location	Date	Compliance status (Operational Guideline)	Comment
K13	Big Bay	05/04/2023	C	Five lines in water (lines number 2, 3, 4, 6, and 7). Lines number 1 and 5 were not in the water. All lines were taught, straight, suitably marked, and not sinking (Figure 5).
K25	Big Bay	05/04/2023	PC	Seven lines in water. All lines were taught, suitably marked, and not sinking (Figure 6). Six of the seven lines were straight, but line 1 was attached to the same end float as line 2 on the northern side of the farm (Figure 7).
Mika Growers	Big Bay	05/04/2023	C	Twelve lines observed in water. Lines were taught, straight, suitably marked, and not sinking (Figure 8).
Pluto Mussels and Trading	Big Bay	05/04/2023	PC	Either three or four lines were in the water (operator to clarify). Visible end floats were suitably marked with unique identifiers (Figure 9). Three end floats were sunken, and one was sinking or very low in the water (Figure 9); on the southern side of the farm end float number 3 was sunken and end float 6 was very low in the water; on the northern end of the farm, end floats number 5 and 6 had sunken. Due to the sunken end floats, it could not be determined whether lines were taught and straight.

Figure 5. Farm K13 in Big Bay. (Left) Live Google Earth pin of location of compliance photograph in relation to K13, Big Bay licence area (yellow boundaries). (Middle and right) Lines were taught, straight, suitably marked using unique infrastructure, and not sinking.

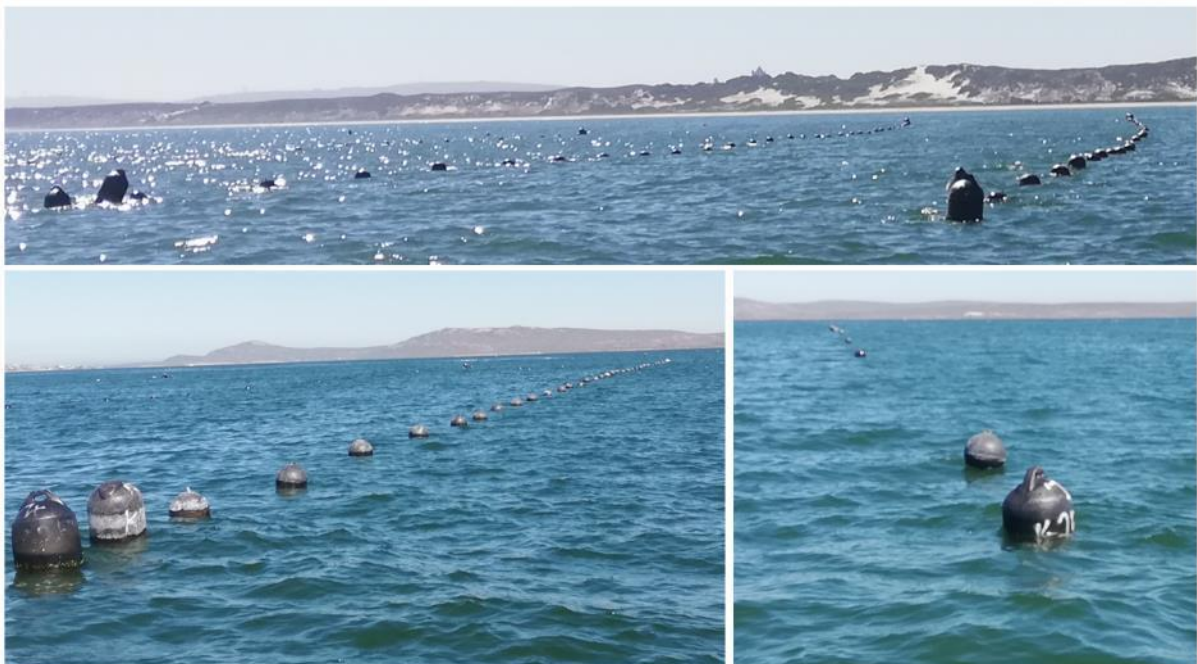
3.5.1.2 K25— Compliance photographs

Figure 6. K25 farm in Big Bay, lines were observed to be taught, suitably marked, and not sinking. All but line 1 was observed to be straight.

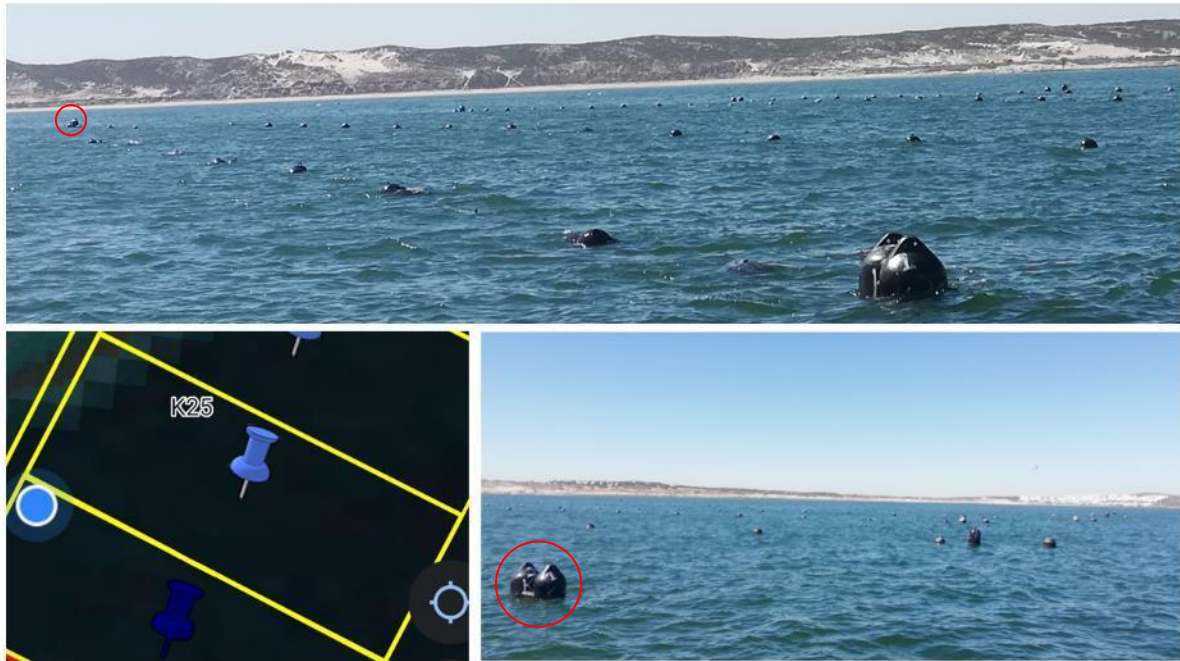
Figure 7. (Bottom left) Live Google Earth pin of location of compliance photograph in relation to K25, Big Bay licence area (yellow boundaries). (Top and bottom right) Lines 1 and 2 are attached to the same end float on the northern side of the farm (red circle).

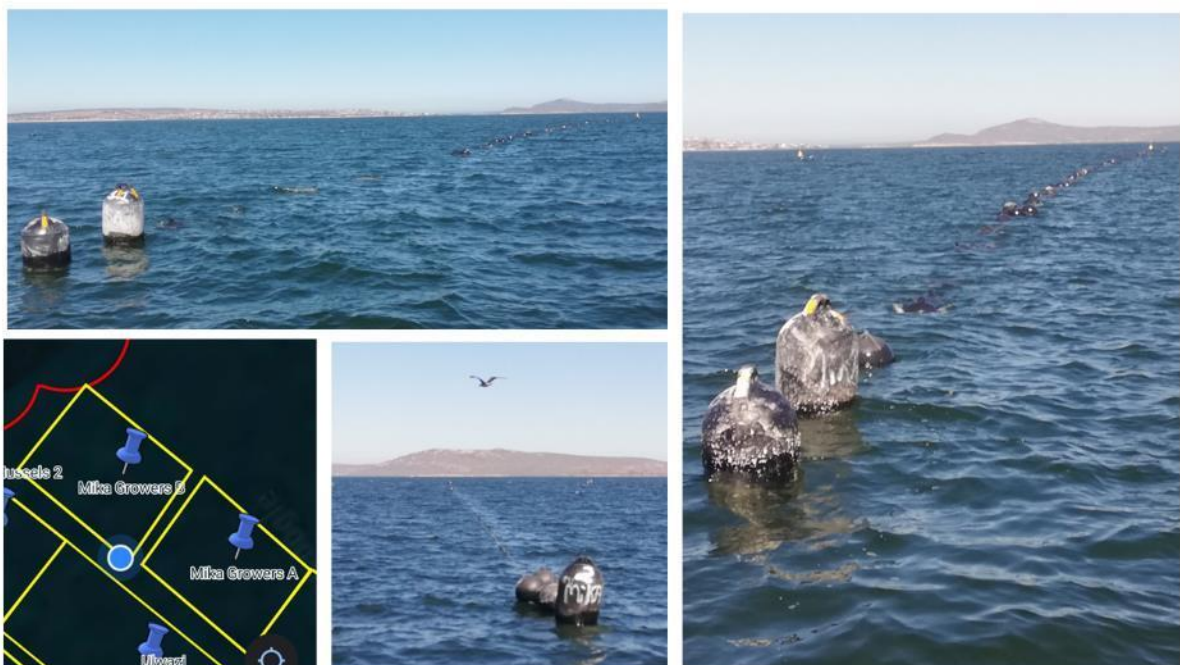
3.5.1.3 Mika Growers

Figure 8. Mika growers farm in Big Bay. (Bottom left) Live Google Earth pin of location of compliance photograph in relation to Mika growers licence area (yellow boundaries). (Top left and right) Lines with product were taught, straight, suitably marked, and not sinking. (Bottom centre) Lines empty of product were also taught, straight, suitably marked, and end floats were not sinking.

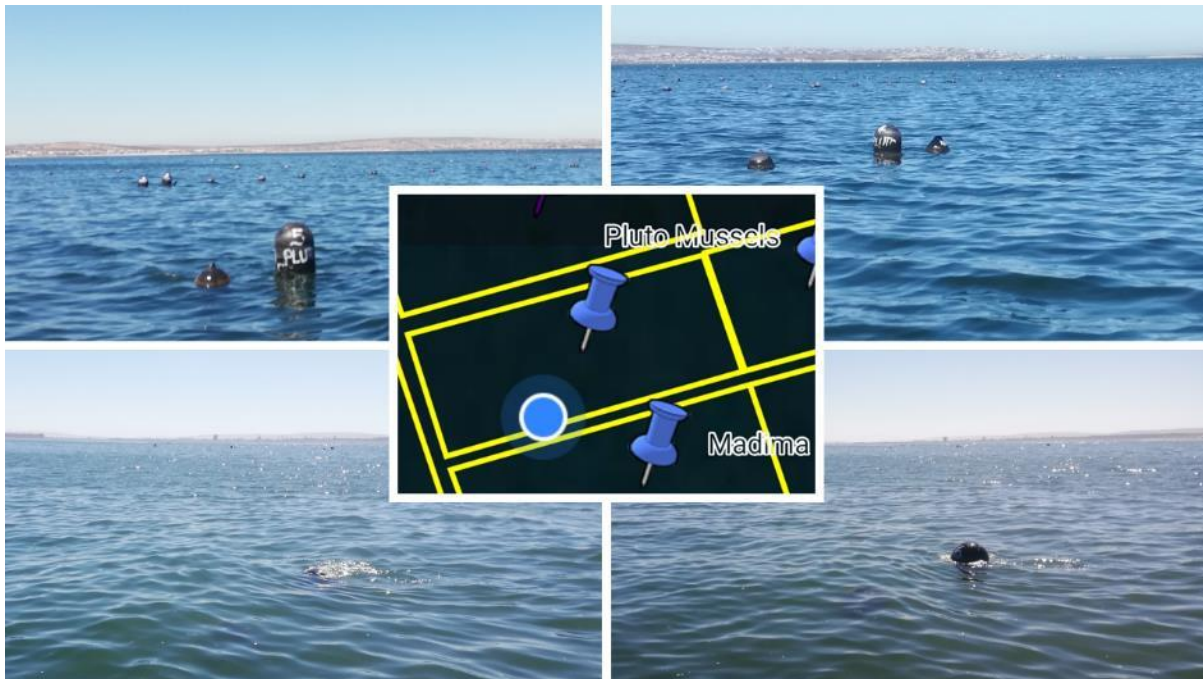
3.5.1.4 Pluto Mussels and Tracing

Figure 9. Pluto Mussels farm in Big Bay. (Centre) Live Google Earth pin of location of compliance photograph in relation to Pluto licence area (yellow boundaries). (Top left and right) Unique infrastructure and unique markers present on visible end floats. (Bottom left and right) End float on the southern side of line 6 was low in the water and sinking.

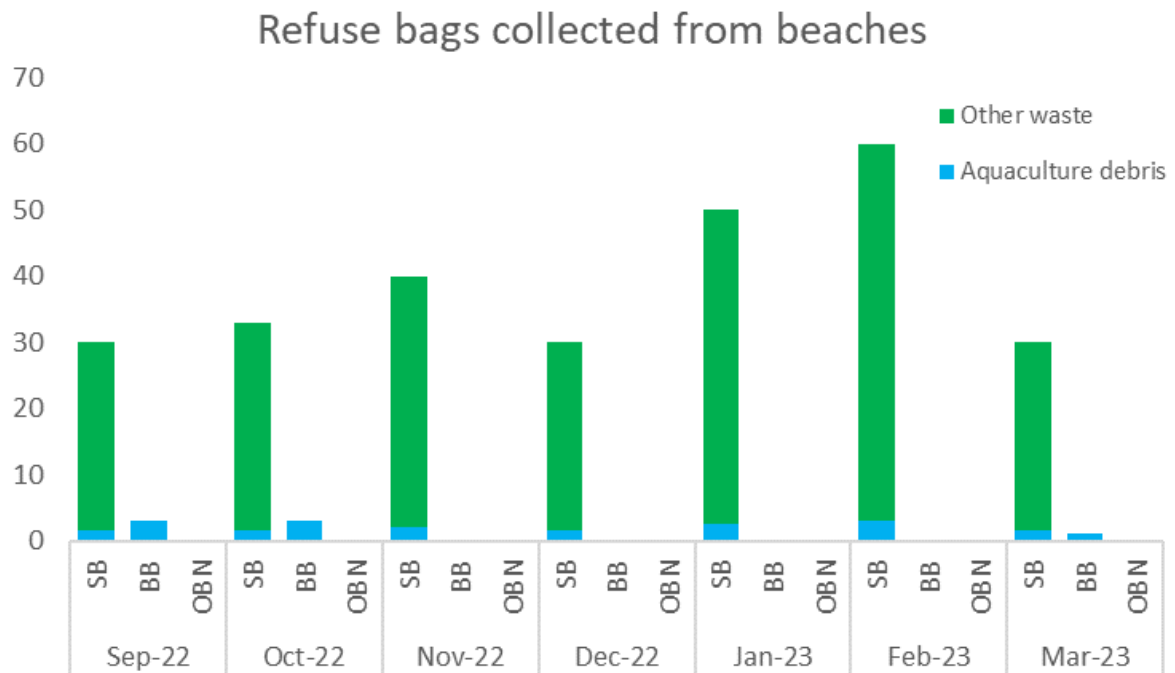
Although no waste data has been provided for Marcus Island, some photographic evidence of beach clean-ups were provided in September 2022. Beach clean-up data should be provided for Outer Bay North as a matter of urgency. Most waste collected from Small Bay is litter and general waste, with a small portion of the waste coming from the aquaculture industry (Figure 10). In October 2022, and January and February 2023 some floats were collected from Small Bay beaches (Figure 11). Aquaculture floats constitute the majority of waste collected from Big Bay beaches (Figure 11) and a smaller portion of the waste is made up of rope offcuts that is collected in refuse bags (Figure 10). All the waste collected in refuse bags from Big Bay comes from the aquaculture industry (Figure 10).

Figure 10. Waste collected in refuse bags from beaches in the various precincts. Total waste collected and portion of waste constituting aquaculture debris is presented.

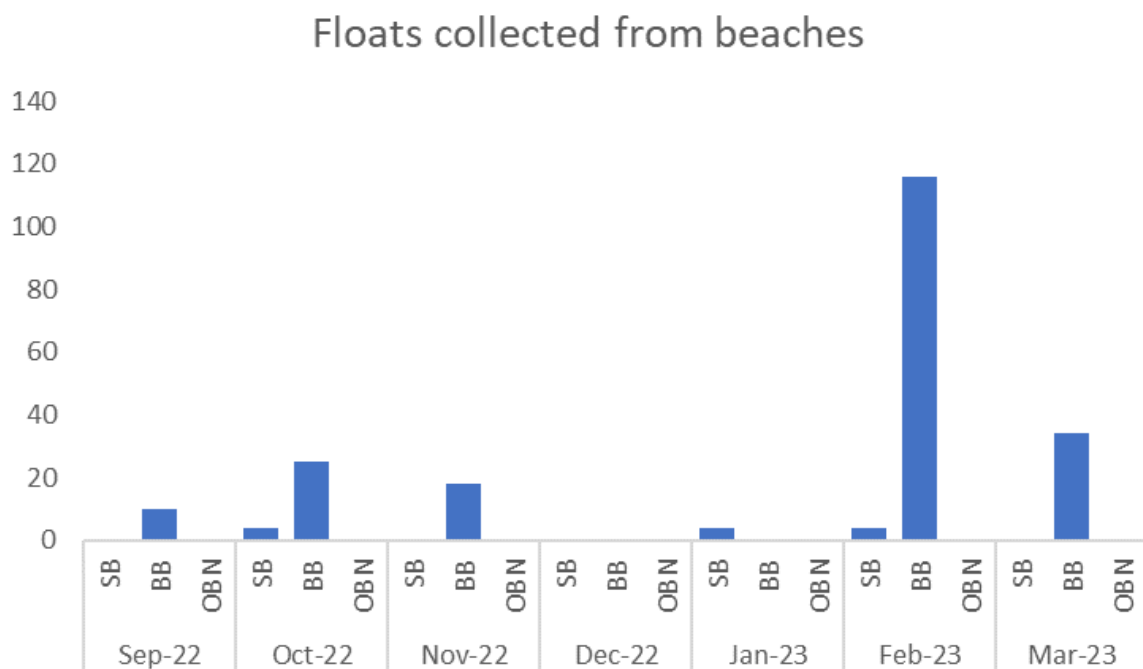
Figure 11. Floats collected from beaches in the various precincts.

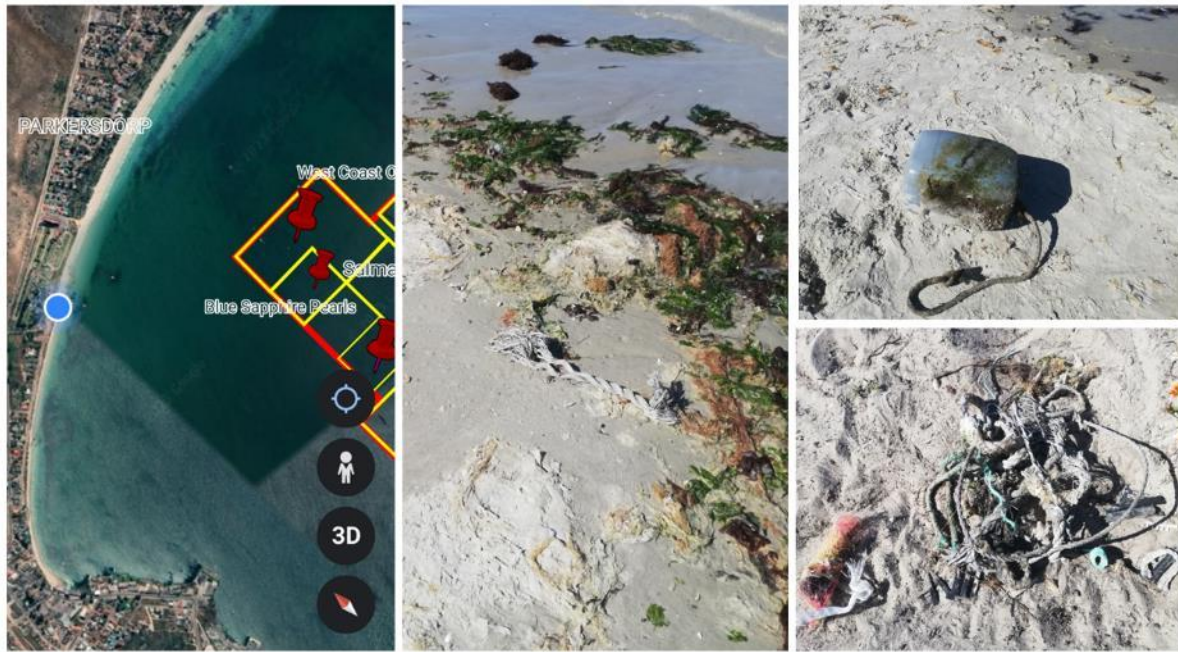
The receiving beaches in Small Bay were inspected by the ECO during the April 2023 site inspection. Minor aquaculture debris was observed on the beaches including rope offcuts, short pvc pipes, netlon bags, and one grey float from Blue Sapphire Pearls (Figure 12).

Figure 12. Small Bay beach inspected for aquaculture debris by the ECO in April 2023. (Left) Live Google Earth pin of location of compliance photographs in relation to the Small Bay precinct (yellow and red boundaries). (Centre) Rope off cut from one of the farms. (Top right) Small grey float from Blue Sapphire Pearls in Small Bay. (Bottom right) Collection of rope offcuts, netlon bags, pvc pipes, and other aquaculture debris.
