SALDANHA BAY AQUACULTURE DEVELOPMENT ZONE ENVIRONMENTAL CONTROL OFFICER SUMMARY REPORT 15

June 2023

Anchor Research & Monitoring (Pty) Ltd

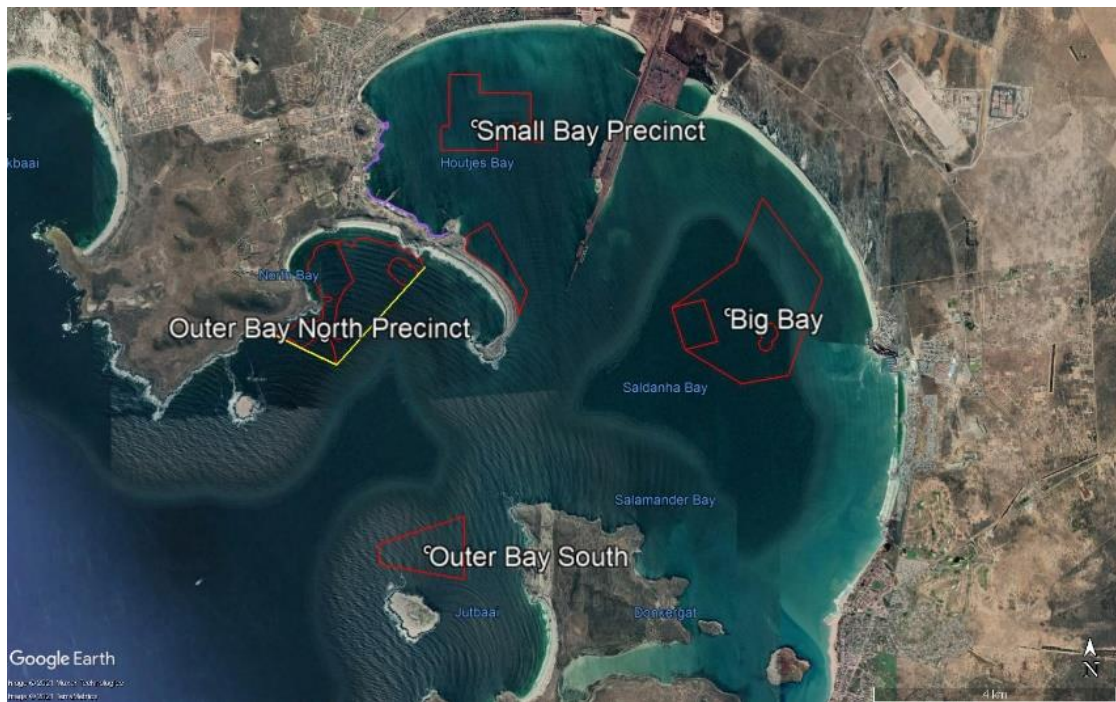
Figure 2.1. Saldanha Bay ADZ precincts.

The Saldanha Bay ADZ comprises 4 precincts, namely Small Bay (SB), Big Bay (BB), Outer Bay North (OBN), and Outer Bay South (OBS) (Figure 2.1). The BA Report summarised the scope for expansion in the ADZ and comprised a mix of finfish and bivalve farms (Table 2.2). Details of each existing lease are depicted in Figure 2.2 and Figure 2.3. Note that there are two lease areas in OBN that are unallocated and have been advertised for lease applications by Transnet Ports Authority (TNPA). Sea-based activities associated with aquaculture in the ADZ include:

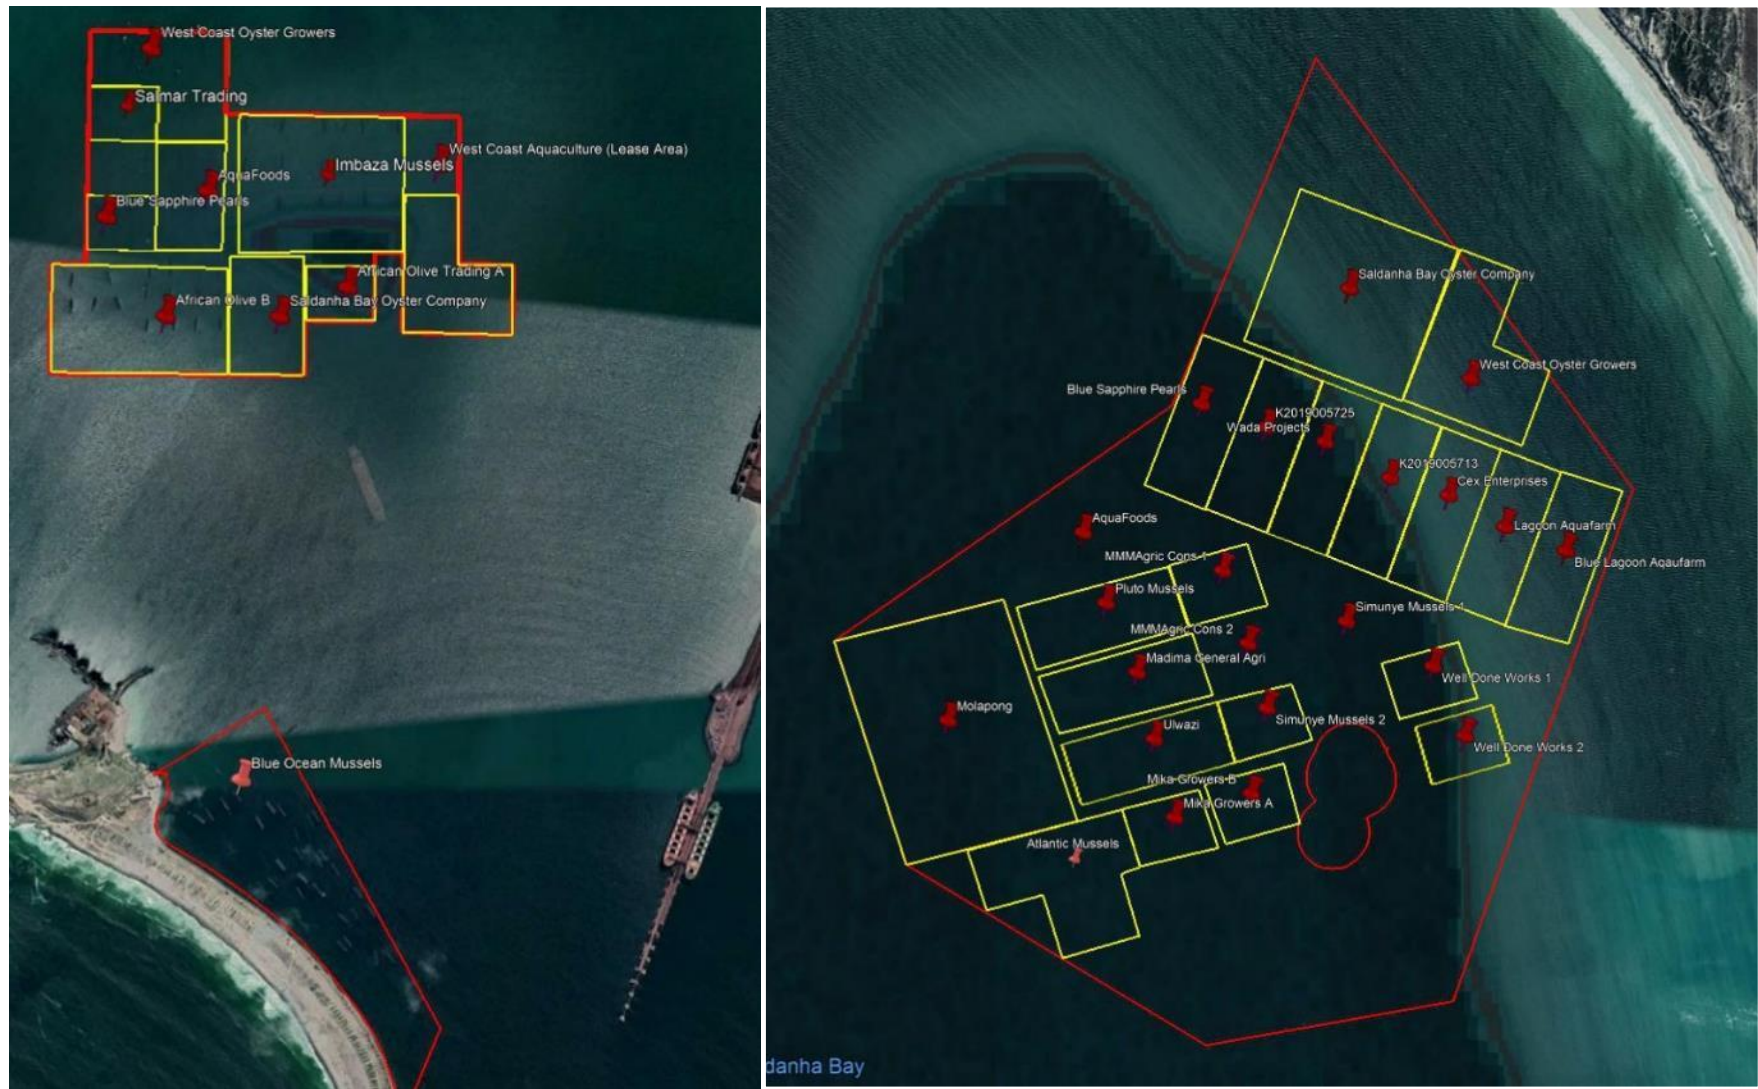
Figure 2.2. (Left) Bivalve culture in Small Bay (SB) and (right) mixed bivalve and finfish culture in Big Bay (BB).

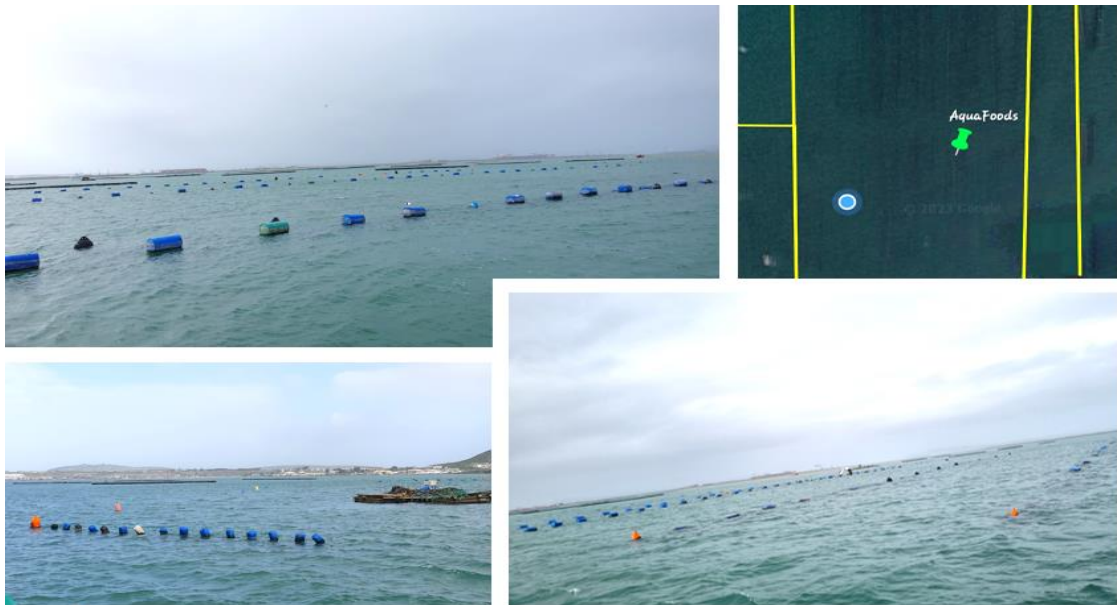
AQU had lines that were sinking and ready for harvesting (mostly mussel lines), and some end floats were sunken or missing (Figure 3.2). Increment weather had prevented earlier harvesting. The windy conditions at the time of the site inspection meant that some lines were observed to be not fully straight (they were being blown downwind), a situation likely exacerbated by the heavy lines. However, AQU's workers were harvesting from the lines at the time of the site inspection. AQU confirmed that maintenance is done on a weekly basis, preferably on a Thursday or Friday depending on weather conditions. In addition, AQU indicated that they have implemented new black floats with a red painted unique identifier (Figure 3.3). These floats are used to replace the old ones which require replacement during maintenance.

Figure 3.2. AQU longlines mostly observed to be straight, taut, suitably floated, and marked with unique identifiers (top and bottom left). Live Google Earth pin of location of compliance photograph in relation to AQU, Small Bay licence area (yellow boundaries) (top right). Approximately 4 sinking lines were noted (bottom right).

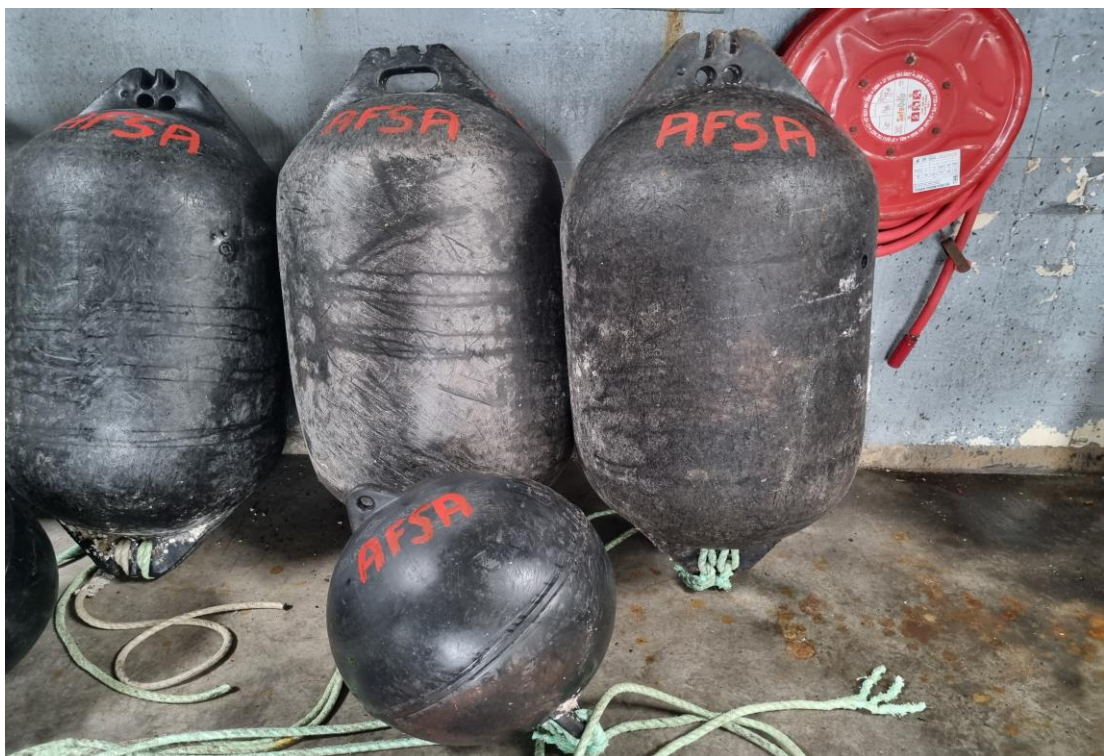
Figure 3.3. Replacement floats for maintenance purposes.

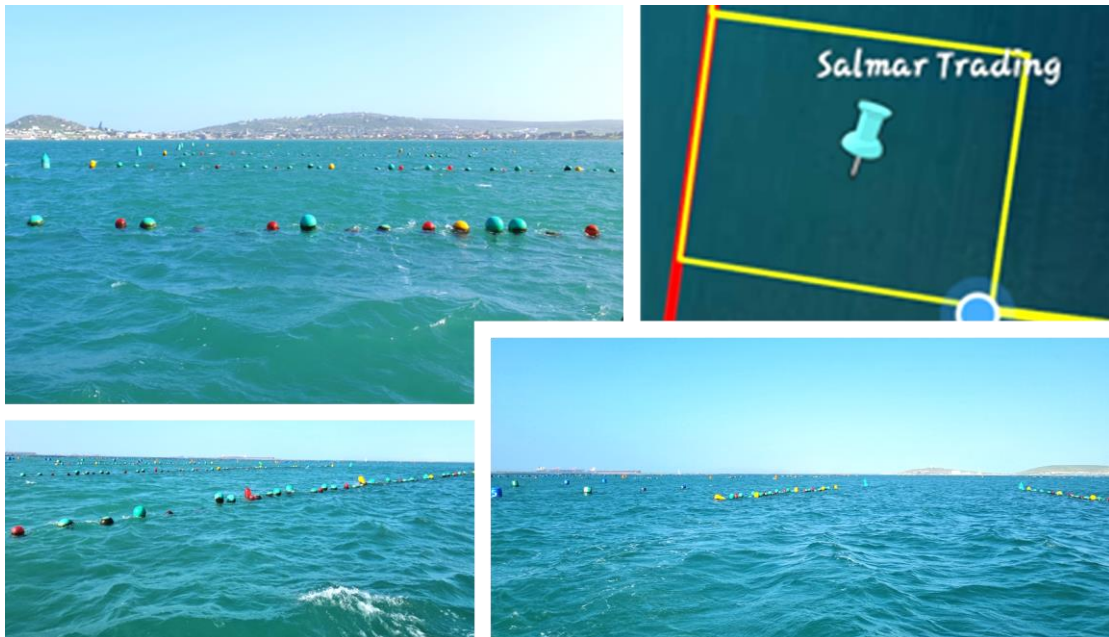
All oyster lines belonging to SAL have sufficient space between them, were taut, straight, suitably floated and marked with unique identifiers (green end floats) (Figure 3.4). The farm owner explained that it is best practice to have them spaced to avoid having the lines close together so that entanglement does not occur. Furthermore, it is easier for their boat to move between lines when seeding or harvesting to avoid damage of the infrastructure.

Figure 3.4. SAL oyster lines observed to be taut, straight, suitably floated and marked with unique identifiers (top left). Live Google Earth pin of location of compliance photograph in relation to WCOG, Small Bay licence area (yellow boundaries) (bottom left).

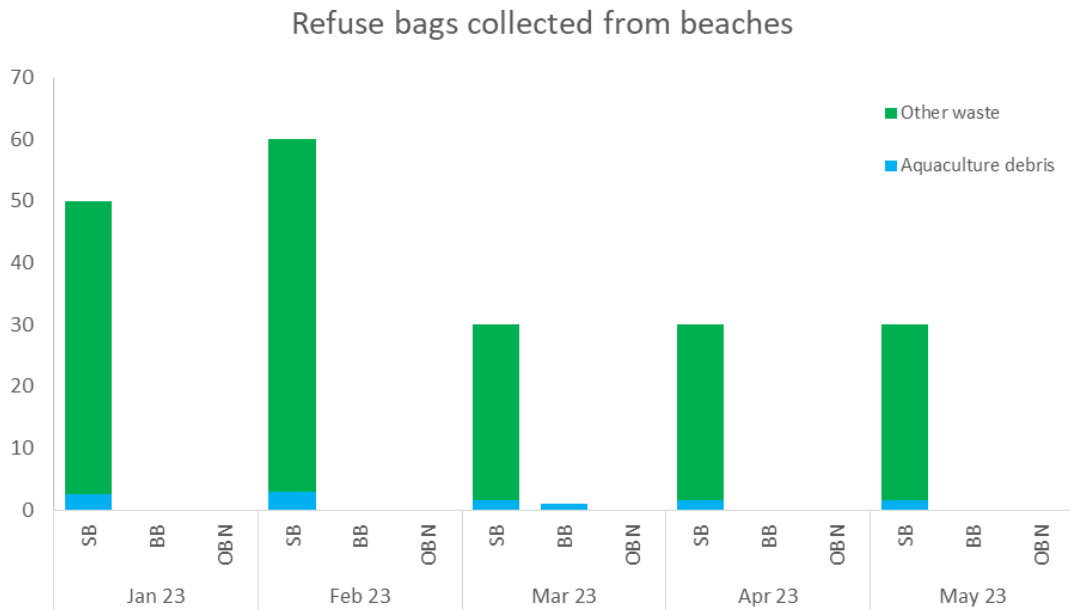
In Small Bay, the waste collected primarily consists of litter and general waste, with only a small portion originating from the aquaculture industry (Figure 3.5). On the other hand, in Big Bay, the majority of waste collected from the beaches is composed of aquaculture floats, while a smaller portion is comprised of rope offcuts that are collected in refuse bags (Figure 3.6). However, no waste collection data or information regarding aquaculture floats has been provided or observed for Big Bay in April and May 2023. This is mainly due to the fact that the SASH group have recently entered business rescue. It is crucial that beach clean-up data for Outer Bay North is urgently provided. Either SASH continues to clean-up these beaches, or a suitable replacement be found, and the ECO should be updated on these activities.

Figure 3.5. Waste collected in refuse bags from beaches in the various precincts. Total waste collected and portion of waste constituting aquaculture debris is presented.

- Monitoring progress with the maintenance plans should continue.
- Monitoring of beach waste data submitted by the Operators should continue. Either SASH continues to monitor and clean-up Outer Bay North and Big Bay beaches, or a suitable replacement be found, and the ECO should be updated on these activities.

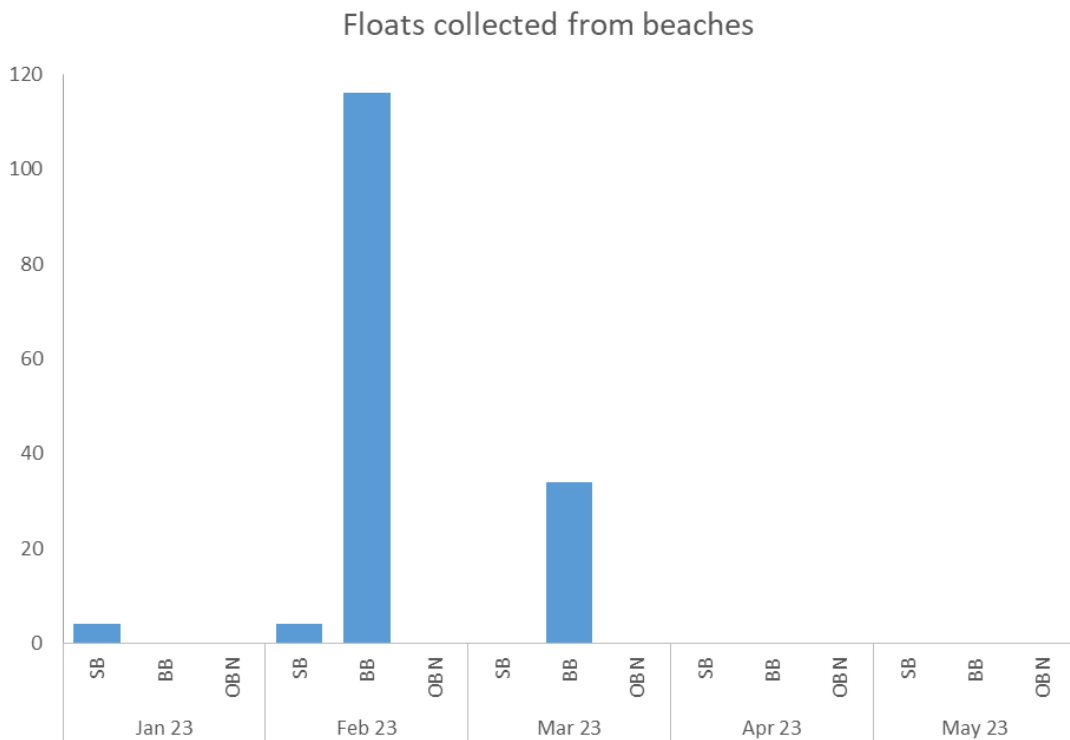
Figure 3.6. Floats collected from beaches in the various precincts.

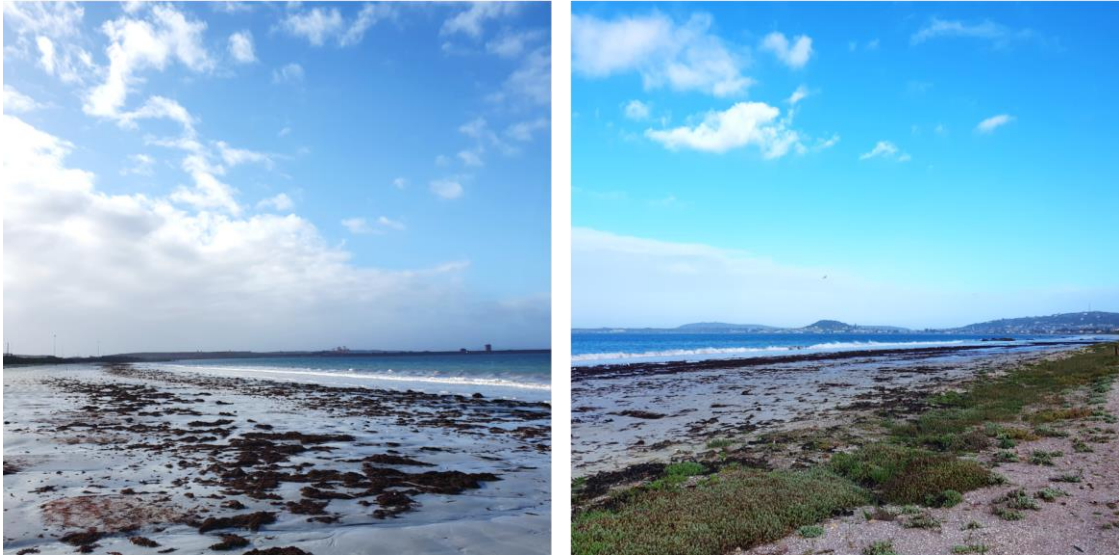
Small Bay beach near Blue Bay Lodge was inspected by the ECO during the June 2023 site inspection (Figure 3.7). During the beach inspection a number of articles of ADZ infrastructure

Figure 3.7. Small Bay beach near Big Bay Lodge showing no aquaculture debris or equipment.

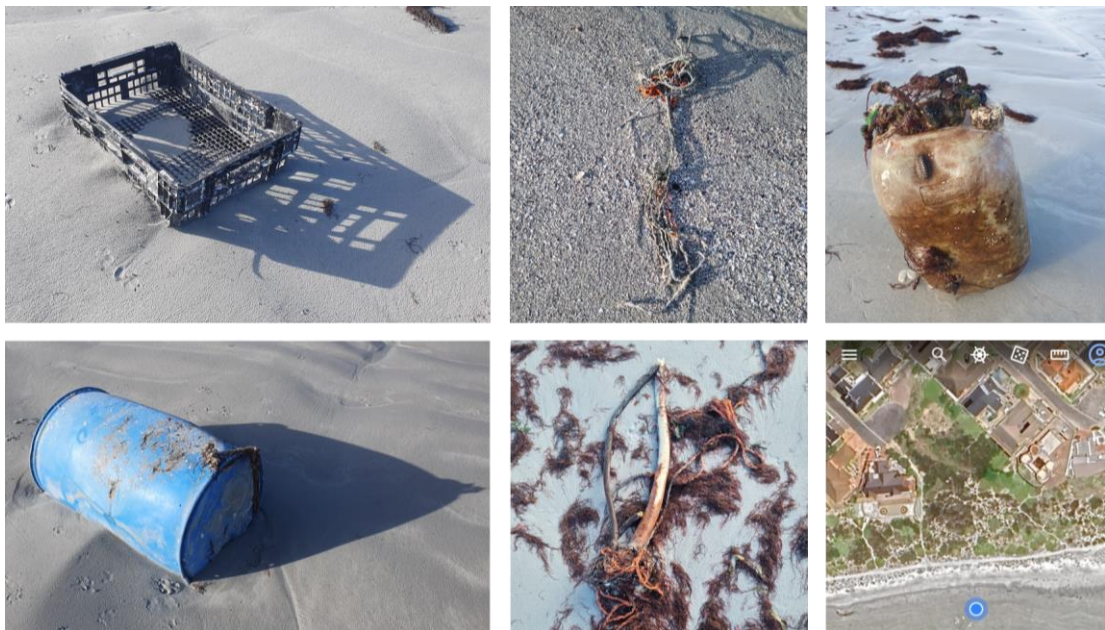
and debris were observed on the beach (Figure 3.8). These included floats, baskets and rope. No identifying features were visible on any of the items. The farmer owners/operators and business rescue practitioners have been notified of the existence and location of this equipment and plans have been made to remove it.

Figure 3.8. Aquaculture infrastructure including black crate (top left), blue drum/float (bottom left), production ropes (middle top and bottom) and white 25L float (top left) washed up at Small Bay beach near Big Bay Lodge. Google Earth live location indicating where this waste is located (bottom right).

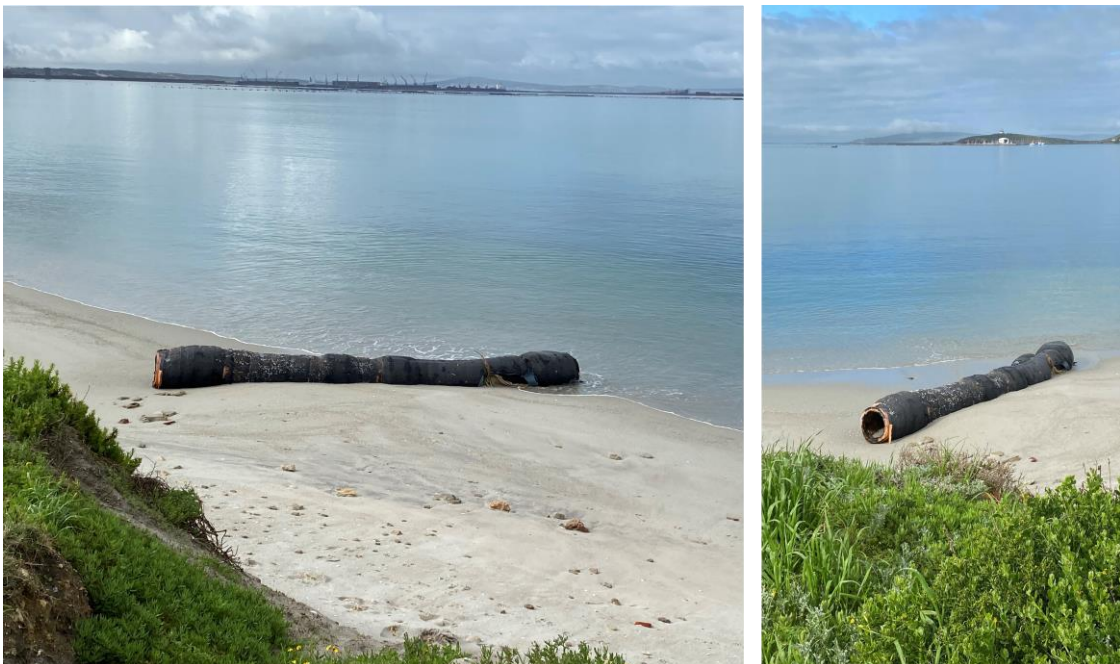
In a non-ADZ related incident, on the 19 June 2023 a pipe measuring approximately 4 meters in length and half a meter in diameter was discovered on the beach near Strandloper guesthouse (Figure 3.9). The farm owners and operators were notified, but there are uncertainties about the ownership of the pipe — similar pipes are used as fenders by other operations within the Bay. As the pipe cannot be directly linked with any ADZ operations, this has not been flagged as an official ADZ incident. As of 30 June 2023, no further information was available regarding whether the pipe has been removed from the beach or not. This matter is being followed up by the ECO and updates will be provided in the July 2023 site inspection report.

Figure 3.9. A pipe found on the beach opposite Strandloper guesthouse on Beach Road, Saldanha
