## SALDANHA BAY AQUACULTURE DEVELOPMENT ZONE ENVIRONMENTAL CONTROL OFFICER SUMMARY REPORT 16

**July 2023**

Anchor Research & Monitoring Report No. 2014/16\_2c

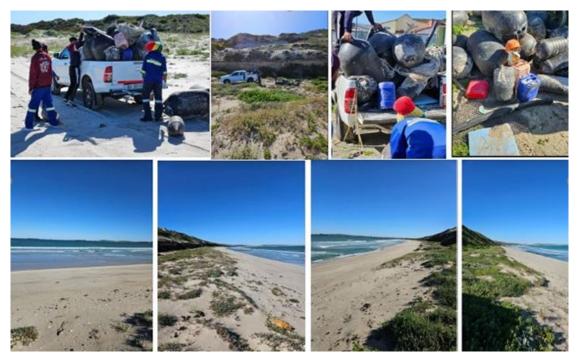
As it stands for now, beach monitoring and clean up by the aquaculture industry now include Wayne Maree from Aquafoods SA who has volunteered to clean up Big Bay precinct on the 5 July 2023 (Table 3.6) Ernie Malan of SASH group is no longer responsible for these clean-ups in Big Bay and Outer Bay North. This responsibility has been passed to the Claritas rescue practitioners. Upon securing funding from an investor, Claritas was able to clean up Spreeuwalle Beach on the 20 July 2023 (Figure 3.13).

Figure 3.13. Beach clean-up evidence by Claritas Business Rescue, Restructuring and Advisory.

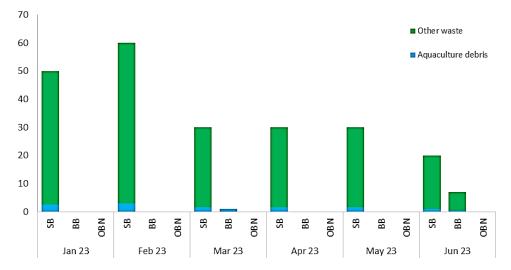
In Small Bay, the waste collected primarily consists of litter and general waste, with only a small portion originating from the aquaculture industry (Figure 3.14). On the other hand, in Big Bay, the majority of waste collected from the beaches is composed of aquaculture floats, while a smaller portion is comprised of rope offcuts that are collected in refuse bags (Figure 3.15). However, no waste collection data or information regarding aquaculture floats has been provided or observed for Big Bay in April and May 2023. This was mainly due to the fact that the SASH group undergoing business rescue through Claritas.

Figure 3.14. Waste collected in refuse bags from beaches in the various precincts. Total waste collected and portion of waste constituting aquaculture debris is presented. For the period of January 2023 to May 2023, no data has been provided for the Big Bay (BB) and Outer Bay North (OBN) precincts. However, there is data available for the month of March and June 2023, but only for the Big Bay precinct (BB).

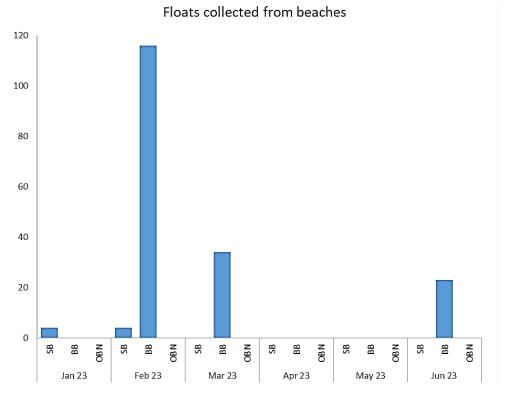
Figure 3.15. Floats collected from beaches in the various precincts. The absence of data is not attributed to the lack of floats, but rather to the absence of reporting.
