SALDANHA BAY AQUACULTURE DEVELOPMENT ZONE ENVIRONMENTAL CONTROL OFFICER SUMMARY REPORT 23

February 2024

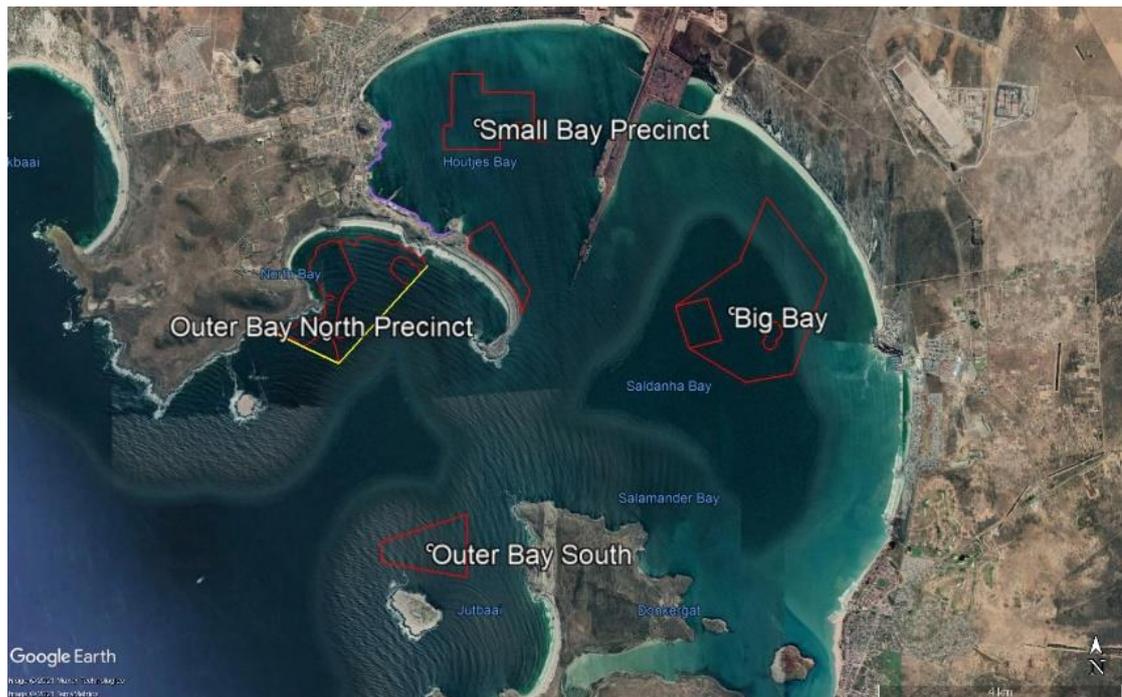
Figure 2.1. Saldanha Bay ADZ precincts.

The Saldanha Bay ADZ comprises 4 precincts, namely Small Bay (SB), Big Bay (BB), Outer Bay North (OBN), and Outer Bay South (OBS) (Figure 2.1). The BA Report summarised the scope for expansion in the ADZ and comprised a mix of finfish and bivalve farms (Table 2.2). Details of each existing lease are depicted in Figure 2.2 and Figure 2.3. Note that there are two lease areas in OBN that are unallocated and have been advertised for lease applications by Transnet Ports Authority (TNPA). Sea-based activities associated with aquaculture in the ADZ include:

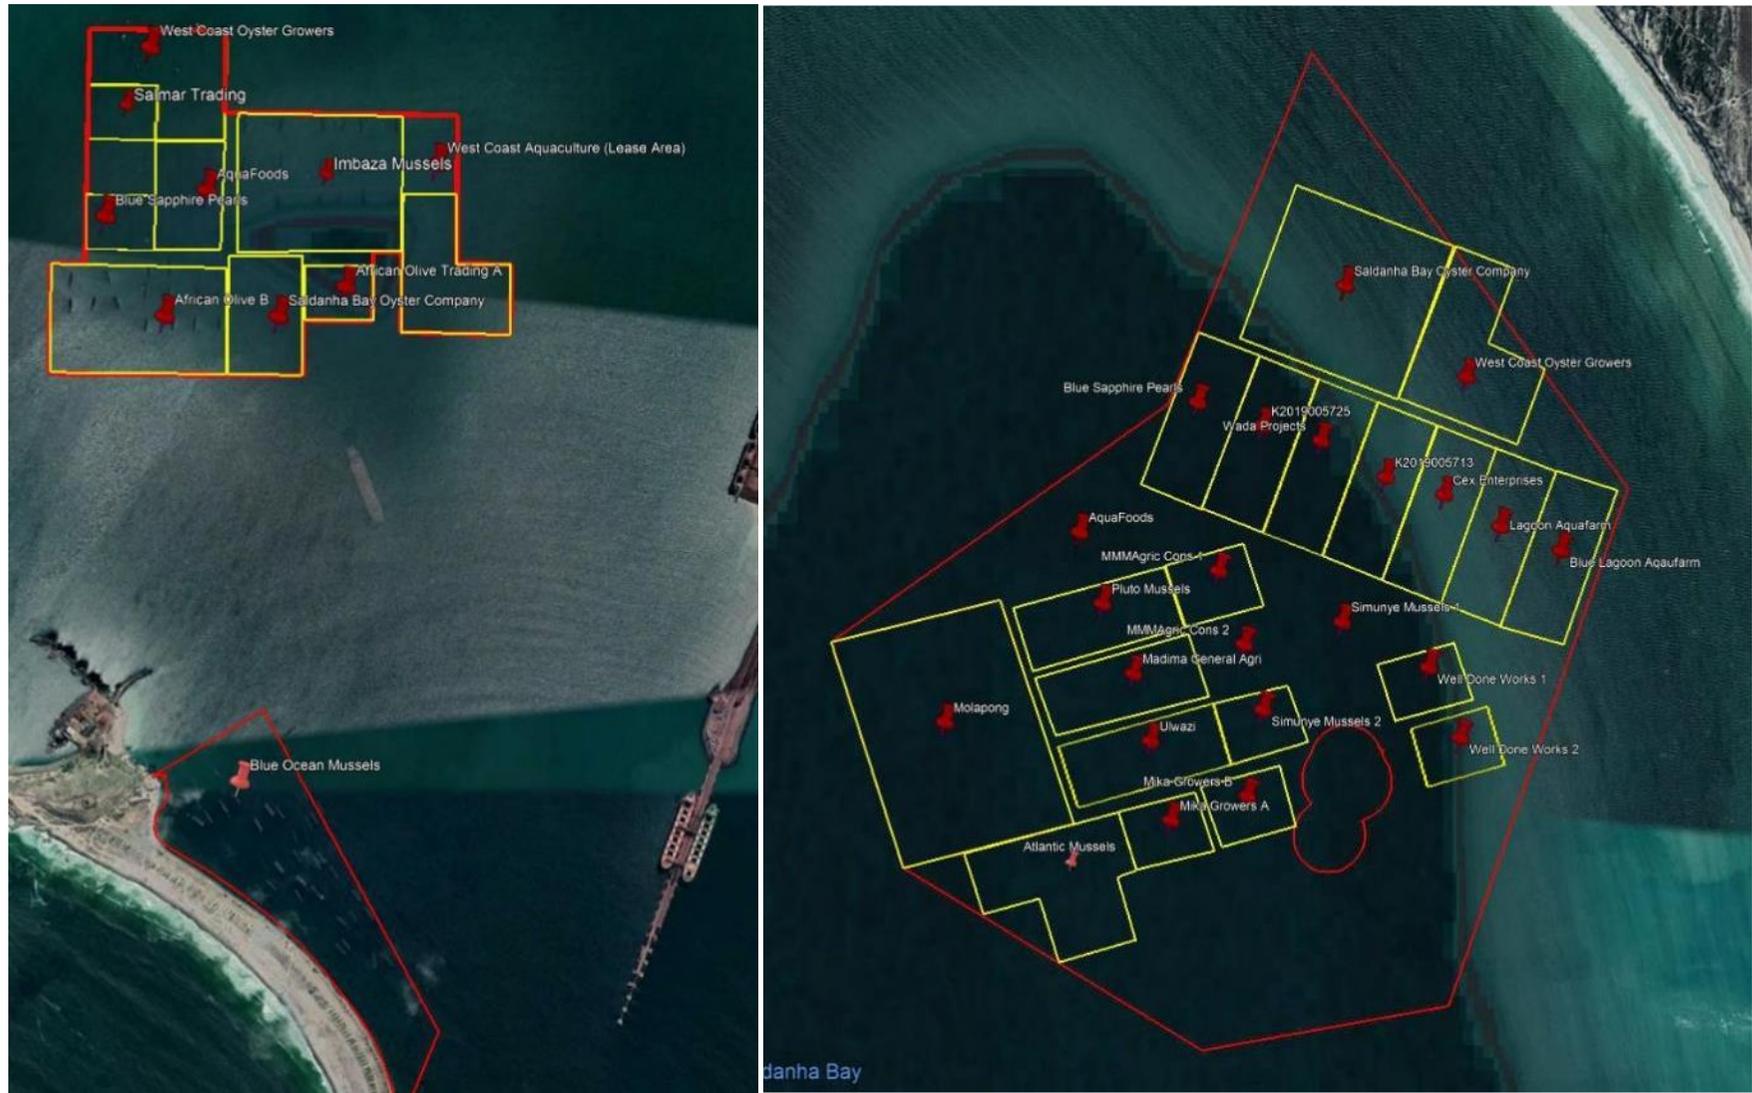
Figure 2.2. (Left) Bivalve culture in Small Bay (SB) and (right) mixed bivalve and finfish culture in Big Bay (BB).

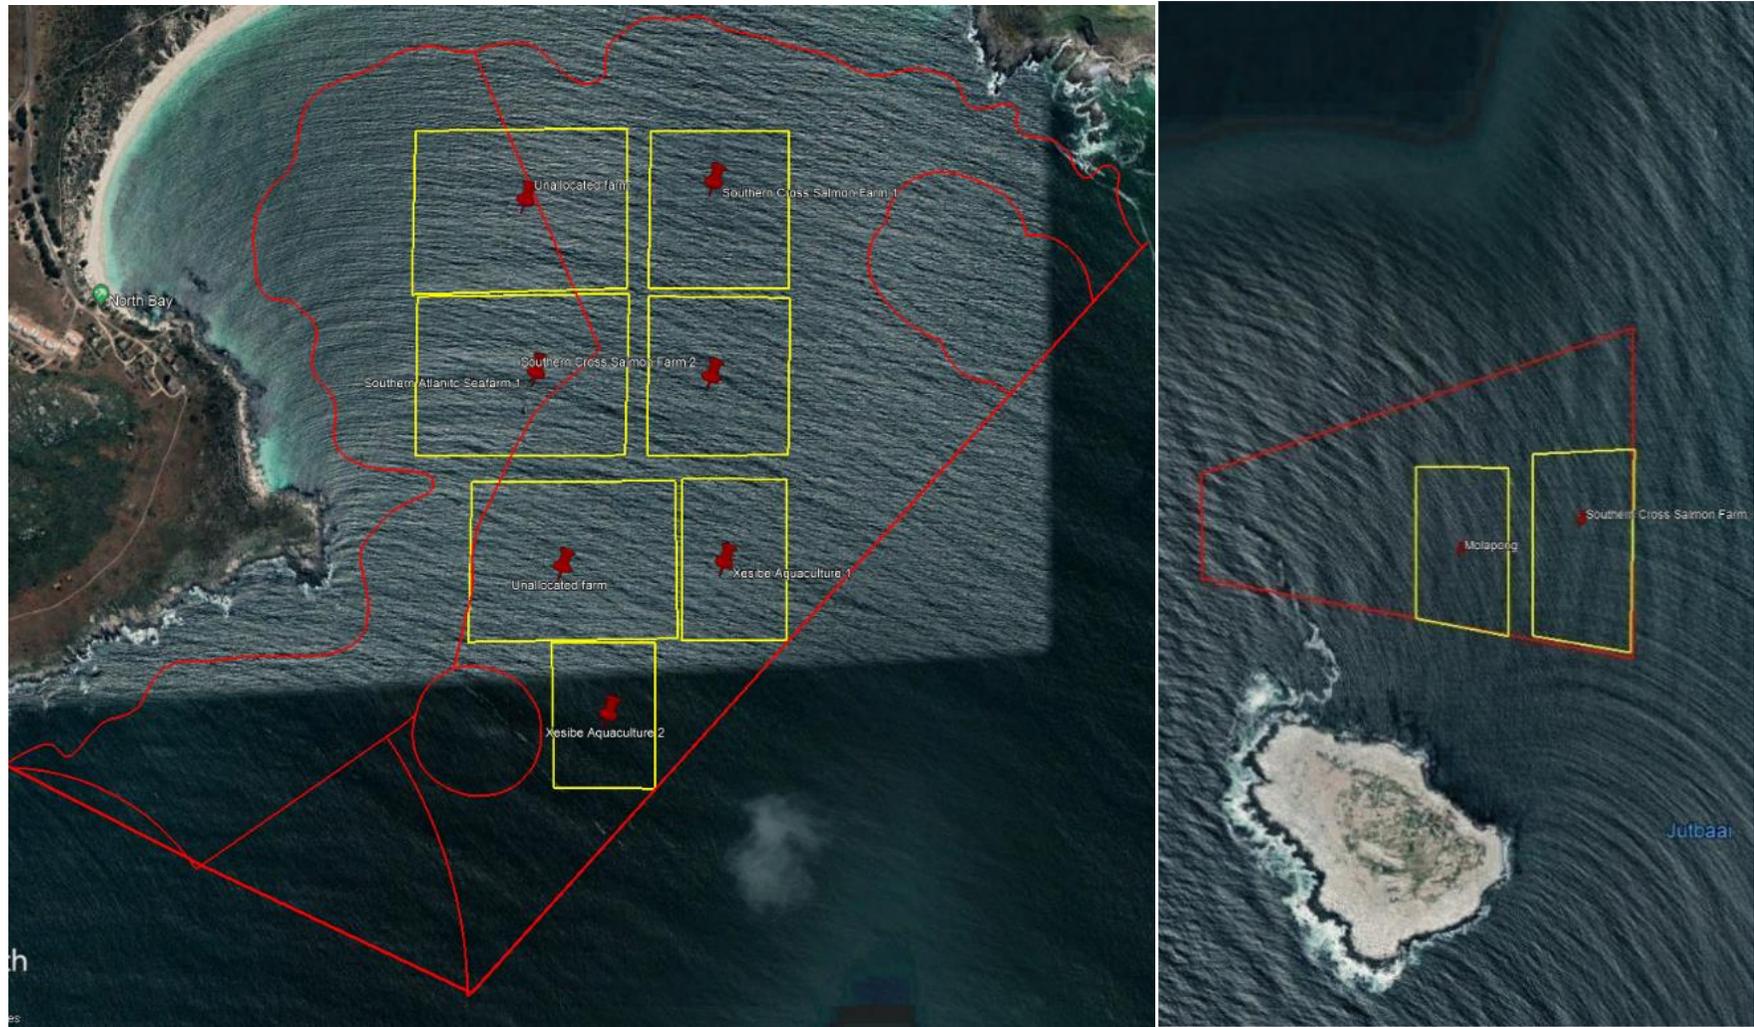
Figure 2.3. (Left) Bivalve culture in Outer Bay North (OBN) and (right) finfish culture in Outer Bay South (OBS).

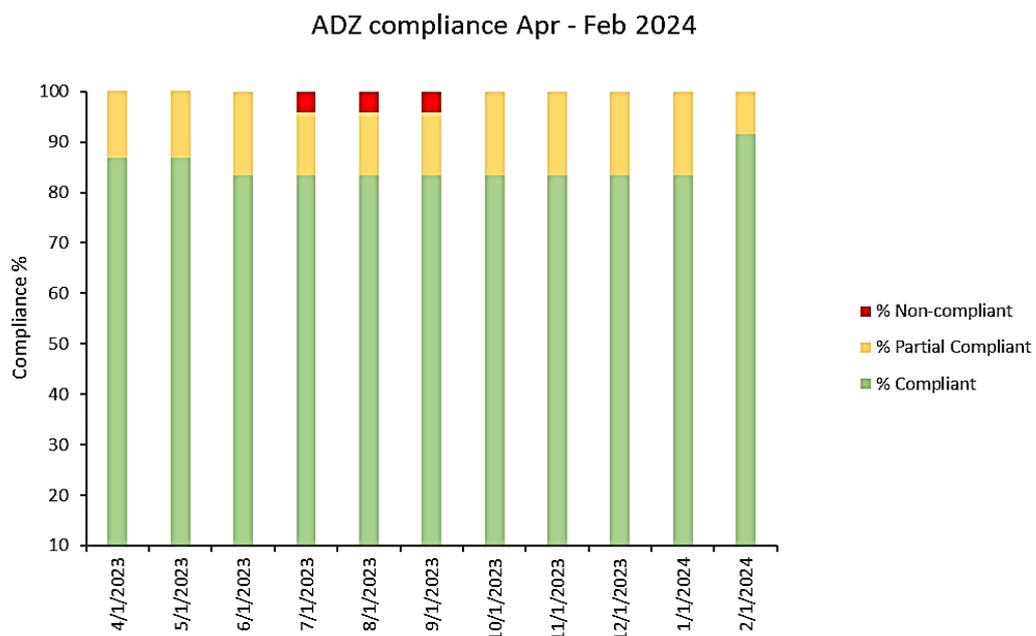
In February 2024, 24 conditions of a possible 27 were auditable, which is equivalent to the auditable conditions for the January 2024 period (Table 3.1). During the audit period in February 2024, the ADZ increased to an overall compliance score of 92%. Partial compliance decreased to 8% and non-compliance remained at 0%. This indicated that there has been a positive change in the compliance percentage compared to the previous audit conducted in January 2024 (Table 3.1, Figure 3.1).

Figure 3.1. ADZ compliance for year 2 of ECO audits conducted by Anchor (April 2023 to February 2024).

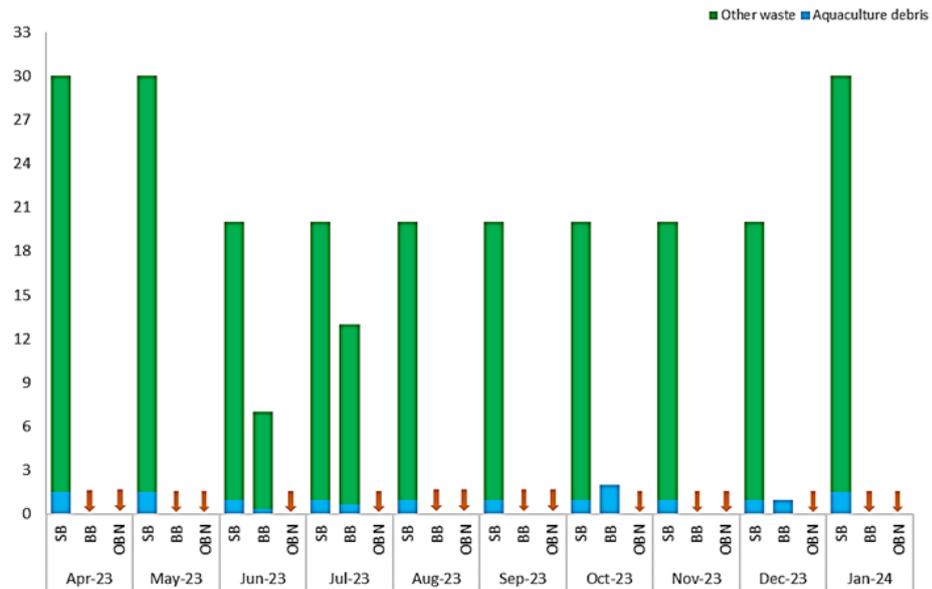
In Small Bay, the waste collected primarily consists of litter and general waste, with only a small portion originating from the aquaculture industry (Figure 3.2). On the other hand, in Big Bay, most of the waste collected from the beaches is composed of aquaculture floats, while a smaller portion is comprised of rope offcuts that are collected in refuse bags (Figure 3.3). However, no waste collection data or information regarding aquaculture floats has been provided or observed for Big Bay in April and May 2023. Beach clean-ups in this precinct resumed during June and July 2023, but ceased again during August 2023, September 2023, and December 2023. A Beach clean-up was conducted in January 2024. There were about 33 floats, but no aquaculture debris was reported.

Figure 3.2. Waste collected in refuse bags from beaches in the various precincts. Total waste collected and portion of waste constituting aquaculture debris is presented. For the period of January 2023 to May 2023, no data has been provided for the Big Bay and Outer Bay North precincts (orange arrows). Beach clean ups were not conducted in August, September, and November 2023 for Big Bay. However, there is data available for the month of June, July, October, December 2023 and January 2024, but only for the Big Bay precinct.

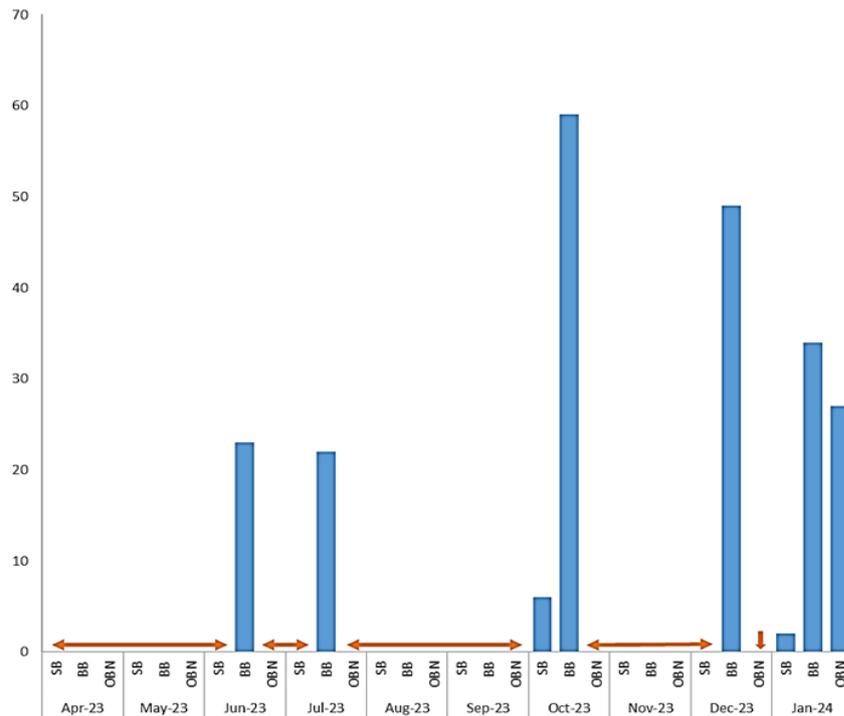
Figure 3.3. Floats collected from beaches in the various precincts. The absence of data is not attributed to the lack of floats, but rather to the absence of reporting.

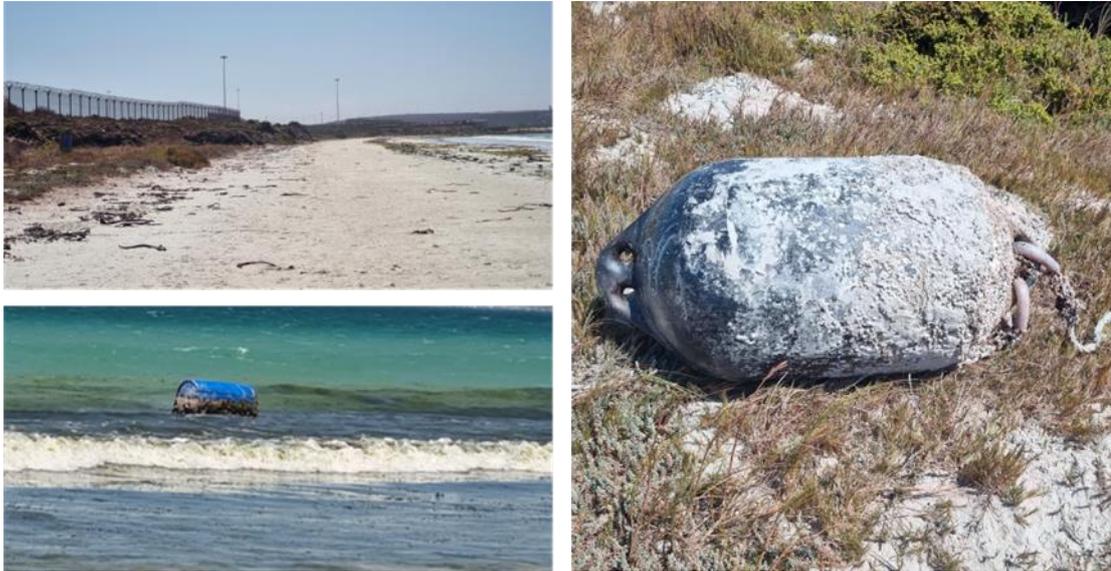
Figure 3.4. Small Bay beach inspection.

The ECO conducted a beach inspection in the Small Bay during the February 2024 audit. There were two large floats, one was washing ashore, and the other was on the beach (Figure 3.4).

Overall, the beach was free of aquaculture debris such as cut ropes and broken pieces of crates. This is because BSASA had just conducted a beach clean-up a couple of hours before the ECO's inspection.
