Incident Management for the Saldanha Bay Aquaculture Development Zone

Version 1: April 2020

Incident Report Form

Sea water pollution observed week ending 03/07/2020

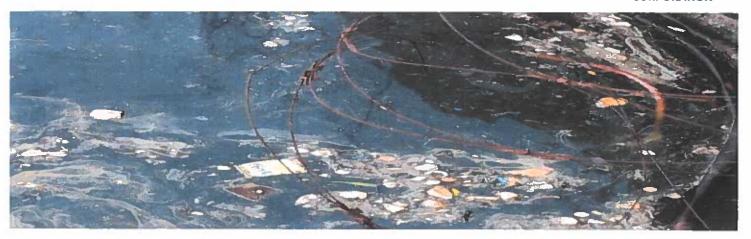
Annexure 1: Pollution observed next to government jetty on 29/06/2020

The Harbour Master was contacted, and he launched a small tugboat to pick up the pieces of sponge and the domestic waste.

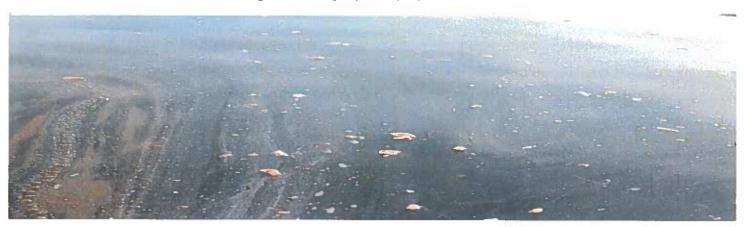
Annexure 2: Pollution observed next to government jetty on 29/06/2020

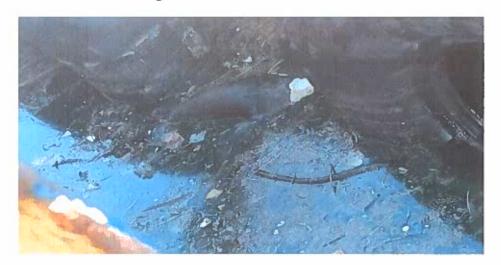
Annexure 3: Pollution observed next to government jetty on 01/07/2020

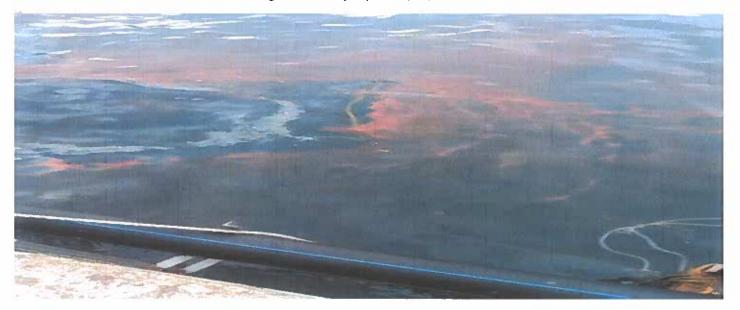
Annexure 4: Pollution observed next to government jetty on 02/07/2020

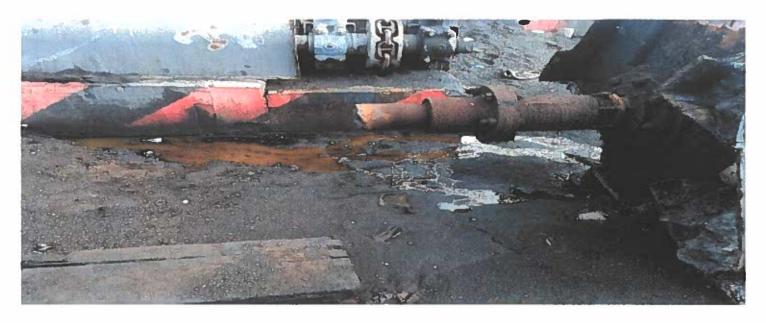
Annexure 1: Oily water running down at slipway, Saldanha

What is the reason that planned c	hanges did not prevent a recurrence of the incident?
N/A	
What is to be changed to ensure t	hat the incident will not be repeated? (Detail)
The oily water of the run-off from the	e vessels on the slipway should be contained in Steel bund-wall. Domestic bins should have lids and not be
Section Two: To be con	mpleted by the ECO
Does the incident comprise a con-	
What action has been taken?	iate actions been taken to the satisfaction
of the ECO?	iate actions been taken to the satisfaction
Have all parties signed the incider	nt form?
D-4-	
Date	Farm manager
Date	ECO

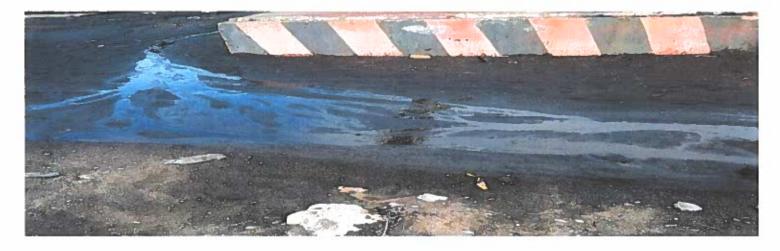
Annexure 2: Oily water running down at slipway, Saldanha

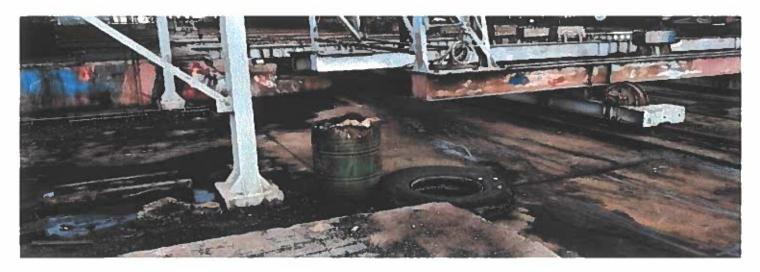
The tide had risen on Sunday morning (28/06/2020) which knocked over the full bin (Refer Annexure B)

Annexure 3: Over full bin containing sponges and oily water running down at slipway, Saldanha

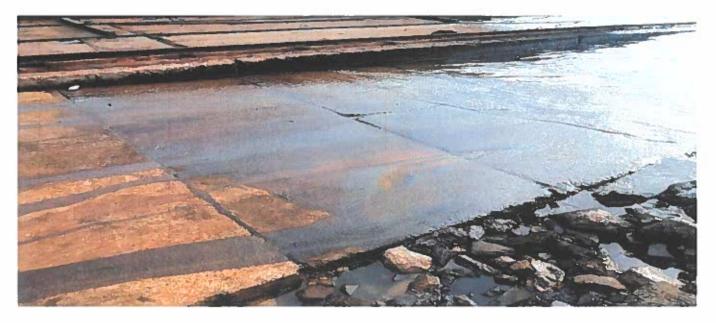
Annexure 4: Oily sheen running down into the sea water at the slipway, Saldanha

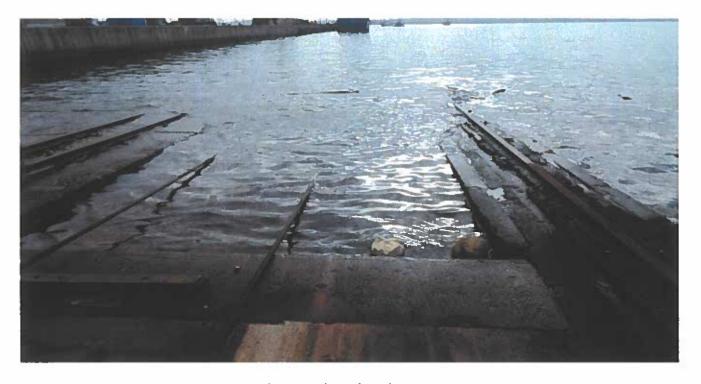
The bins have not been emptied at the slipway and the oily water is still running into the sea. There were still pieces of sponge floating on the sea surface.(Refer **Annexure A**)

Annexure 5: Remaining sponges observed at the slipway
